***Federal Railroad Administration  
Office of Railroad Safety  
Accident and Analysis Branch***

***Accident Investigation Report  
HQ-2019-1329***

***Union Pacific Railroad Company (UP) Derailment  
Lynndyl, Utah  
March 30, 2019***

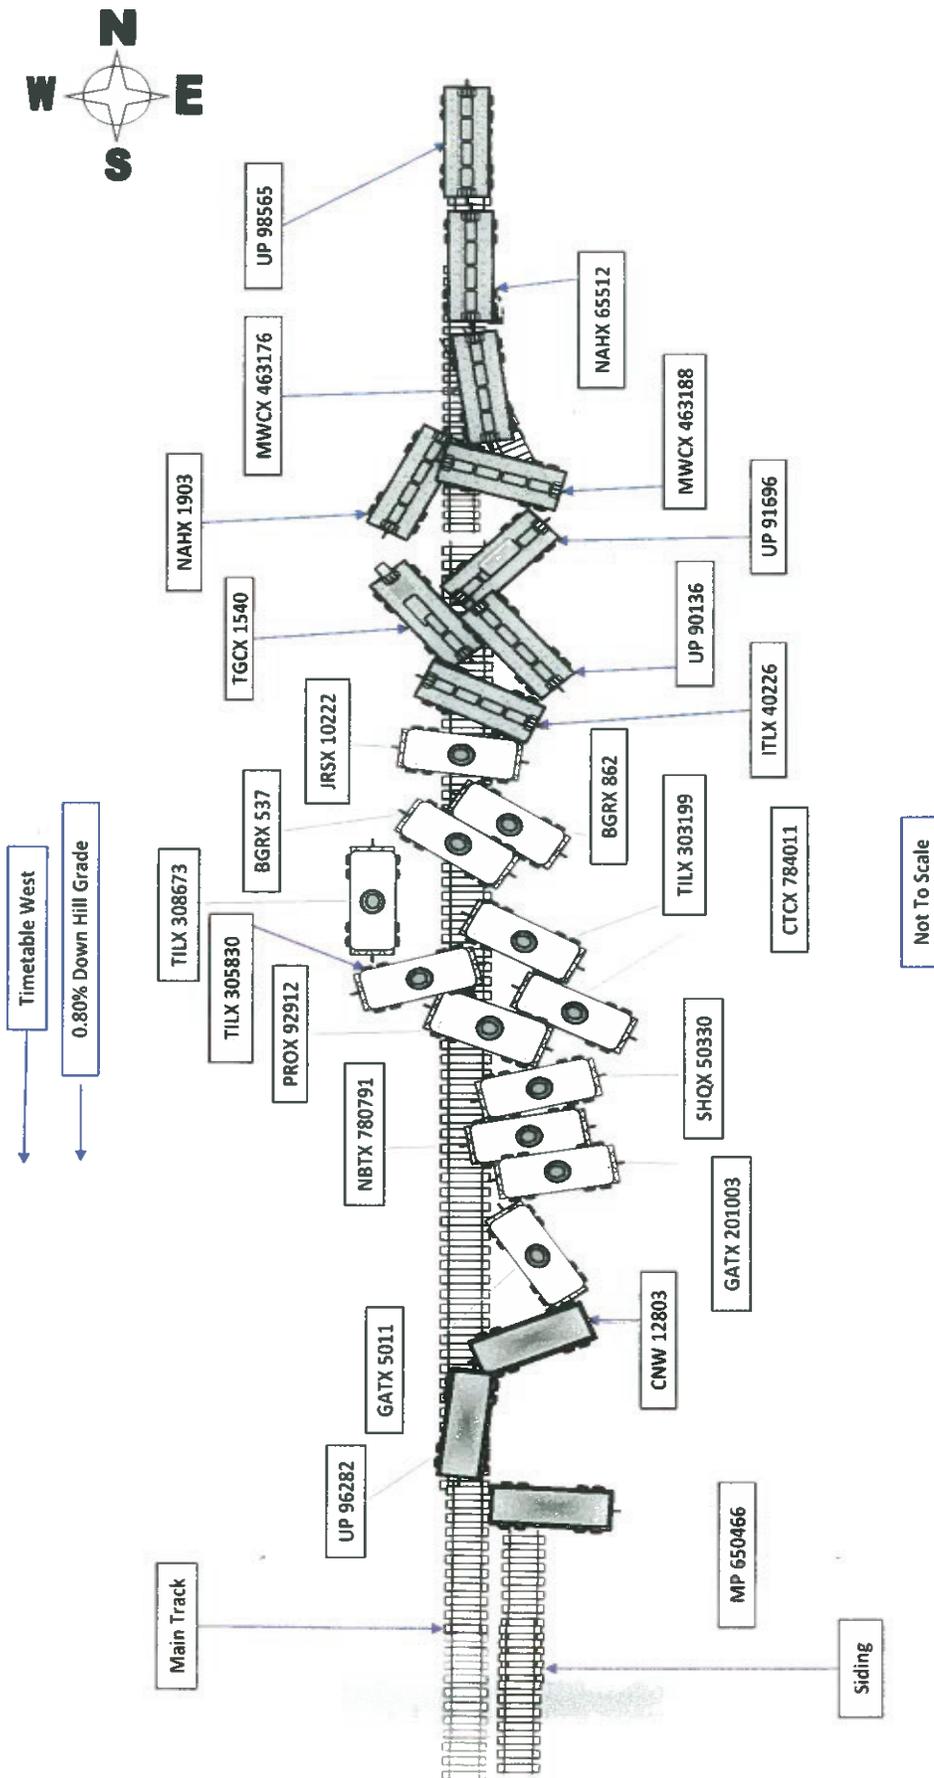
Sketch - Lynndyl Sketch

At approximately 9:06 a.m., Train 1 experienced an undesired emergency brake application at MP 685.7. The train had derailed 24 freight cars of various car types, representing lines 18-41 from the head-end, at approximately MP 686.5, station Jericho, on the UP Lynndyl Subdivision. The derailment occurred in a remote area of Juab County, Utah, approximately 20 miles east of Lynndyl. At the time of the derailment, the train was traversing a 0.80-percent downhill grade on tangent track with the PTC system cut in, in moderate dynamic brake, maintaining 35 mph. The maximum speed for this train was 50 mph. The crew called the dispatcher and told him that they were in emergency and the conductor was going to walk the train. The conductor could smell the escaping propane gas vapor. He then notified the engineer of the

Approximately 600 feet of mainline track and 600 feet of siding track were torn up along with another 600 feet of mainline rail rolled over, requiring 32 track panels to repair. Also, the power switch at MP 692.7 was damaged and minor damage sustained on the ties between MP 696.7 to MP 686.5, representing the initial point of derailment to the derailment site.
