***Federal Railroad Administration  
Office of Railroad Safety  
Accident and Analysis Branch***

***Accident Investigation Report  
HQ-2019-1359***

***Union Pacific Railroad Company (UP) Derailment  
Hillsboro, Texas  
August 19, 2019***

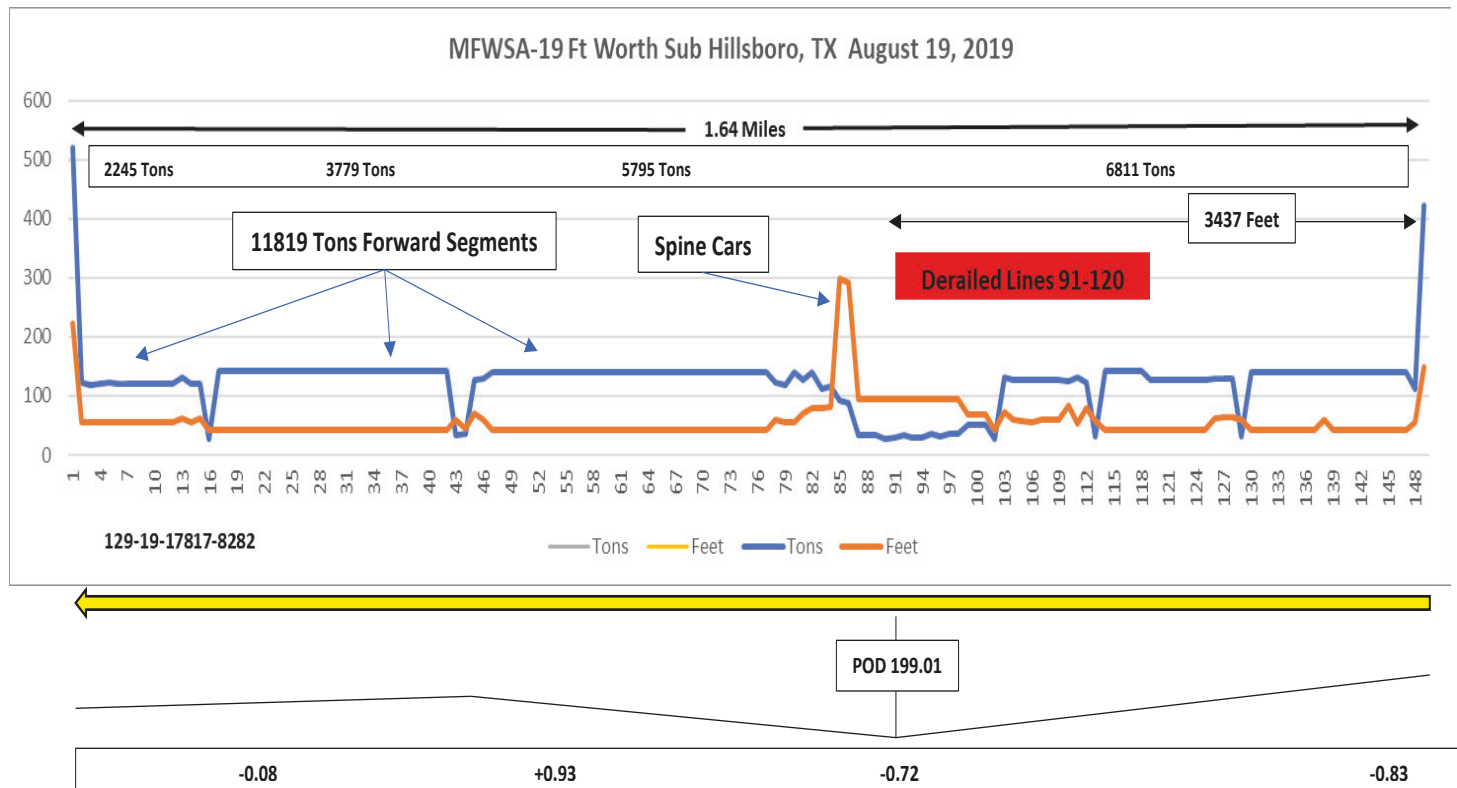
**Sketch - MFWSA Analysis**

**UP 8758 WRE RECORDER Data Analysis – 1 Minute Graph Data**

SPEED @ MP 199 = App 51 MPH due to run-in push from rear.

No Air Brakes Applied

Throttle = T2, T1, IDLE

Dynamic Brake Set-up @ MP 199

Dynamic Brake % @ MP 199 = 45-50%

DPU Rear Throttle = MP 200 T4, MP 199 T5

Hypothesis: The H/E was fenced from the Rear DPU's – with the H/E in Dynamic Brake / the rear pushing T4-5 – as the heavier H/E started uphill – the rear ran into a wall creating excessive buff forces creating vertical lift in the empty flat cars. The forces would certainly be well beyond the acceptable range of 160K Draft and 105K Buff forces.
