U.S. Department of  
Transportation

**Federal Railroad  
Administration**

## **Ground Penetrating Radar (GPR) Technology Evaluation and Implementation: Appendices A Through F**

**BB/Zetica - ZR0345-15-R01-B (Ravenna Sampling Report) -  
12.06.17b**

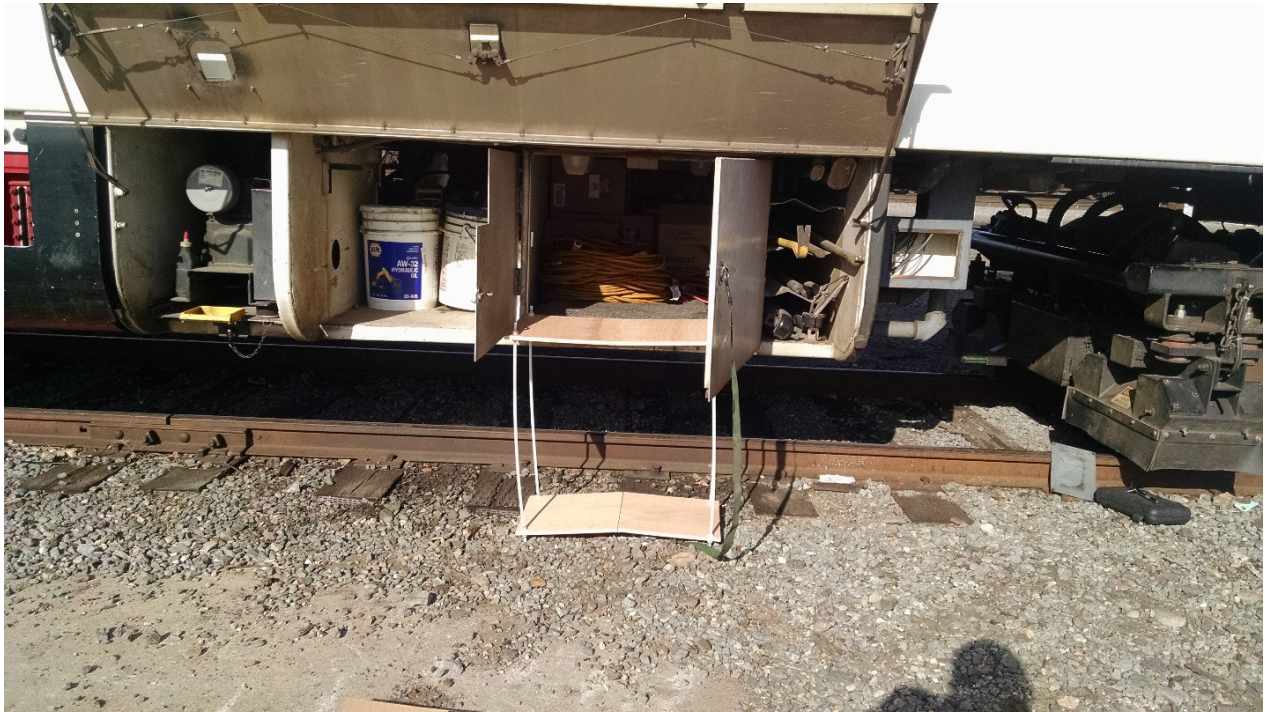
It was agreed that the most practical location to mount the antennas are the storage compartments just aft of the lead truck (Figure A 1). The 2 GHz antennas will fit in this space, toward the outside of the carbody. The storage compartments must be modified. At least one of the 400 MHz antennas can be mounted in the center of this space; the other may be mounted slightly aft in the air compressor compartment, or on the rear of the car near the holding tank compartment if this proves impractical. Additional stringers must be added to the bottom of the storage compartments for strength. Convenient access for cabling can be had by drilling directly through the floor of the coach in the uninterruptible power supply (UPS) room—power locker—and through the floor of the compartment. It may be necessary to use 90- or 45-degree connectors to accommodate the cable, as large bending radii are required.

**Figure A 1. DOTX220 storage compartment with plywood mockup of 2 GHz antenna**

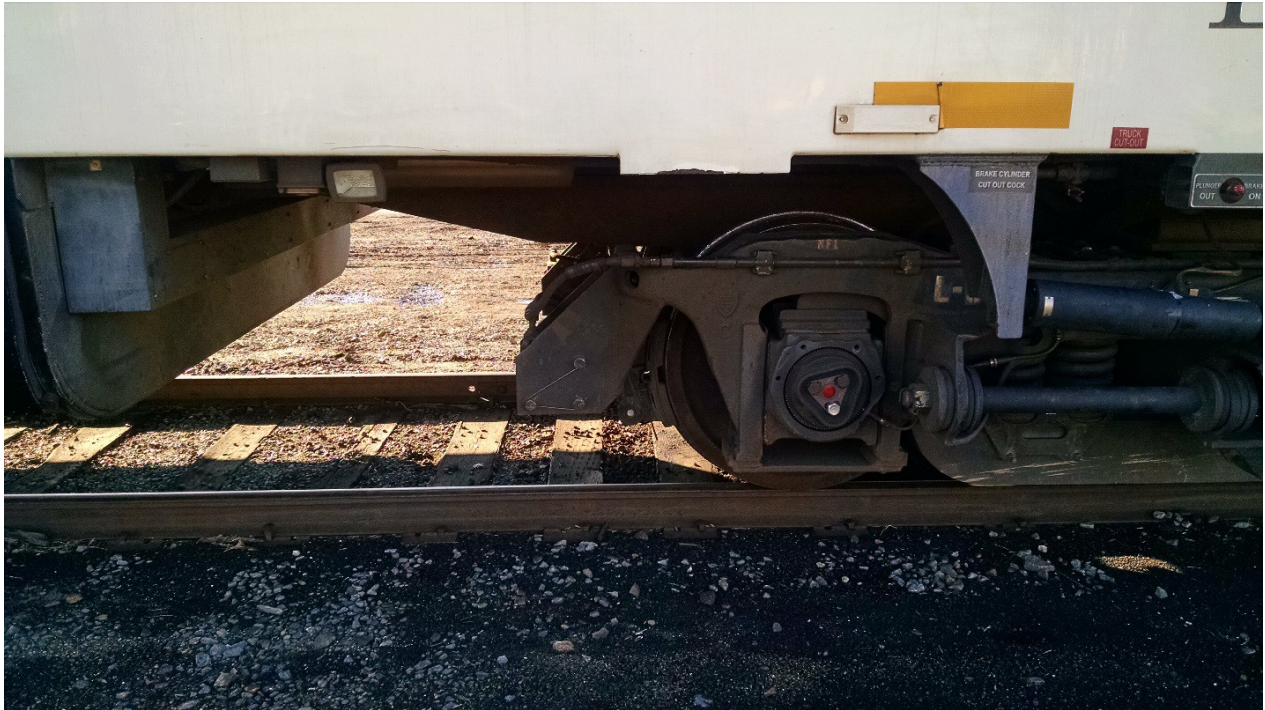
There are two each of the 2 GHz antennas and 400 MHz antennas to be mounted under the DOTX220 car. The car has available space on the trucks and undercarriage. Possible places to mount the antennas include the rear end—observation end—of the car between the holding tank and the truck (Figure A 2), between the rear truck and the rear end of the car, and between the trailing end of the lead truck and the storage forward storage compartments. ENSCO expressed a desire to reserve the space at the rear end of the car for future equipment. It was also decided to keep the area aft of the leading truck clear, so that maintenance crews have free access to service the TG measurement system (Figure A 3). Approximately 7 inches of both potential spaces must be kept clear for truck rotation.

**Figure A 2. DOTX220 available space between tank and rear truck**

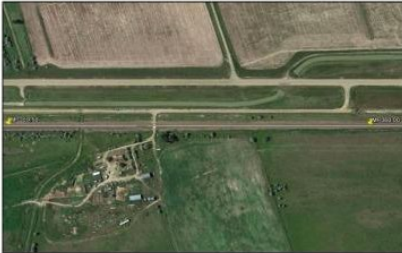
<b>Trackbed Condition Summary</b>	The overall condition of the trackbed within this 1/2 mile is classified by the CTQI as Moderate. A short section of Poor quality trackbed is identified either side of the road crossing at MP359.718. The modelled BFI throughout the 1/2 mile in the track center is Highly Fouled and the modelled free-draining layer (FDL) depth is typically less than 4 inches, indicating minimal clean ballast. On the shoulders the ballast condition is slightly better with predominantly Moderately Fouled ballast and a slightly deeper average FDL (~8 inches). Despite the high fouling the layer interfaces within the trackbed are relatively flat with no significant evidence of sub-grade failure resulting in the Moderate CTQI rating.
<b>Trackbed Layer Summary</b>	A well-defined primary layer interface, interpreted as the base of ballast, is evident throughout the majority of the 1/2 mile on both shoulders at a modelled depth of between 8 to 20 inches. In the center the interface lies at similar modelled depths but is less continuous. As indicated in the Trackbed Condition Summary above, the profile of the interface is typically smooth suggesting that the trackbed is relatively stable. There is no evidence within the GPR data of the formation of ballast pockets or developing mud spots. On the right shoulder a secondary interface identified from MP359.539 to MP359.604 and from MP359.876 to MP360.000 at modelled depths of between 32 - 48 inches, has been interpreted as the likely top of sub-grade.

<b>Trackbed Defects Summary</b>	No significant trackbed defects identified within this 1/2 mile.

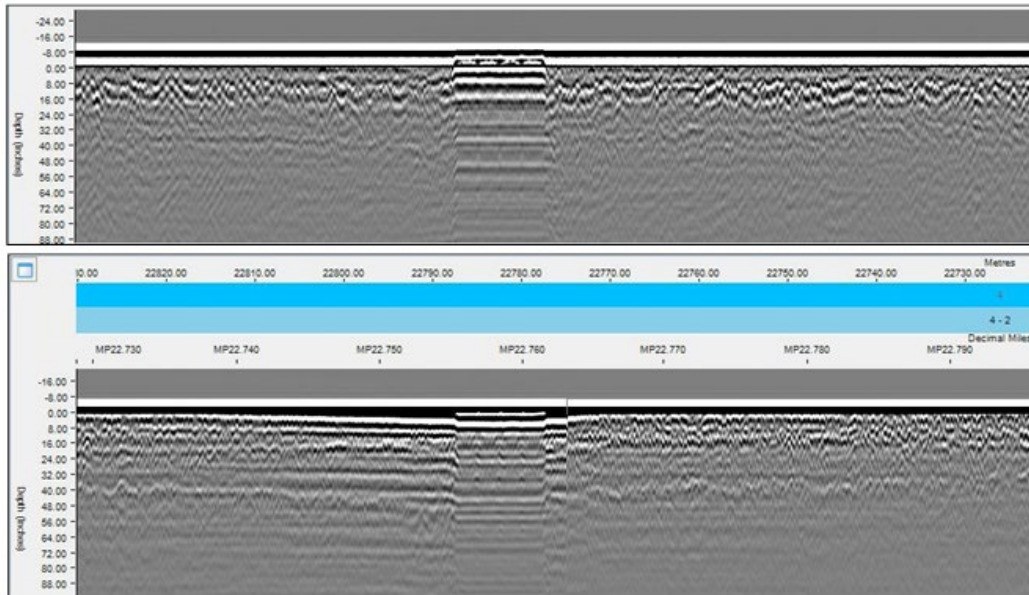
- The 400 MHz data from DOTX220 at the bottom acquired over wood ties on Main 2 is similarly of reduced quality in terms of definition of sub-surface layer interfaces when compared to the hi-rail dataset.

**Figure E 14. (Top) DOTX220, (bottom) hi-rail**

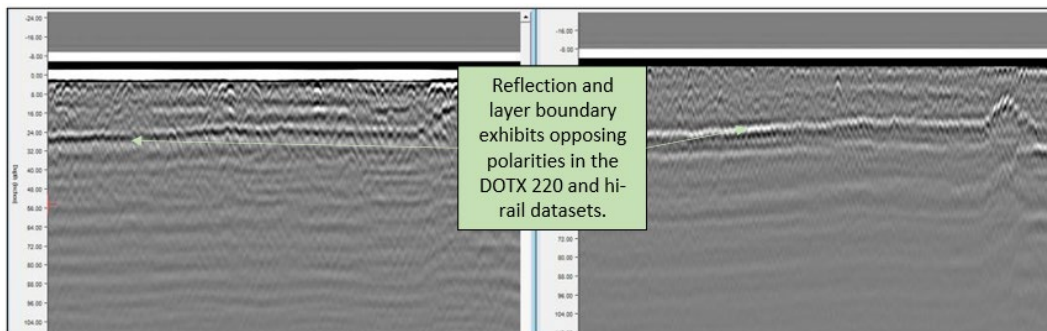
- Where layer reflections are observed in the DOTX220 400 MHz dataset the polarity of the reflection is reversed compared to the same reflection in the hi-rail data.
- This points to a potential problem with the 400 MHz antenna on DOTX220 during the Ravenna survey.

**Figure E 15. (Left) DOTX220, (right) hi-rail**

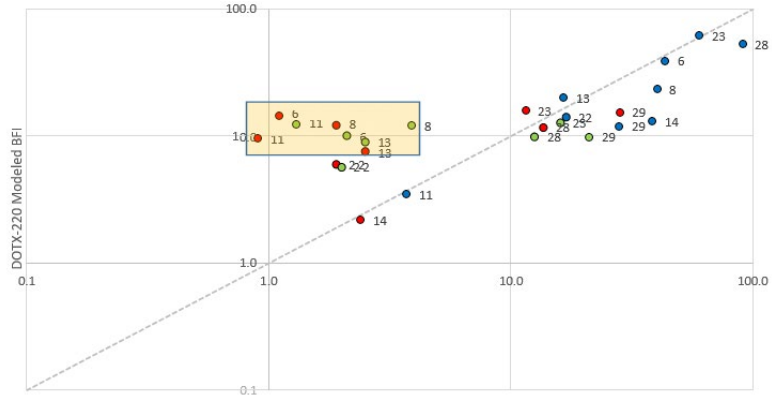
- Samples acquired on the ballast shoulders over concrete ties—exclusively Main 1—sit above the 1- to-1 line, indicating a discrepancy between the train and hi-rail results.
- Whilst this discrepancy may be partly due to the different positions of the shoulder antennas on the two vehicles it is also attributed to residual interference observed within the DOTX220 dataset.

**Figure E 21. Residual interference attributed to shoulder antennas on the two vehicles**

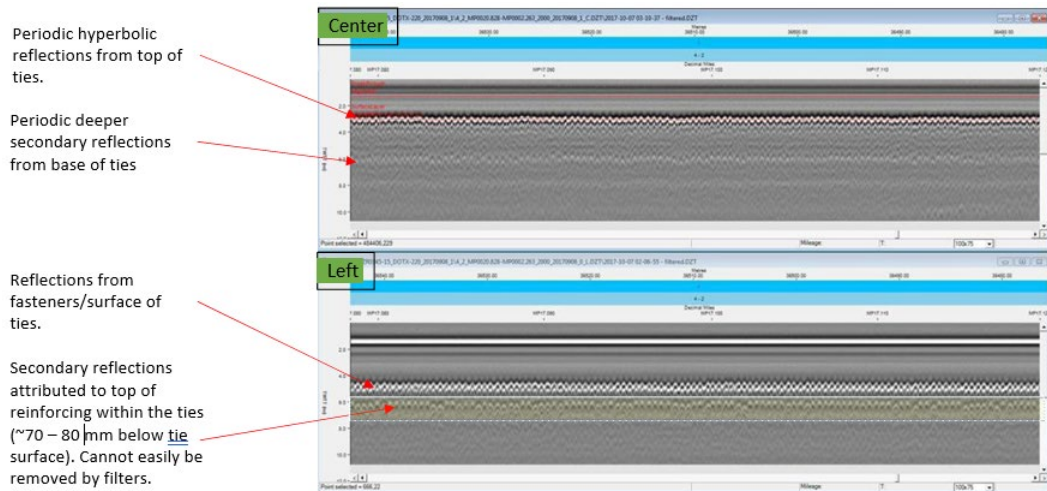
- Examination of the raw 2 GHz data from these outlier shoulder locations suggests that the modeled BFI has been affected by residual near-surface hyperbolic artefacts highlighted in [Figure E 22](#) associated with the reinforcing bars within the ties.
- This effect is not observed in the track center data due to the different orientation of the antenna, which is optimized to avoid electromagnetic coupling with the reinforcing.

**Figure E 22. BFI has been affected by residual near-surface hyperbolic artefacts**

- To address the issues identified with the DOTX220 datasets the following recommendations are made: Consider moving the shoulder 2 GHz antennas up by ~50 mm to take advantage of the increased width of the Plate C clearance envelope at 360 mm above top of rail. This is illustrated in the figure below.

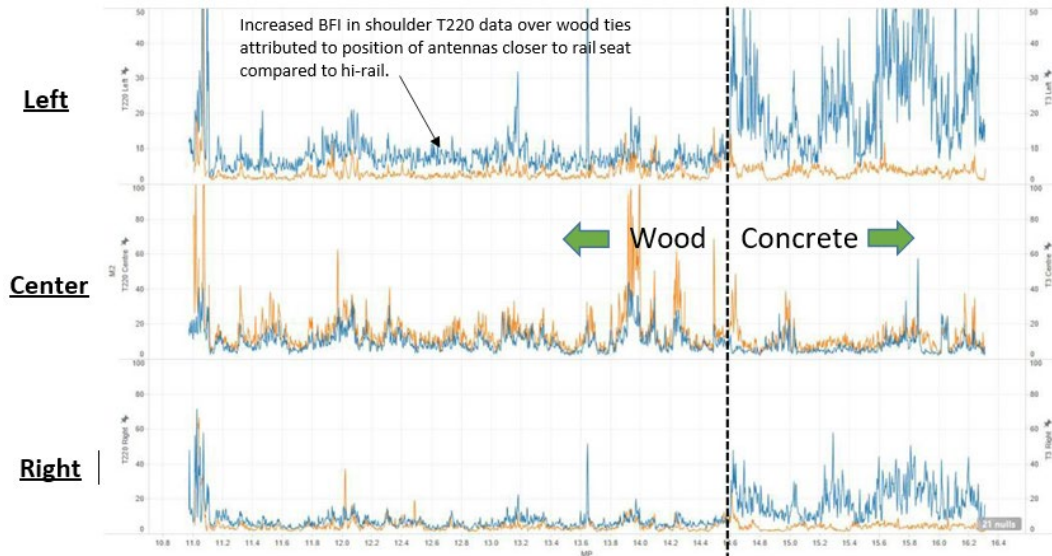
(orange) and DOTX220 (blue) for a section of both wood and concrete ties on Main 2 between ~MP 11.0 and MP 16.3. The transition from wood to concrete occurs at ~MP 14.6

**Figure E 25. Increased BFI in shoulder T220 data over wood ties**

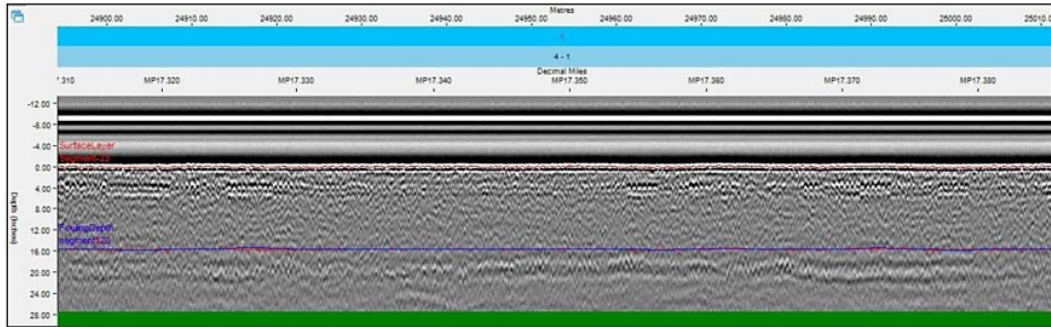
**Figure E 26. Well-defined deep ballast/sub-grade interface at ~18–20 inches depth**

The right shoulder 2 GHz radargram from recently constructed track on Main 1 at ~MP 17.350 illustrates well-defined deep ballast/sub-grade interface at ~18–20 inches depth, a deep FDL depth (+16 inches) and BFI of less than 5.

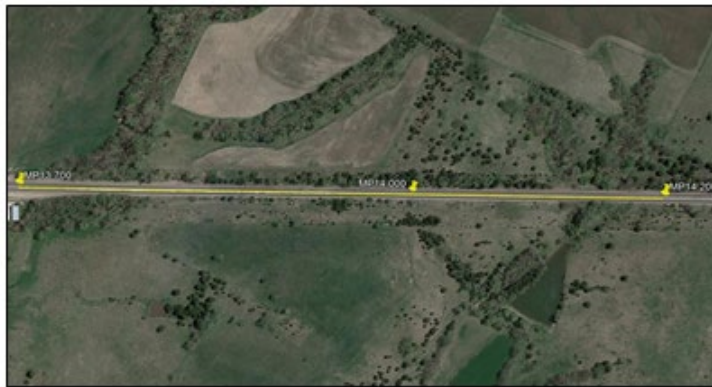
**Table F 1. Trackbed inspection report summary**

<b>Trackbed Condition Summary</b>	The general condition of the trackbed within this 1/2 mile is classified by the Combined Trackbed Quality Index (CTQI) as Good, with relatively low levels of ballast fouling (predominantly CAT 4 - Moderately Clean) on all three data channels (left & right shoulders and track center) and a Good to Poor free-draining layer depth of between 8 to +16 inches. Short sections of Moderate to Poor quality trackbed are associated with localized defects (see below). Increases in track geometry Profile and Twist have been identified at a number of locations within this section but all lie within exception limits for the posted track speed / class.
<b>Trackbed Layer Summary</b>	A well-defined Primary layer interface interpreted as the base of clean ballast, has been identified in the track center for the majority of the 1/2 mile and less continuously on the ballast shoulders. <del>With the exception of</del> a number of identified ballast defects, the modeled depth to the interface is generally at or close to design depth, lying at between 16 - 20 inches from surface. Through much of this section, local increases in reflection strength on the primary interface and attenuation of the GPR signal in the underlying materials suggest that the sub-grade is likely to comprise relatively moist, cohesive materials. On the right shoulder, the Primary interface is generally absent and is instead replaced by a more uniform Secondary interface lying at modeled depths of between 24 - 28 inches. This interface is interpreted as the base of sub-grade. Between ~MP13.700 and MP13.780 it is additionally evident within the track center and on the right shoulder.

<b>Trackbed Defects Summary</b>	<b>MP13.774 - MP13.785, MP13.840 - MP13.852, MP13.865 - MP13.879, MP14.060 - MP14.018, MP14.149 - MP14.158 - Ballast pockets:</b> These are characterized by localized increases in the depth to the Primary layer interface of between 4 - 8 inches indicative of possible locally soft subgrade / soil conditions. They are predominantly observed within the track center. The three anomalies between MP13.774 and MP13.879, are associated with small-scale deviations (<math>\pm</math>0.5 inches) in track geometry Warp, Twist and Profile. Examination of aerial imagery of the site indicates that the defect between MP14.149 and MP14.158 coincides with an apparent cross-cutting drainage feature and may be associated with an unidentified cross-track culvert or pipe. A similar pocket has been identified at the same location in the GPR data acquired on Main 2 (see TBIR# ZR0345_2017_0002). <b>MP13.788 - MP13.801, MP13.943 - MP13.999, MP14.048 - MP14.069, MP14.091 - MP14.115 - Subgrade pumping / failure, mud spot development:</b> These defects are characterized by localized reductions in the modeled depth to the Primary layer interface, indicative of potential intermixing of the ballast and sub-ballast materials. The shallowest and most extensive of the defects occurs between MP13.943 and MP13.999. The western end of this feature is associated with a slight deterioration in track geometry quality. A similar deterioration is observed over the defect between MP14.091 and MP14.115.

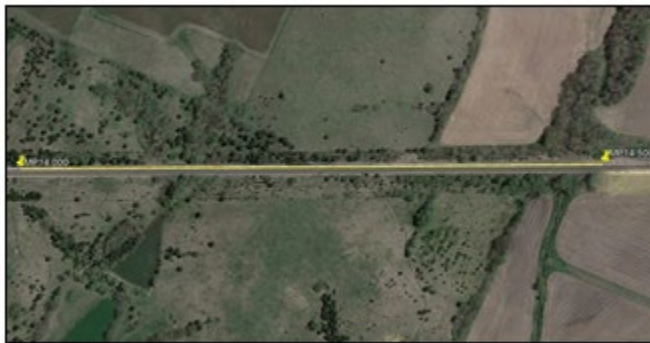
**Table F 2. Trackbed inspection report summary (continued)**

Trackbed Condition Summary	The condition of the trackbed within this 1/2 mile is classified as generally Moderate to Good within areas outside of the identified trackbed defects. The condition on the ballast shoulders is typically slightly better than that of the track center, primarily as a result of improved ballast quality. Areas of Poor quality trackbed are characterized by modeled ballast fouling ranging from Moderately Fouled to Fouled, a shallow (<8 inches) modeled free-draining layer (FDL) depth, particularly in the track center, and an irregular ballast profile.
Trackbed Layer Summary	A well-defined continuous Primary layer interface has been identified over the majority of the 1/2 mile on all three data channels (left & right shoulders and track center) at modeled depths of between <4 inches and 24 inches. The interface is variably interpreted as representing the boundary between clean ballast and fouled material, and clean ballast and sub-grade. There is no evidence of a deeper, secondary, interface within the 2GHz datasets indicating that the base of the trackbed lies below ~3 feet through this section. No 400MHz data was available from the DOTX-220 survey.

Trackbed Defects Summary	<p><b>MP14.000 - MP14.012 - Ballast pocket:</b> Characterized by a localized increase in the modeled depth to the Primary layer interface from ~10 - 16 inches to over 20 inches on both the left and right shoulders attributed to soft sub-grade conditions. Attenuation of the GPR signal below the interface is potentially indicative of increased % moisture within the underlying materials.</p> <p><b>MP14.019 - MP14.112 - Insufficient clean ballast thickness, mud spot development and surface mud:</b> This section of track is characterized by a shallow Primary layer interface (&lt; 8 inches in center) and correspondingly shallow FDL together with evidence of both active (surface) and developing (sub-surface) mud spots in the center and on the right shoulder. Coincident with this defect is a well-defined negative (Dip) left and right profile deviation of ~1 inch in the track geometry data, potentially indicating locally soft trackbed conditions. The deviation does not constitute a track geometry exception for the posted track speed/class.</p> <p><b>MP14.135 - MP14.153 - Ballast pocket:</b> This feature comprises a relatively broad low in the ballast profile that extends to a modeled depth of ~28 inches. It is coincident with a cross-track drainage feature visible in aerial imagery of the site and may be associated with an unidentified culvert/pipe. A similar anomaly is identified here in the GPR data acquired on Main 1.</p> <p><b>MP14.214 - MP14.300 - Developing and active mud spots, insufficient clean ballast thickness, elevated % moisture:</b> This defect is characterized by an irregular and very shallow (&lt;4 inches) Primary layer interface and correspondingly shallow FDL. The elevated reflection amplitude of the Primary interface and attenuation of the signal in the underlying materials is potentially indicative of elevated moisture levels within the near-surface materials. Various TG surface parameters are slightly elevated within this section but lie within exception limits.</p> <p><b>MP14.376 - MP14.404 - Ballast pocket (center only), MP14.485 - MP14.495 - Active mud spot (center only):</b> Well-defined ~30-ft wide anomaly. No significant track geometry response.</p>

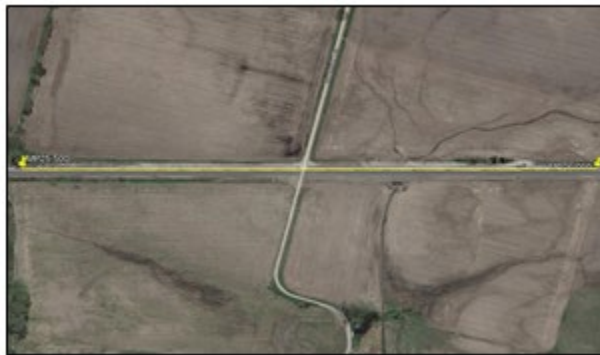
**Table F 3. Trackbed inspection report summary (continued)**

<b>Trackbed Condition Summary</b>	The overall condition of the trackbed within this 1/2 mile is classified by the Combined Trackbed Quality Index (CTQI) as Moderate to Poor in the track center and generally Moderate to Good on the shoulders. The main contributing factors to areas of Poor quality trackbed in the center are elevated levels of ballast fouling (modeled ballast fouling index [BFI] of Moderately Fouled or higher), a relatively shallow modeled free-draining layer (FDL) depth (< 8 inches) and a corresponding shallow Primary layer interface (the interpreted ballast/sub-ballast interface). On the shoulders both the BFI and the FDL are typically better than in the center.
<b>Trackbed Layer Summary</b>	A well-defined Primary layer interface has been identified for the majority of the 1/2 mile on all three data channels (left & right shoulders and track center) at modeled depths of between 4 - 20 inches below ballast surface. The interface generally lies close to or sits slightly below the modeled FDL suggesting that it most commonly represents the boundary between clean and fouled ballast. The highly irregular depth to the interface, which is particularly evident beyond ~MP25.59, points to soft sub-grade conditions and intermixing of the ballast and sub-grade materials. An intermittent secondary interface identified in the shoulder and center data at modeled depths of between 24 - 32 inches is interpreted as the base of sub-grade.

<b>Trackbed Defects Summary</b>	<p><b>MP25.735 - MP25.800 &amp; MP25.880 - MP26.000 - very shallow Primary Interface &amp; FDL (&lt;8 inches):</b> These two areas are characterized by insufficient thickness of clean ballast, as defined by a very shallow modeled free-draining layer depth and correspondingly shallow Primary layer interface, with potential for mud spot formation. The track geometry within each area at the time of the GPR survey was good with no identified exceptions for the posted track speed/class, suggesting that the trackbed is currently stable.</p> <p><b>MP25.839 - MP25.847 - Ballast / subgrade pocket:</b> This defect is characterized by a localized increase in the depth to the Primary layer interface and a corresponding increase in the depth to the base of the underlying sub-grade, consistent with trackbed subsidence. The deviation in the modeled depth to the base of the Primary interface is ~12 inches over a distance of 33 feet. Examination of aerial imagery of the site indicates that the defect coincides with an apparent cross-cutting drainage feature and may be associated with an undertrack culvert.</p> <p><b>MP25.585 - MP25.625 - Potential incipient mud spot development / poor drainage:</b> This defect is characterized by an interpreted localized increase in % moisture at the interface between the ballast and sub-ballast and a decrease in the modeled depth to the interface indicative of potential sub-grade failure. The increase in moisture is characterized by an increase in the GPR reflection amplitude at the boundary and a corresponding increase in attenuation below it, both in the 2G/Hz and 400M/Hz (hi-rail) datasets. The location is also characterized by slightly elevated left and right surface Profile and Twist, although all TG parameters fell below exception levels for the posted track speed/class.</p> <p><b>MP25.539 - MP25.550 - Trackbed subsidence:</b> Characterized by a negative ~1.25-inch deviation in left/right profile coinciding with a localized increase in the depth to the Primary interface in the track center and a possible cross-cutting service (pipe / culvert) observed at a modeled depth of ~32 inches in the hi-rail center 400M/Hz data.</p>
