***Federal Railroad Administration
Office of Railroad Safety
Accident and Analysis Branch***

***Accident Investigation Report
HQ-2019-1350***

***Union Pacific Railroad Company (UP) Derailment
Caliente, Nevada
July 10, 2019***

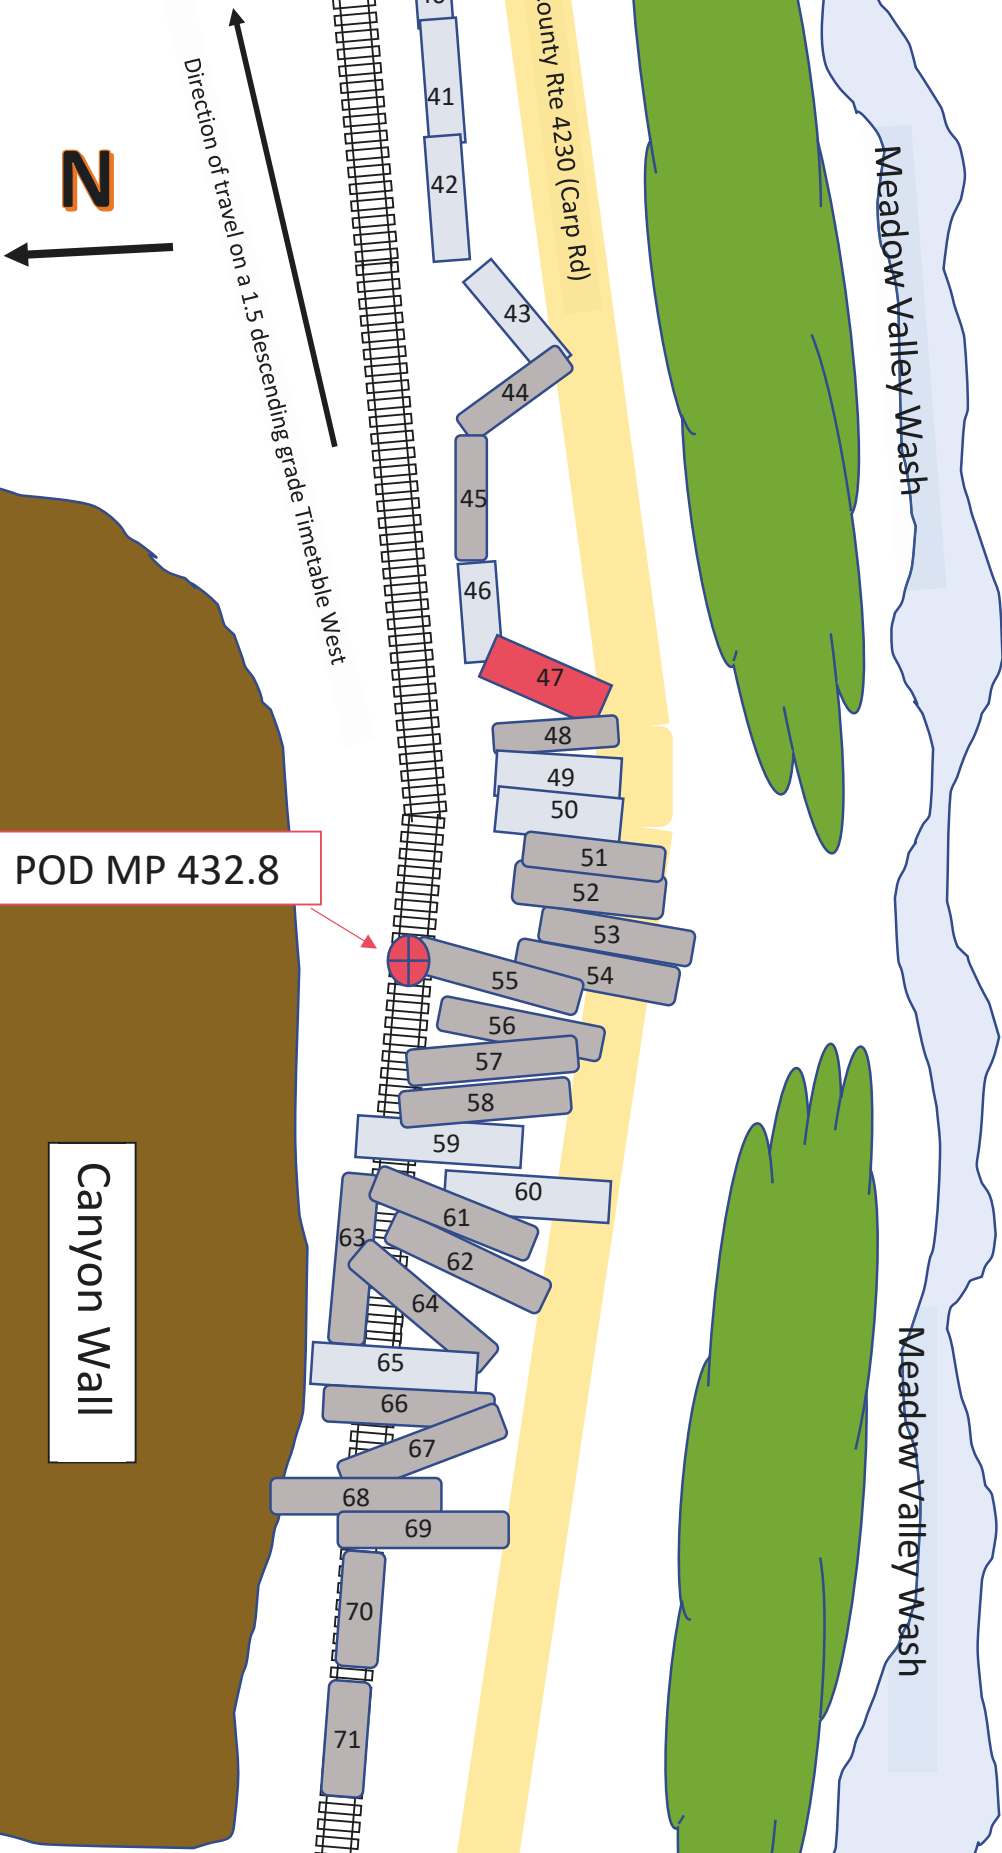
Sketch - Caliente Sketch

Position from Headend	Derailed Cars	
40	TTGX	710709
41	TTGX	999091
42	TTGX	964375
43	TTGX	953269
44	TTGX	994673
45	TTGX	995916
46	CTTX	694232
47	TTGX	940788
48	TTGX	697499
49	TTGX	694824
50	GTW	504147
51	BNSF	301509
52	TTGX	965610
53	CP	542679
54	TTGX	704797
55	TTGX	982680
56	BNSF	301815
57	TTGX	603854
58	CTTX	694260
59	TTGX	993080
60	TTGX	994757
61	TTGX	978314
62	TTGX	985964
63	TTGX	887109
64	TTGX	697212
65	TTGX	978217
66	TTGX	996658
67	TTGX	702433
68	TTGX	712144
69	NKCR	7548
70	TTGX	978331
71	BNSF	301795
