**Federal Railroad
Administration**

In-service Performance of a Truck Component Inspection System

1. AGENCY USE ONLY (Leave blank)		2. REPORT DATE August 2020	3. REPORT TYPE AND DATES COVERED Technical Report December 2016–December 2018	
4. TITLE AND SUBTITLE In-Service Performance of a Truck Component Inspection System			5. FUNDING NUMBERS DTFR53-11-D-00008L Task Order 0018

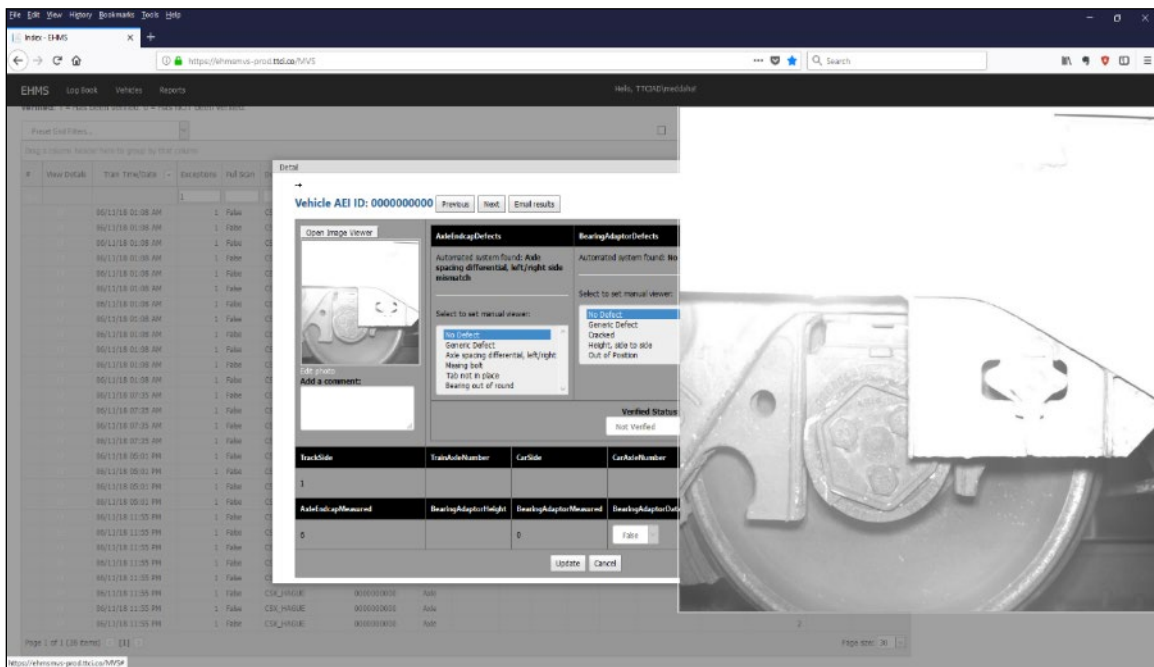
Figure 5 shows an example of an image with an overexposure issue from the AxleScan module. Several similar instances were identified at the Hague site that KLD was notified about. KLD subsequently made changes to correct the exposure.

Figure 5. Over-exposed, washed out image

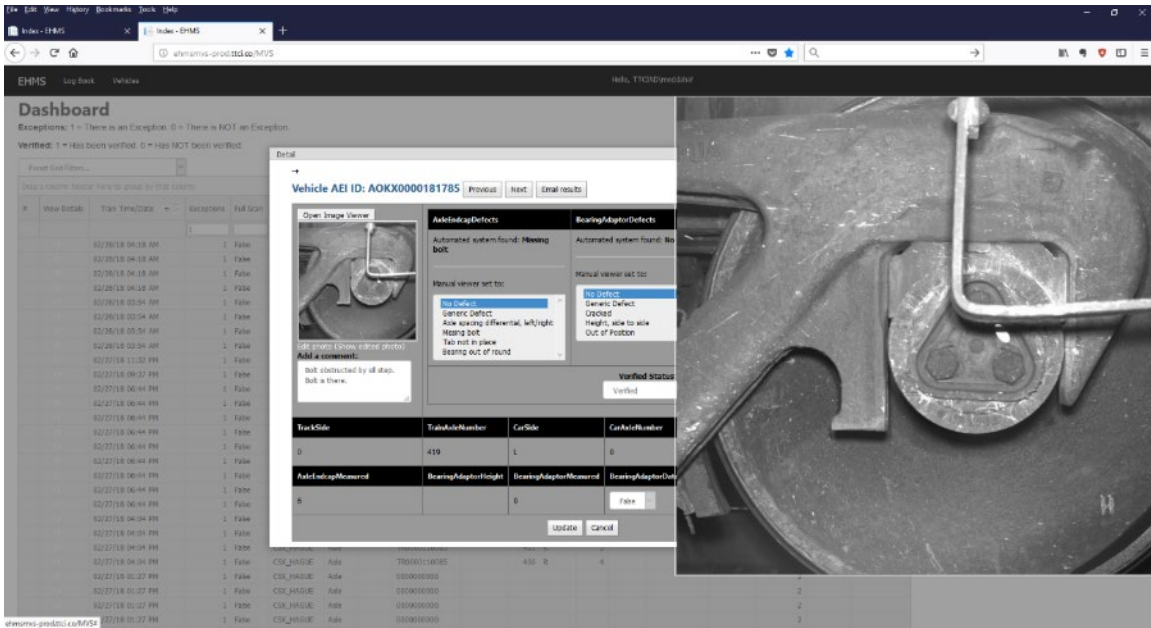
Early on, when the KLD system was deployed, it was observed that the AxleScan algorithm incorrectly identified several instances of missing wheel bolts as vehicles rolled by at track speed. Figure 6 shows a bolt obstructed by sill step, which was flagged as missing. Figure 7 shows an instance where no obstruction was present yet the wheel was still flagged as having a missing bolt. In this case, there was insufficient contrast to detect the bolt.

Figure 6. Obstructed bolt incorrectly flagged as missing

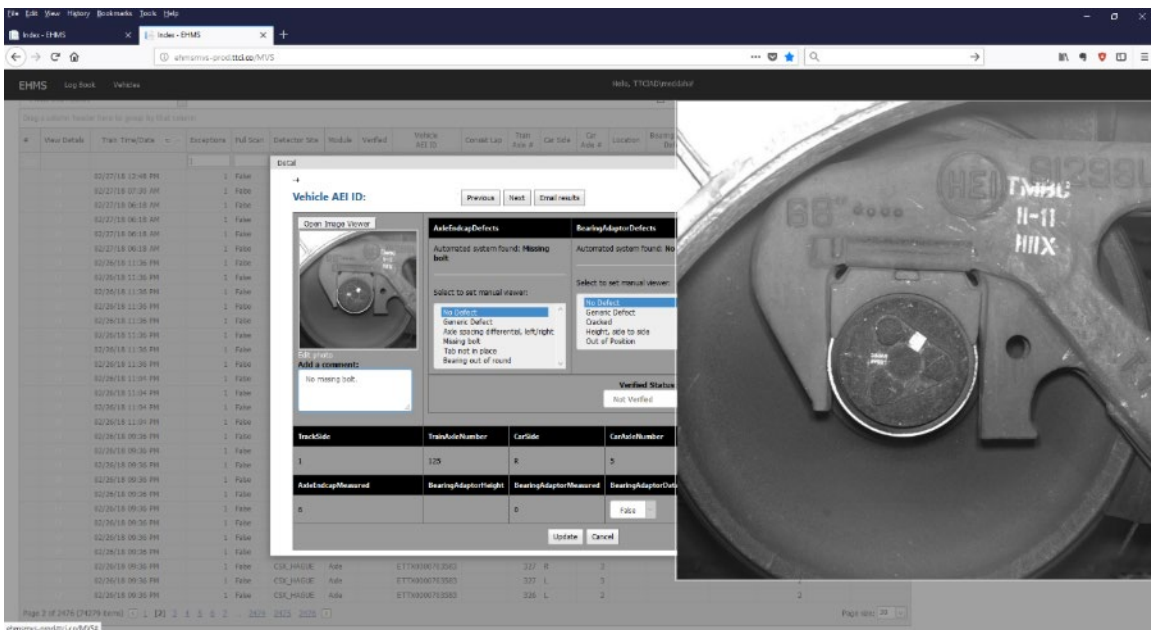
Figure 7. Image example incorrectly identified as missing bolt (all bolts present)

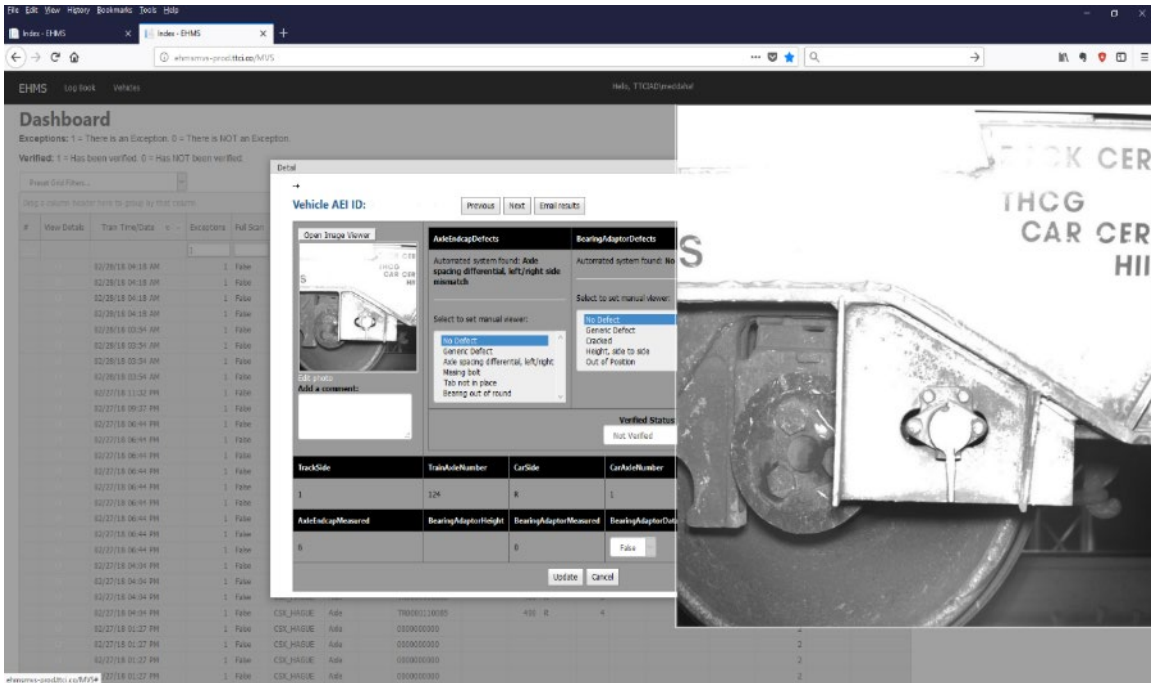
Figure 8. Bolt mostly obstructed yet not flagged as missing

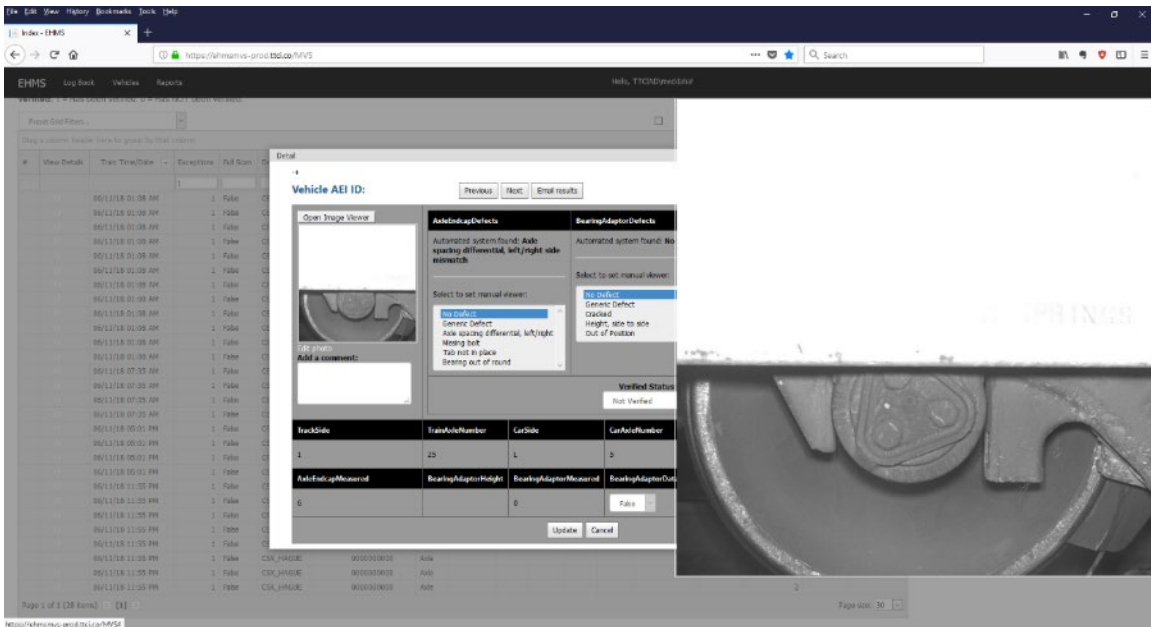
Figure 9. Bolt partly obstructed by side sill and not flagged as missing

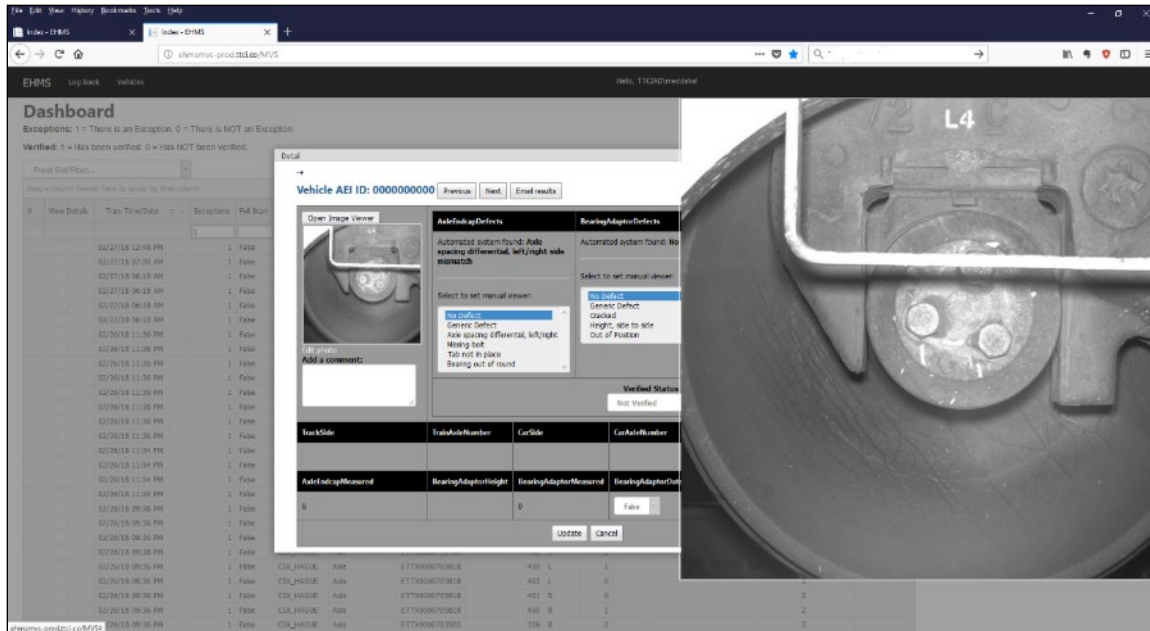
Figure 10. Bolt fully obstructed by sill step

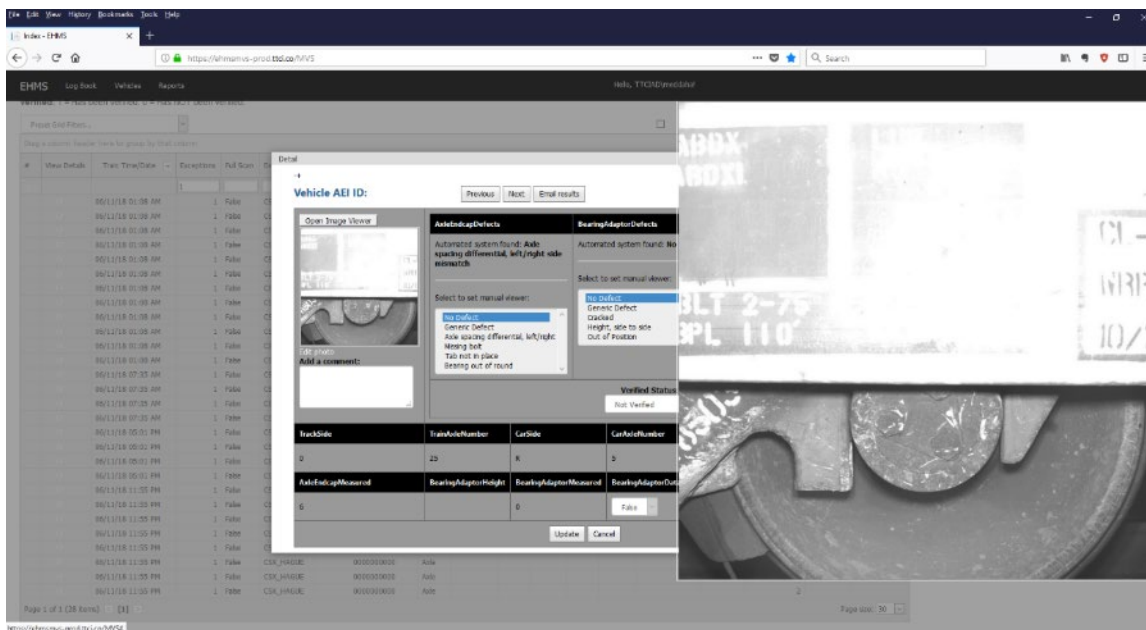
Figure 11. Bolt fully obstructed by side sill

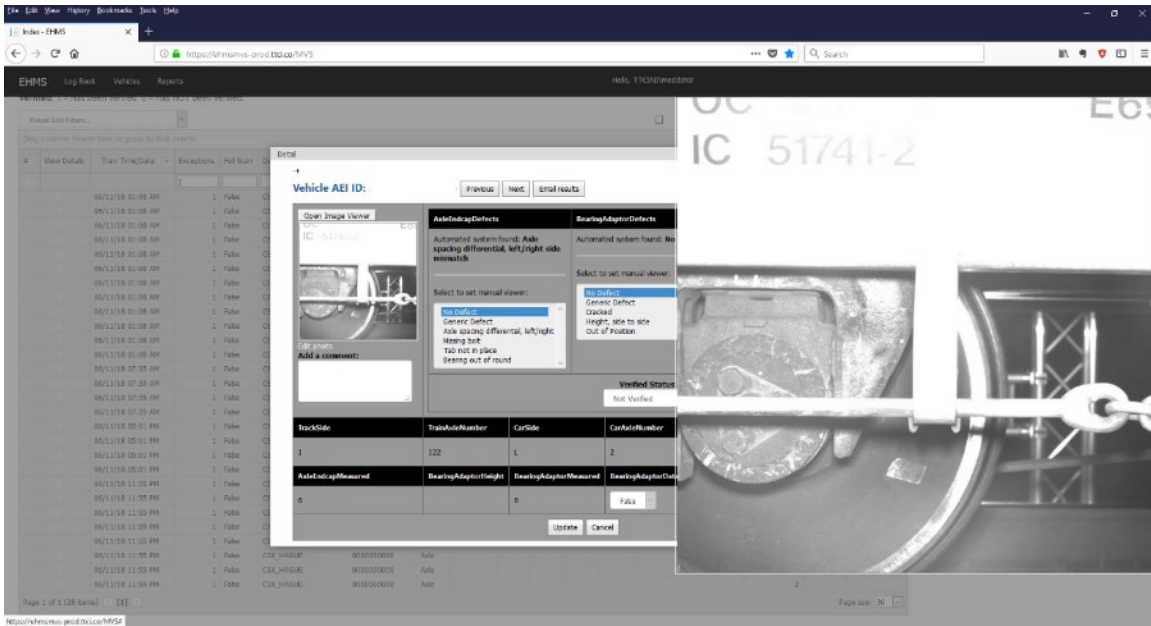
Figure 12. Bolt obstructed by handbrake link

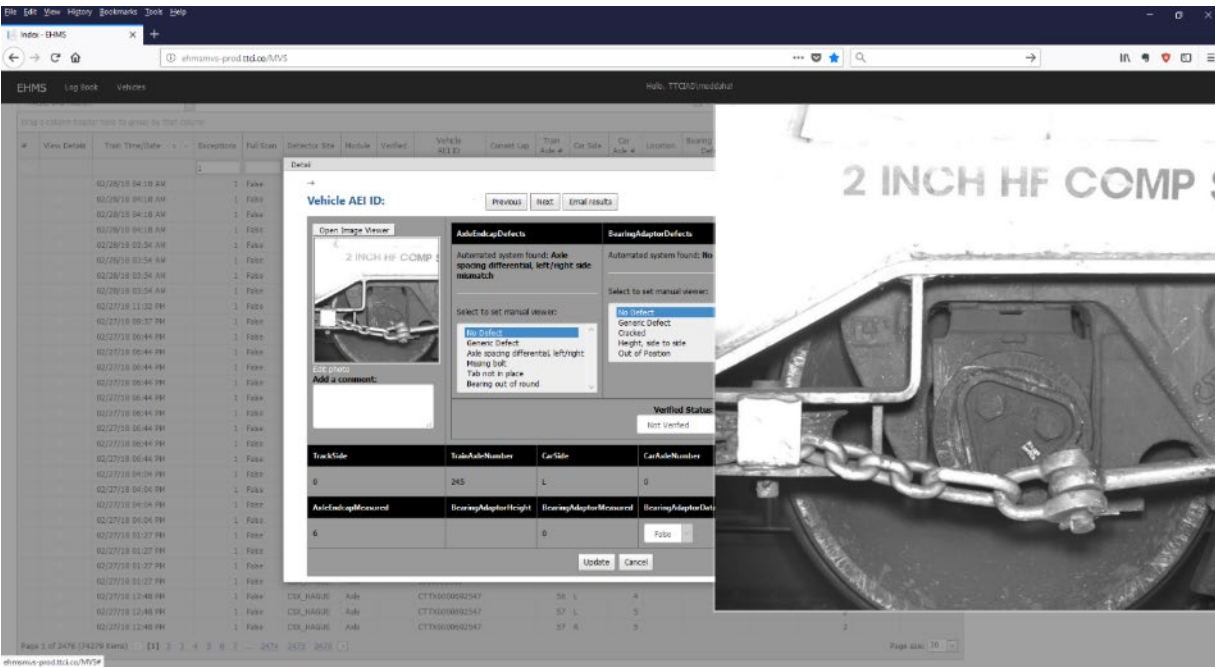
Figure 13. Bolt partly obstructed by handbrake chain and link

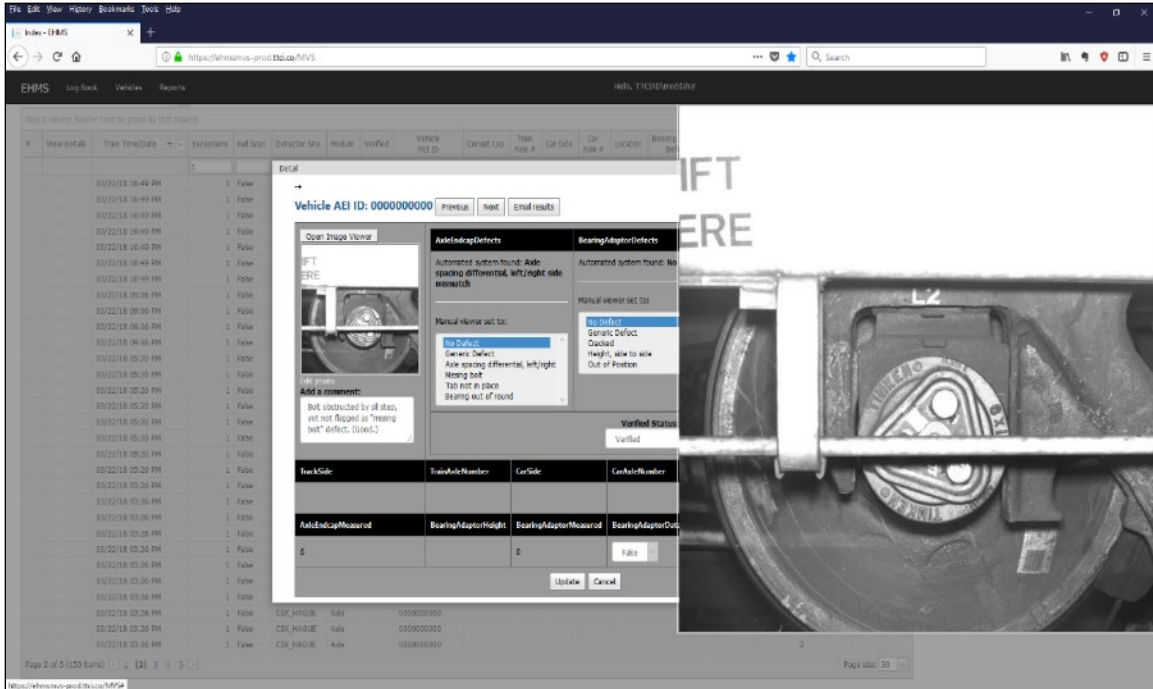
Figure 14. Bolt obstructed by handbrake link

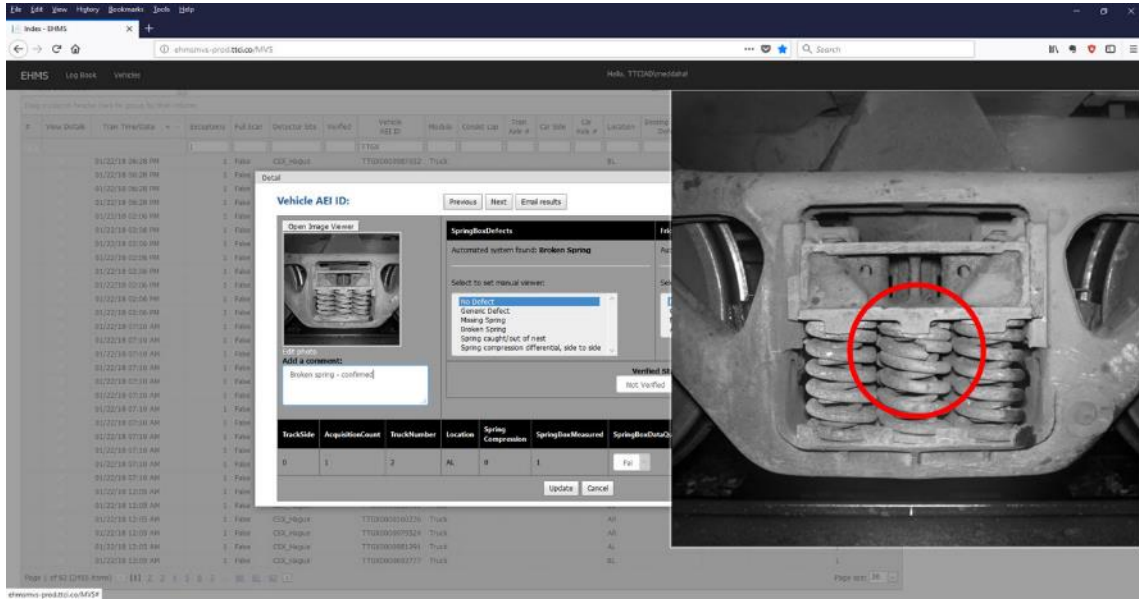
Figure 16 and Figure 17 are examples from the TruckScan module showing, respectively, instances of broken spring and a spring out of nest. Those two instances were not automatically identified. They were detected through manual data reviewing of the raw images and CSX was promptly notified.

Figure 16. Broken spring (circled in red)

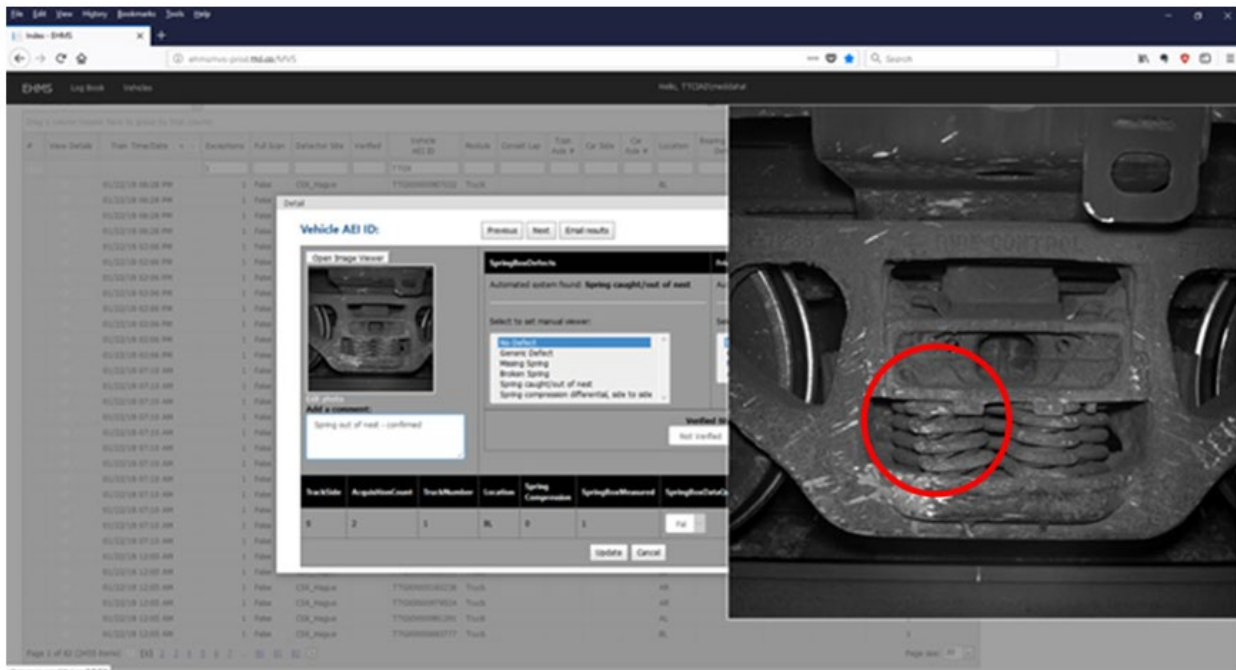
Figure 17. Spring out of nest (circled in red)

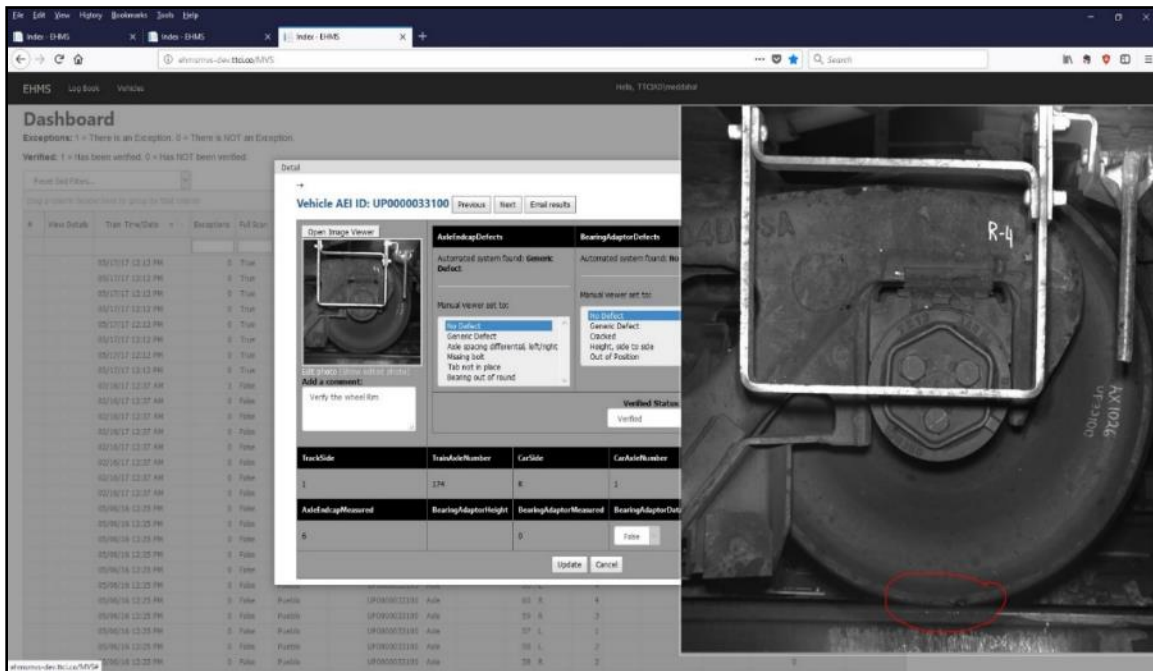
Figure 18 shows an interesting example of a shattered rim wheel that was manually identified by examining the raw images generated onsite at the TTC. Figure 19 shows a zoomed-in image of the defect. Since this event occurred on site, it was possible to locate the defective wheel and verify the event validity. Figure 20 shows the actual wheel with the shattered rim after it had been removed. It should be noted that there is no algorithm yet to automatically identify such defects real-time. This defect was identified and vetted using the manual viewer.

Figure 18. Shattered rim event (circled in red)

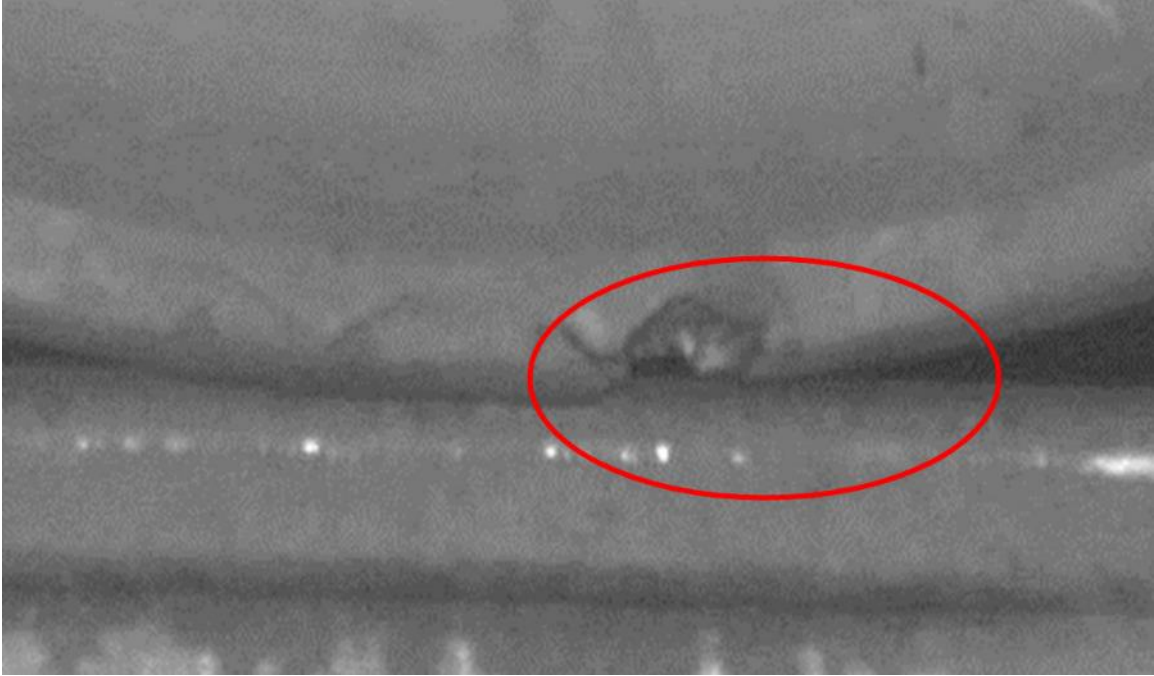
Figure 19. FAST wheel with shattered rim (circled in red)

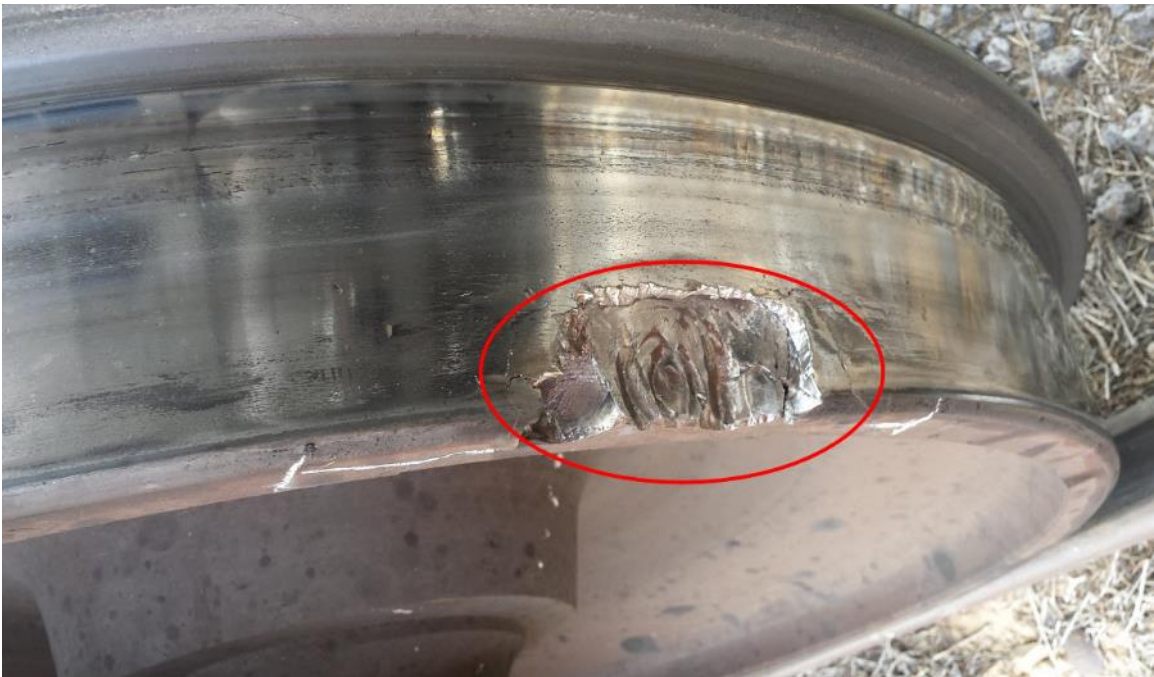
Figure 20. FAST wheel with shattered rim verified in field
