***Federal Railroad Administration
Office of Railroad Safety
Accident and Analysis Branch***

***Accident Investigation Report
HQ-2019-1327***

***Union Pacific Railroad Company (UP) Derailment
Oshkosh, Nebraska
March 3, 2019***

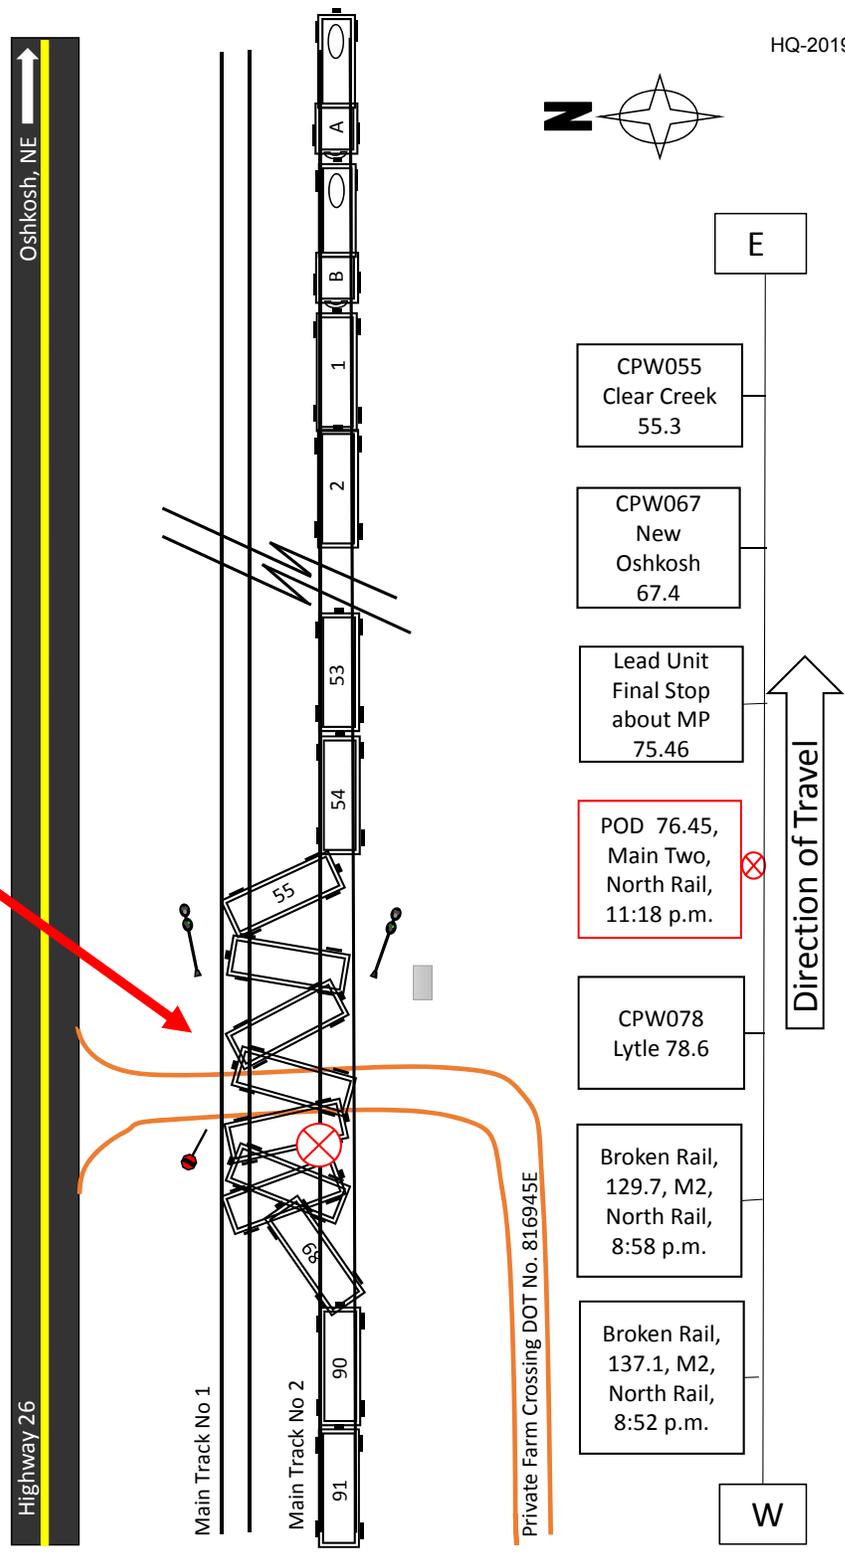
Sketch - S1

Note: All trailing wheels from UCEX 2373, north side (35th from Head), after direction of travel showed marks consistent with a broken rail.

Note: 35 Cars derailed in accordion fashion

POD 76.45,
Main Two,
North Rail,
11:18 p.m.

Broken Rail,
129.7, M2,
North Rail,
8:58 p.m.

Broken Rail,
137.1, M2,
North Rail,
8:52 p.m.
