***Federal Railroad Administration
Office of Railroad Safety
Accident and Analysis Branch***

***Accident Investigation Report
HQ-2019-1373***

***Union Pacific Railroad
Medicine Bow, Wyoming
December 26, 2019***

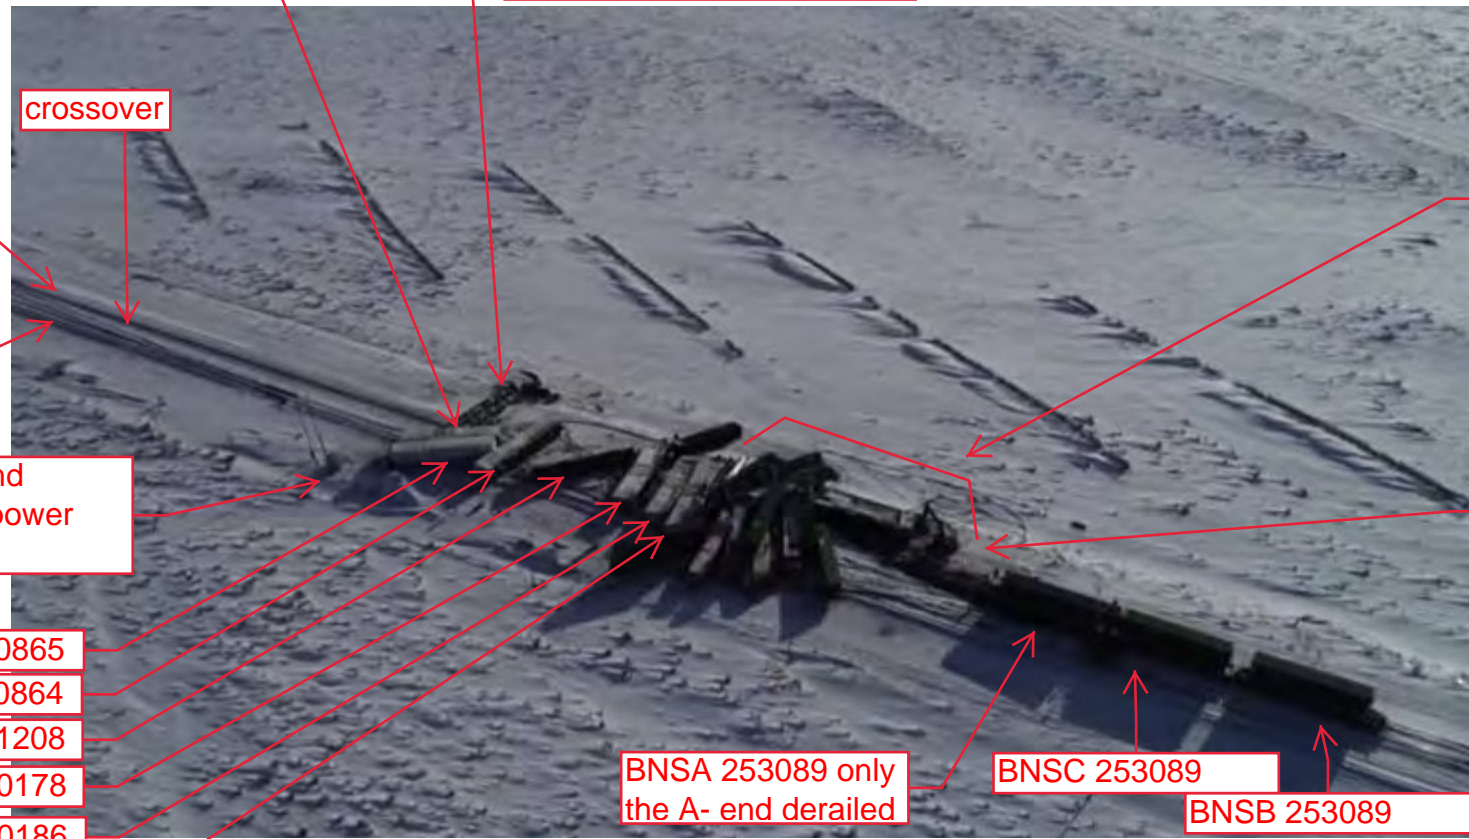
ARMN 110538 is out of frame to the left (East)

This view is from the North looking South
The train was traveling East (toward the left)

ARMN 110606 suspect car

General pile of cars and containers; IAIC 55125, IAIA 55125, TTAX 753196 (5 pack), DTTX 865584 (2 spine), DTTA 888953, DTTC 888953, DTTB 888953, DTTX 646798 (2 spine)

BNSA 253089 only the A- end derailed

These two cars not derailed
