***Federal Railroad Administration
Office of Railroad Safety***

***Accident Investigation Report
HQ-2020-1399***

***Kansas City Southern Railway Company (KCS) Derailment
Mauriceville, Texas
October 29, 2020***

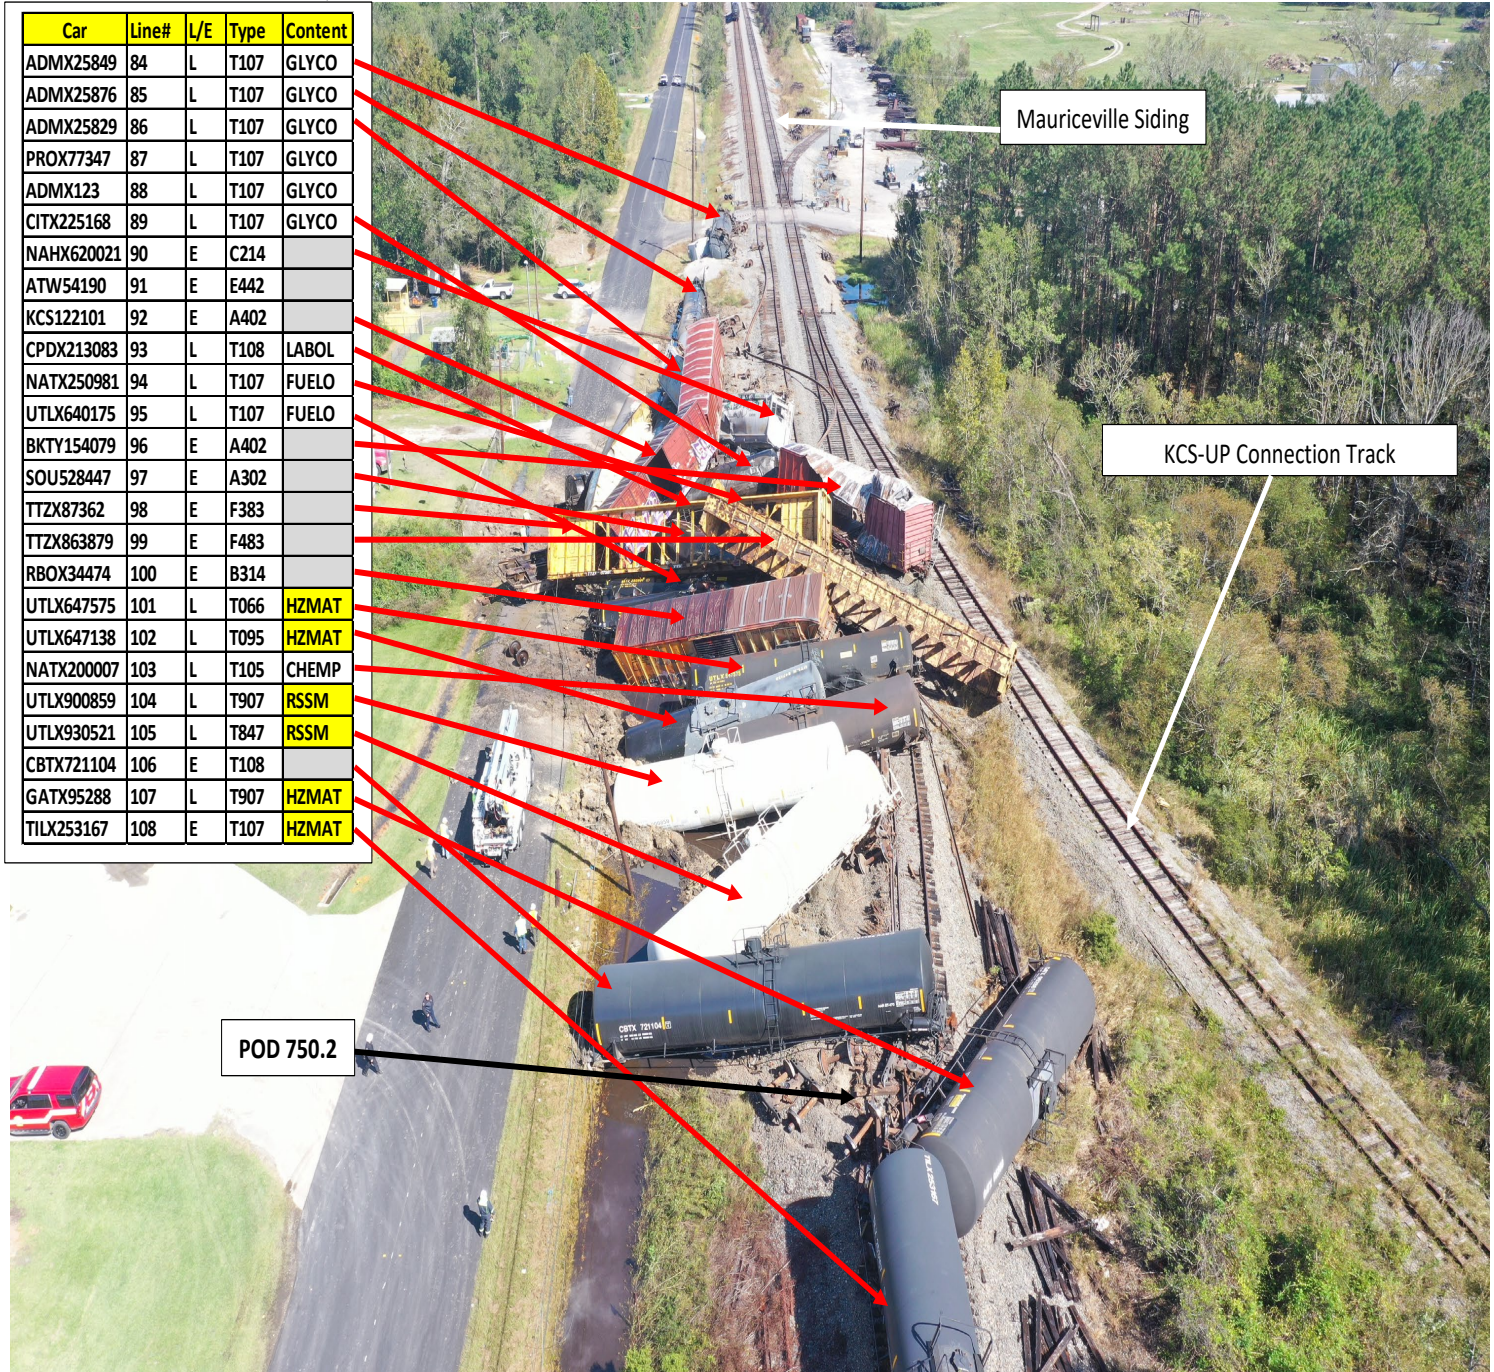
Sketch - Sketch

KCS Derailment Mauriceville, TX MP750.2 October 29, 2020 7:23AM CDT View North
