***Federal Railroad Administration
Office of Railroad Safety
Accident and Analysis Branch***

***Accident Investigation Report
HQ-2020-1397***

***BNSF Railway Company (BNSF) Derailment
Temple, Texas
September 6, 2020***

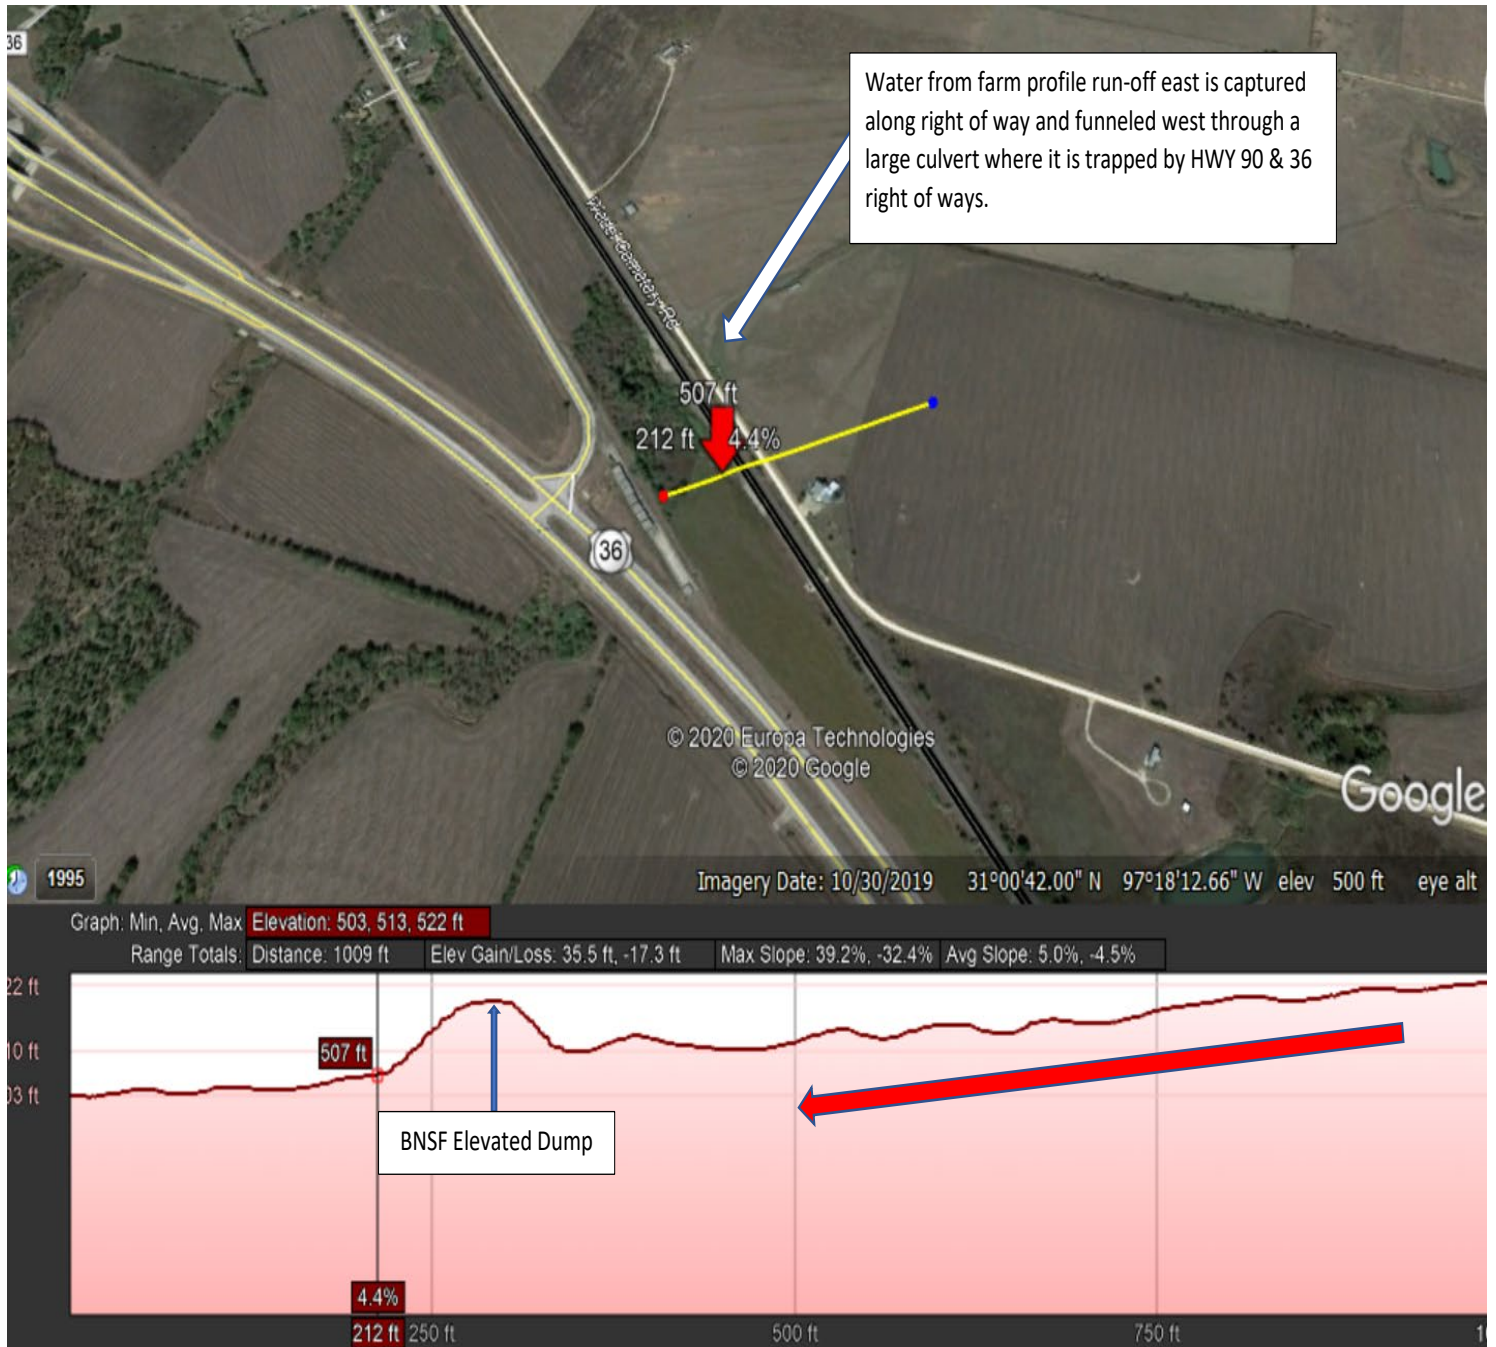
Sketch - Area Drainage Profile

Heidenheimer, TX Derailment Site – Drainage Profile 09282020

Prior to the derailment, BNSF stated there was 6-7 inches of rainfall recorded at this location in a three-day period. A flash flood order had been in effect from MP 198 going southbound prior to the time of derailment. No flash flood order was in effect at the time of the derailment.

The Roadmaster stated that this segment of track was a chronic location for the subgrade failing to hold geometry, and that track surfacing was performed every month leading up to the derailment to keep the track in compliance with FRA Class 4 standards. The Roadmaster could not give an exact date of the last time this segment of track was surfaced. Grout injections were completed in July of 2019 in this segment of track.

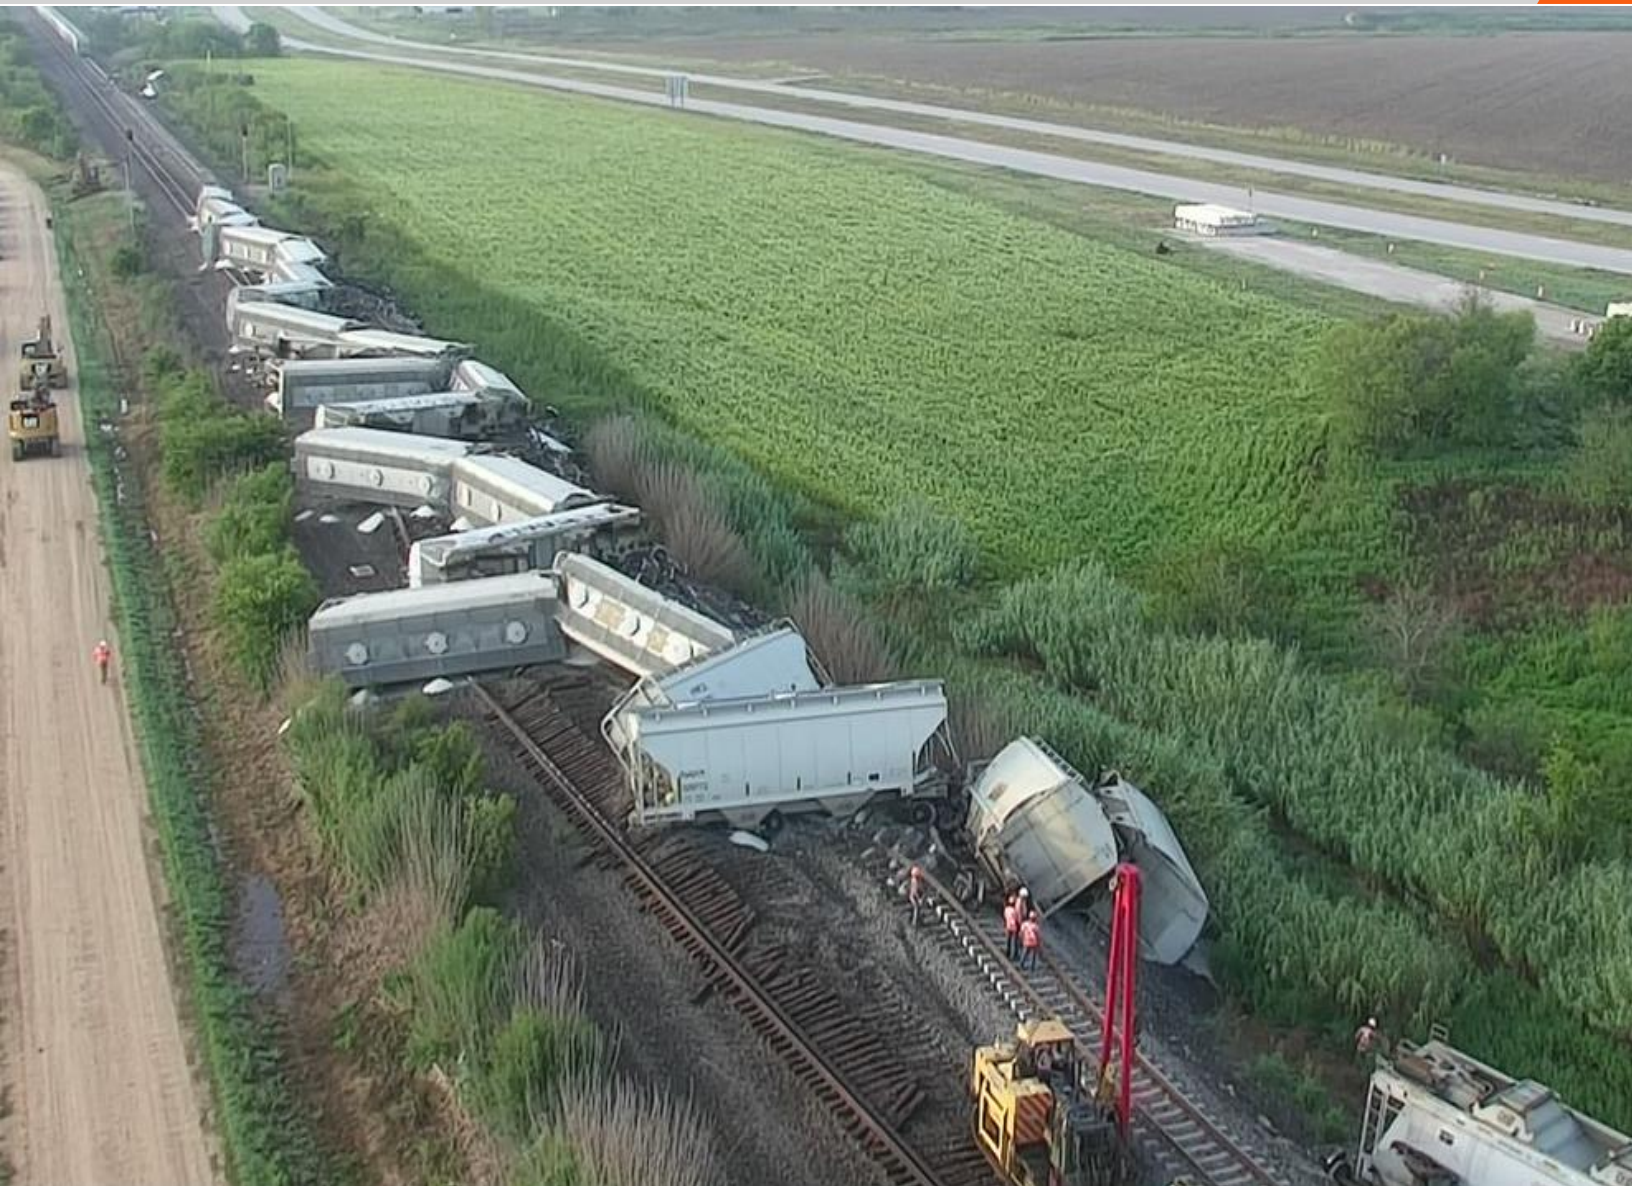
Sketch - Drone Overview

U-OGISOX-0-02T Looking South

At approximately 12:37 a.m., CDT, on September 6, 2020, Train 1 was moving southbound on Main Track 1 at a recorded speed of 39 mph when it encountered poor track conditions at MP 211.0 due to subgrade failure. As cars traversed the track over the subgrade location, the west field side of the track collapsed causing cars 62 and 67-91 (inclusive) to derail in an accordion-fashion – fouling both main tracks.

Following the derailment, a total of 74 track panels were used to reconstruct the main tracks and temporarily restore service (51 track panels in Main Track No. 1 and 23 track panels in Main Track No. 2). A subgrade stabilization project is now planned to be completed in the coming months.

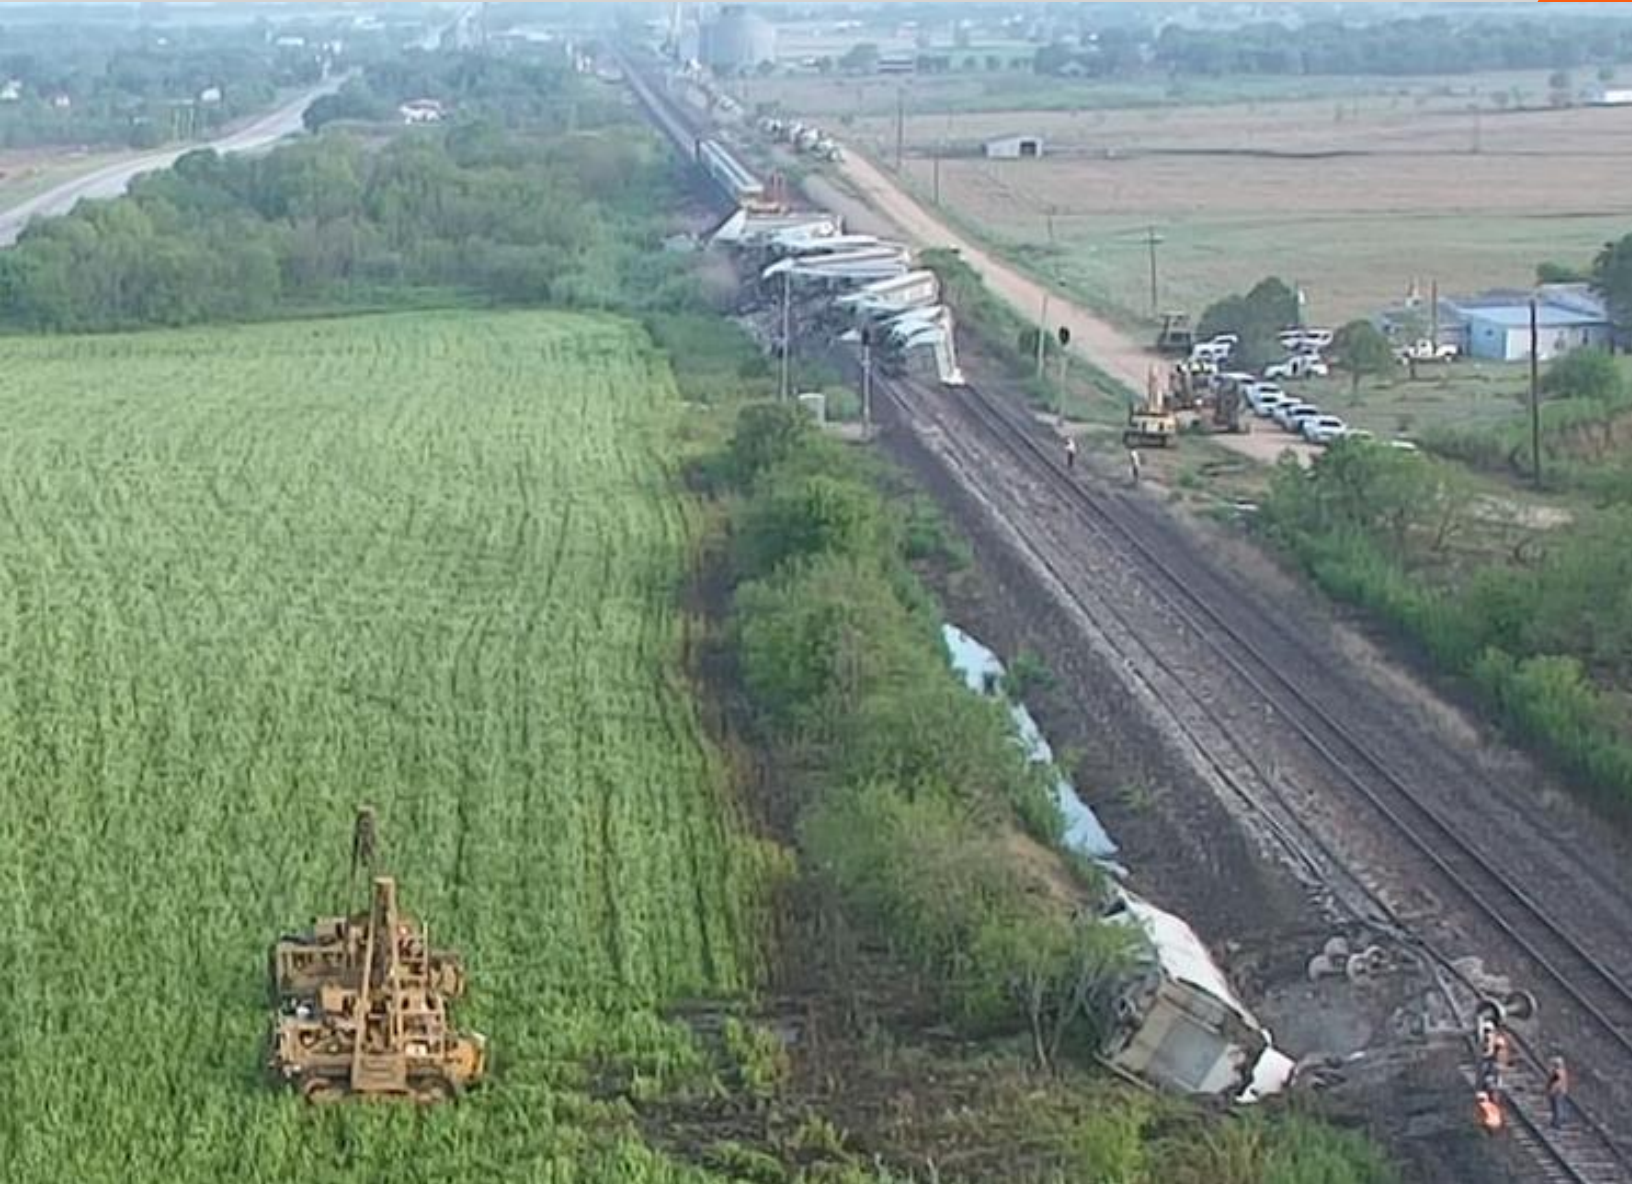
U-OGISOX-0-02T Looking North
