# Federal Railroad Administration Office of Railroad Safety Accident and Analysis Branch

Accident Investigation Report HQ-2020-1405

CSX Transportation (CSX) Rear End Collision Connersville, Indiana December 30, 2020

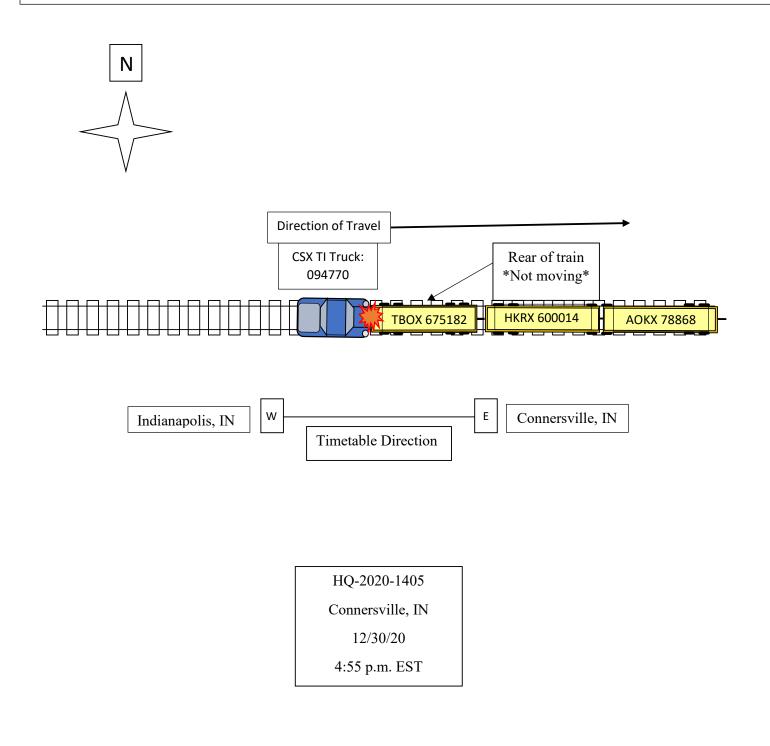
#### Sketch - CSX Connersville

The rear of Eastbound Train 2 was struck by a hi-rail vehicle at MP BD 71.7; Train 2 was not in motion at the time of the incident. As a result of the collision, the employee operating the hi-rail sustained serious injuries and was transported to Reid Hospital located in Connersville for treatment. The hi-rail vehicle sustained heavy damage with no damage reported to track or Train 2 equipment. There were no injuries to the train crew.
