***Federal Railroad Administration
Office of Railroad Safety
Accident and Analysis Branch***

***Accident Investigation Report
HQ-2021-1430***

***Union Pacific Railroad
San Marcos, Texas
June 6, 2021***

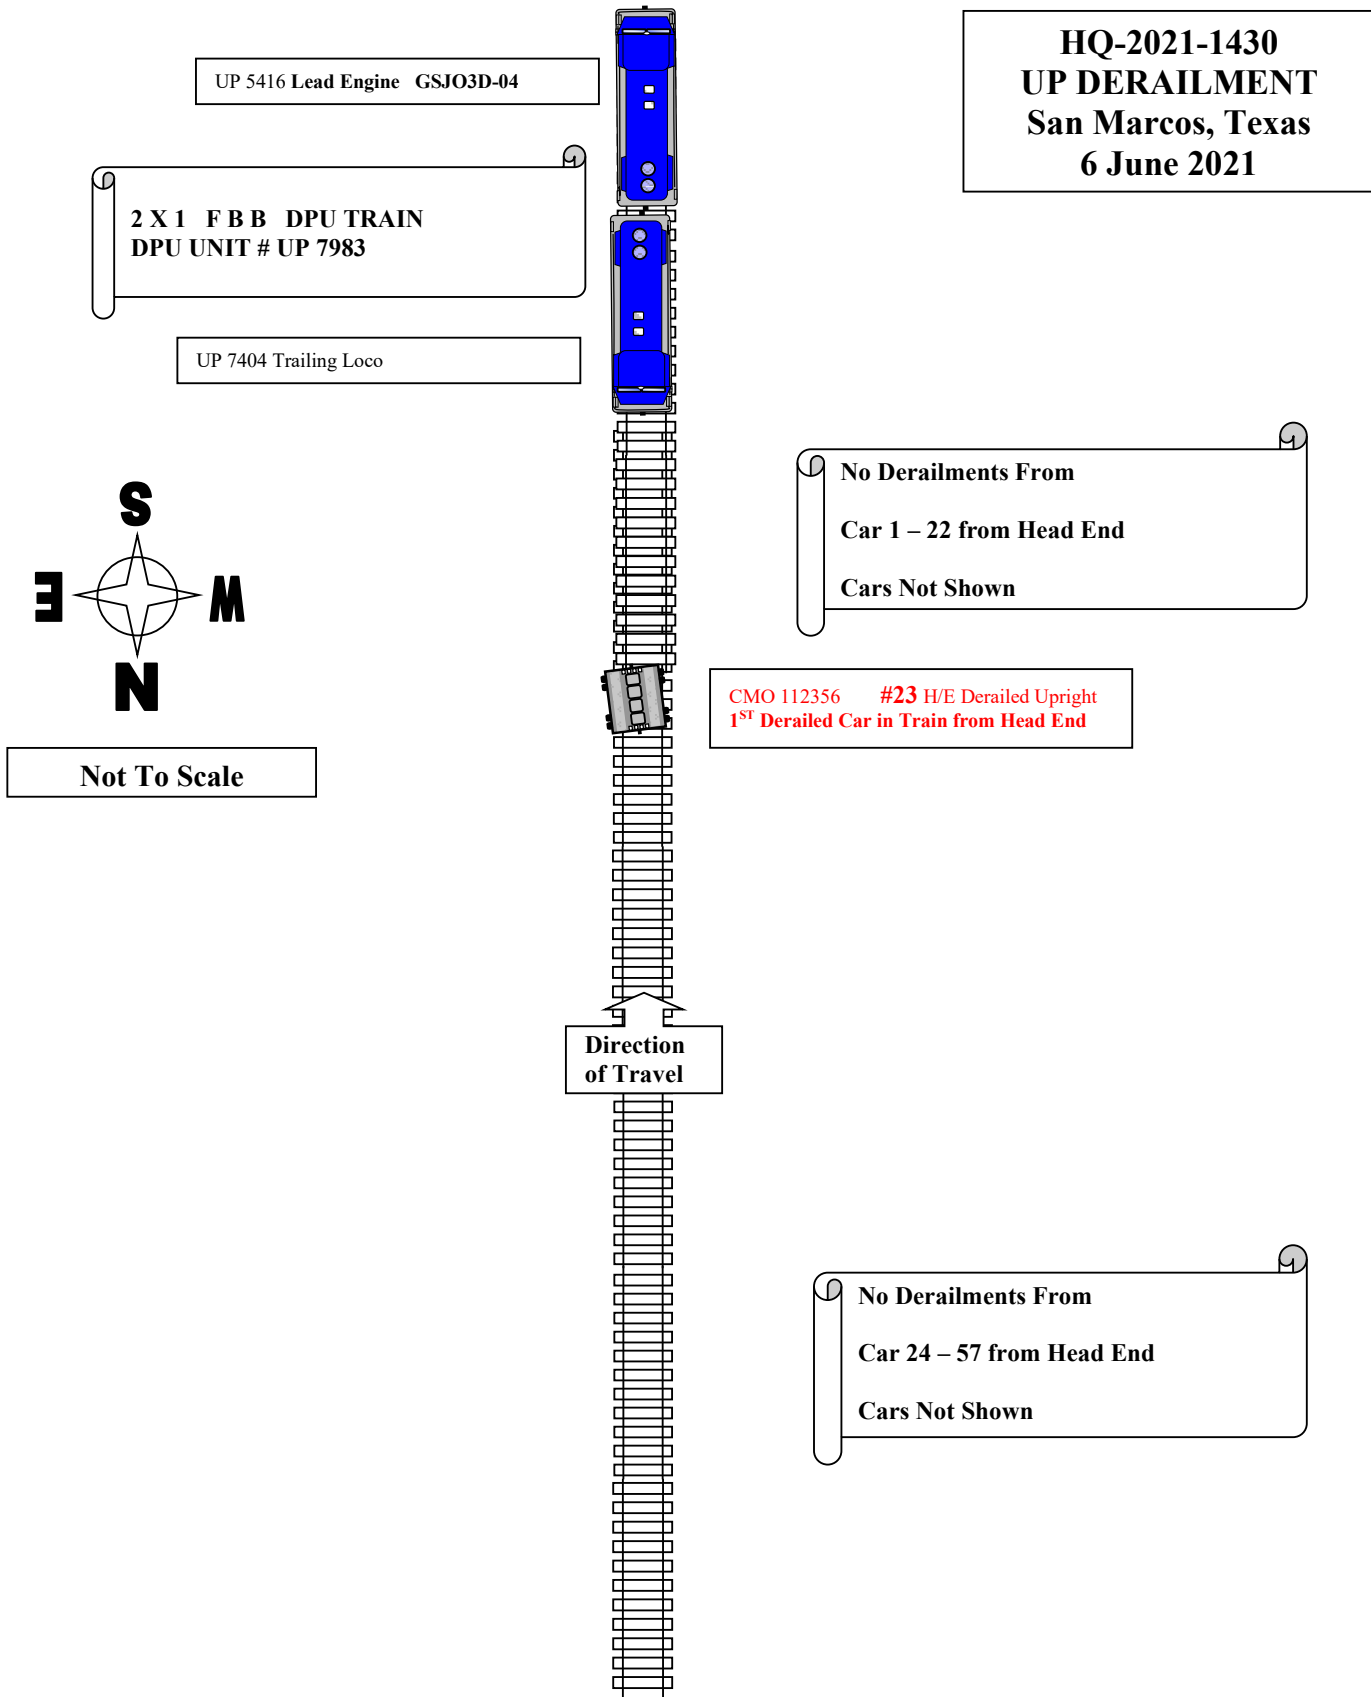
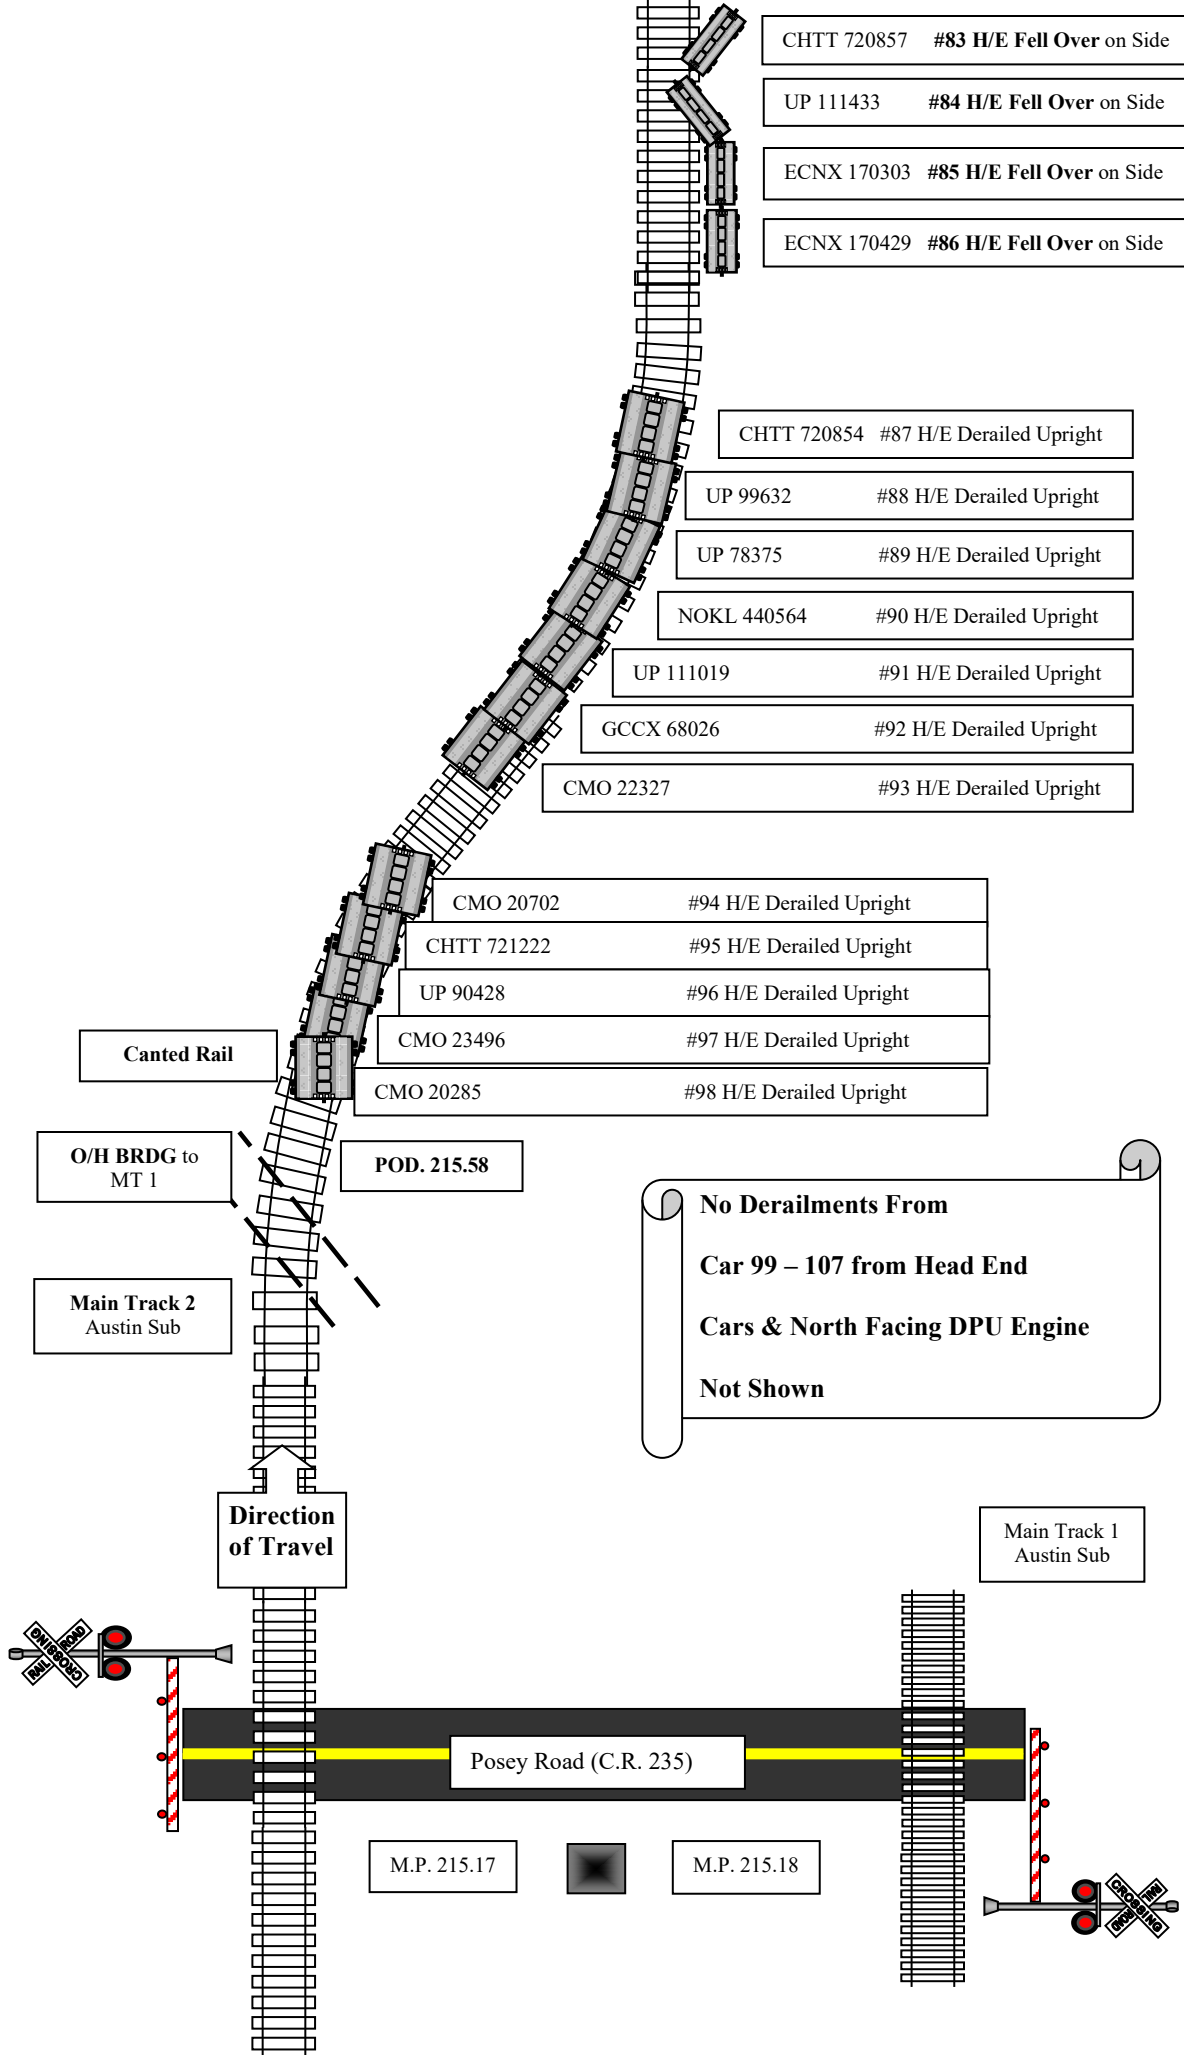
Sketch - Sketch

CHTT 721052 #58 H/E Derailed Upright

UP 93222 #59 H/E Derailed Upright

ECNX 170472 #60 H/E Derailed Upright

CMO 101132 #61 H/E Derailed Upright

CMO 20580 #62 H/E Derailed Upright

UP 91665 #63 H/E Derailed Upright

UP 90666 #64 H/E Derailed Upright

UP 99786 #65 H/E Derailed Upright

UP 111144 #66 H/E Derailed Upright

CMO 112333 #67 H/E Derailed Upright

ECNX 170066 #68 H/E Derailed Upright

MP 722754 #69 H/E Derailed Upright

CMO 21084 #70 H/E Derailed Upright

FURX 842954 #71 H/E Derailed Upright

EFNX 160118 #72 H/E Derailed Upright

CHTT 721016 #73 H/E Derailed Upright

UP 111569 #74 H/E Derailed Upright

CMO 101148 #75 H/E Derailed Upright

NOKL 846015 #79 H/E Derailed Upright

CMO 21262 #80 H/E Fell Over on Side

UP 99917 #81 H/E Fell Over on Side

CMO 200173 #82 H/E Fell Over on Side
