***Federal Railroad Administration
Office of Railroad Safety***

***Accident Investigation Report
HQ-2020-1390***

***Union Pacific Railroad
Tempe, Arizona
July 29, 2020***

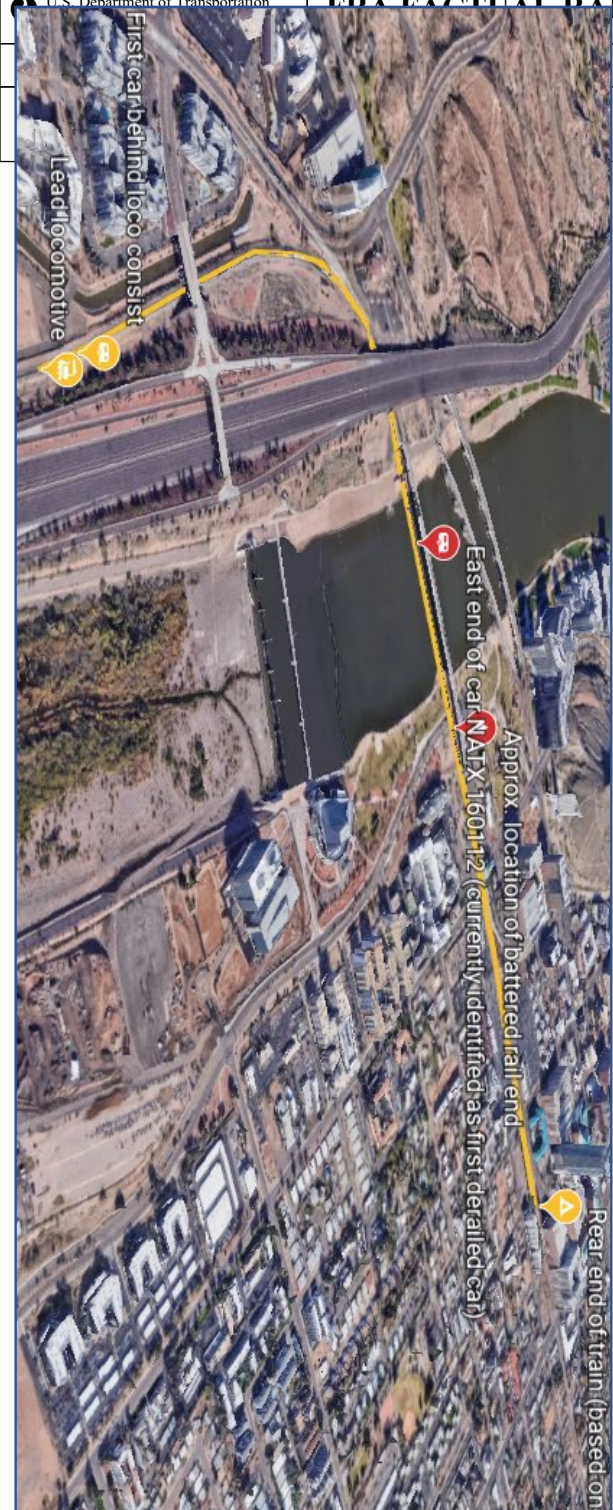
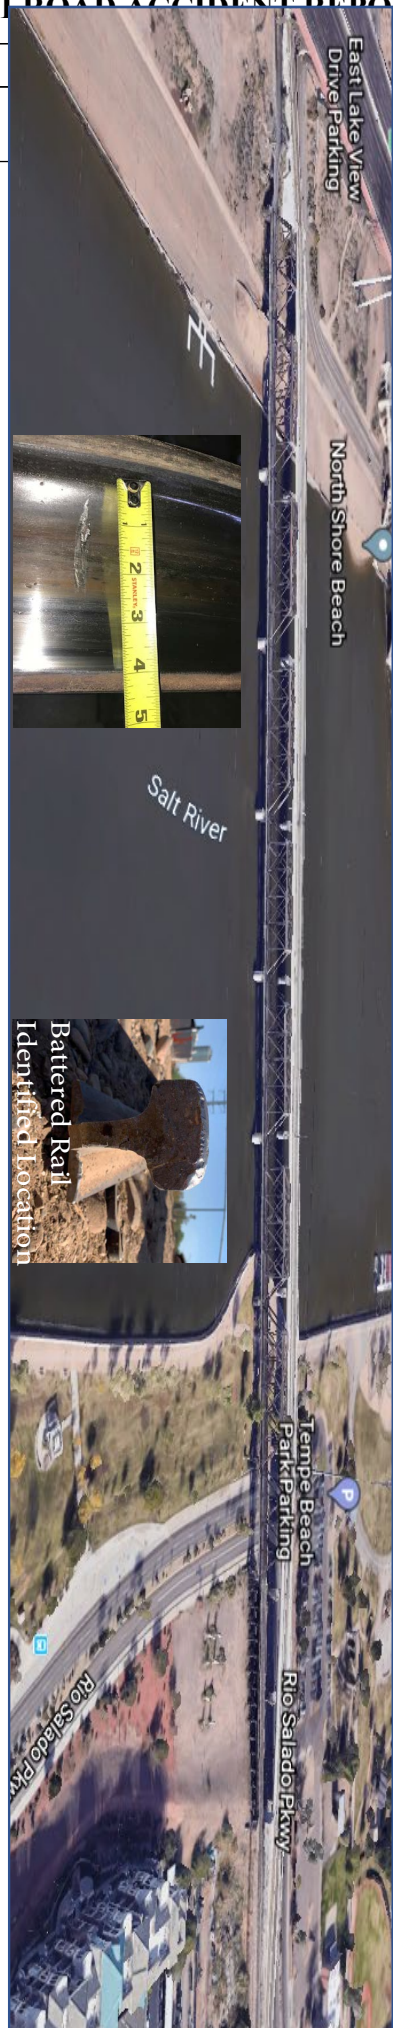
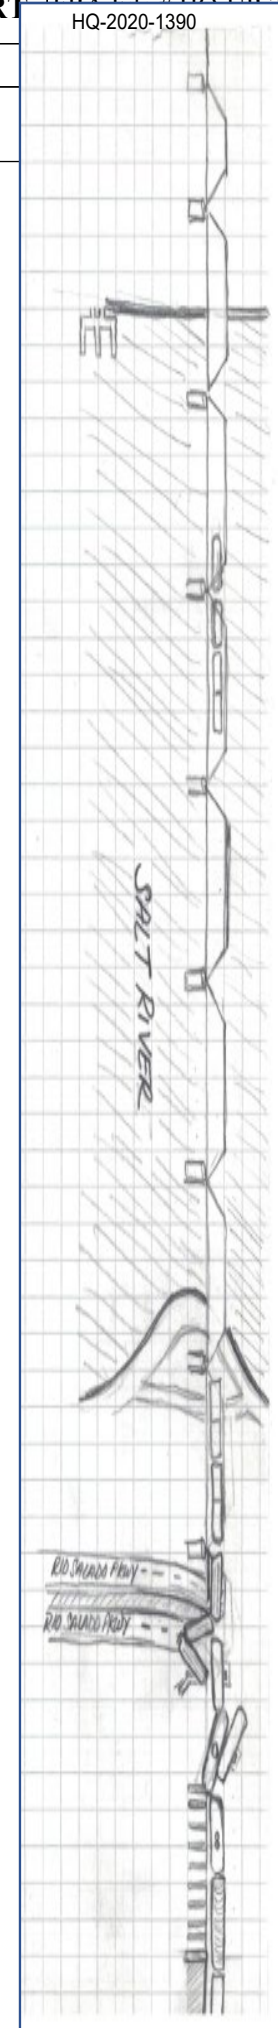
- Train Consist Legend**
- Head end portion of train (locomotive consist and cars lines 97 to 50) taken to Phoenix Yard.
- Line 50- TILX 518747 (Lumber) west most car identified with witness marks.

- Line 49- NATX 160112 (sodium hydroxide) west most left on bridge. Witness Marks R3 & R4
 - Line 48- GATX 6479 (Sulfuric Acid)
 - Line 47- TTZX 861493 (Lumber)

- Line 46- TTZX 856959 (Lumber)
 - Line 45- TTZX 862290 (Lumber)
 - Line 44- TILX 540850 (SBMEAL)
 - Line 43- GACX 55605 (SBMEAL)
 - Line 42- TILX 540613 (SBMEAL)

- Line 41- GATX 90208 (CYCLOHEXANONE)
 - Line 40- ACFX 72540 (CYCLOHEXANONE)
 - Line 39- DBCX 201081 (RUBBER)
 - Line 38- GATX 1384 (CYCLOHEXANONE)
 - Line 37- TTGX 715892 (Avis/Rent- Trucks)

- Line 36- S00 601398 (Lumber) East most car left on approach.
- Rear portion of train lines 35 to 1 taken back to Mesa Yard.
- Bullet Point denotes derailed cars- **Red Font** denotes cars involved in collapse.

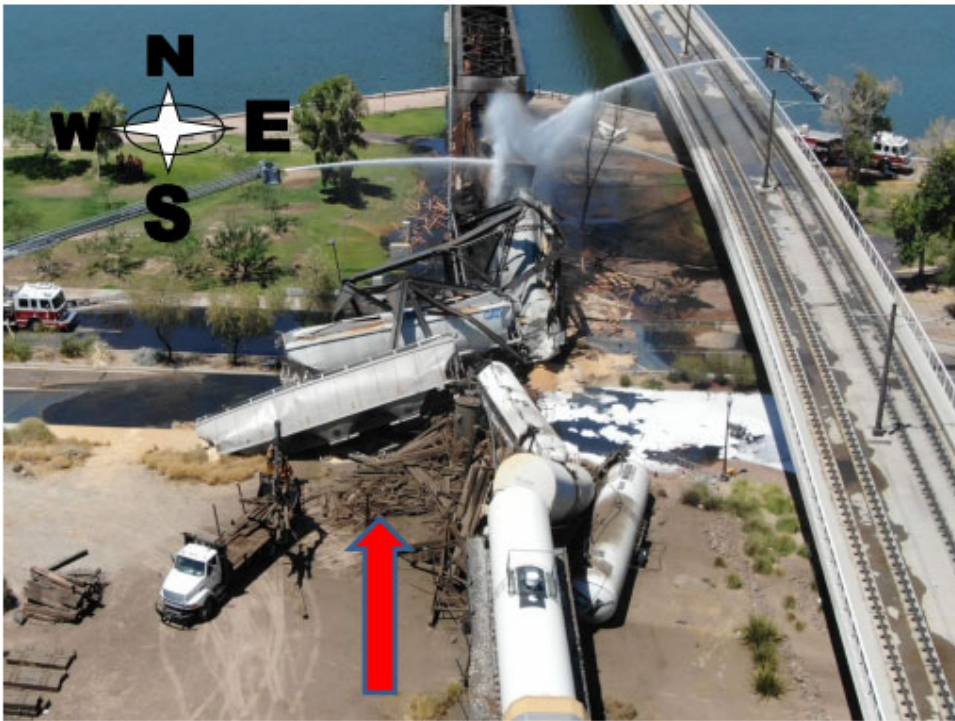
Figure 1. Aerial photo of the derailment site. Red arrow shows direction of train. Light rail operation to the east of UP's right-of-way. Note: Is the compass correctly positioned?
