***Federal Railroad Administration
Office of Railroad Safety***

***Accident Investigation Report
HQ-2022-1521***

***CSX Transportation (CSX) Collision
Spencer, MA
February 20, 2022***

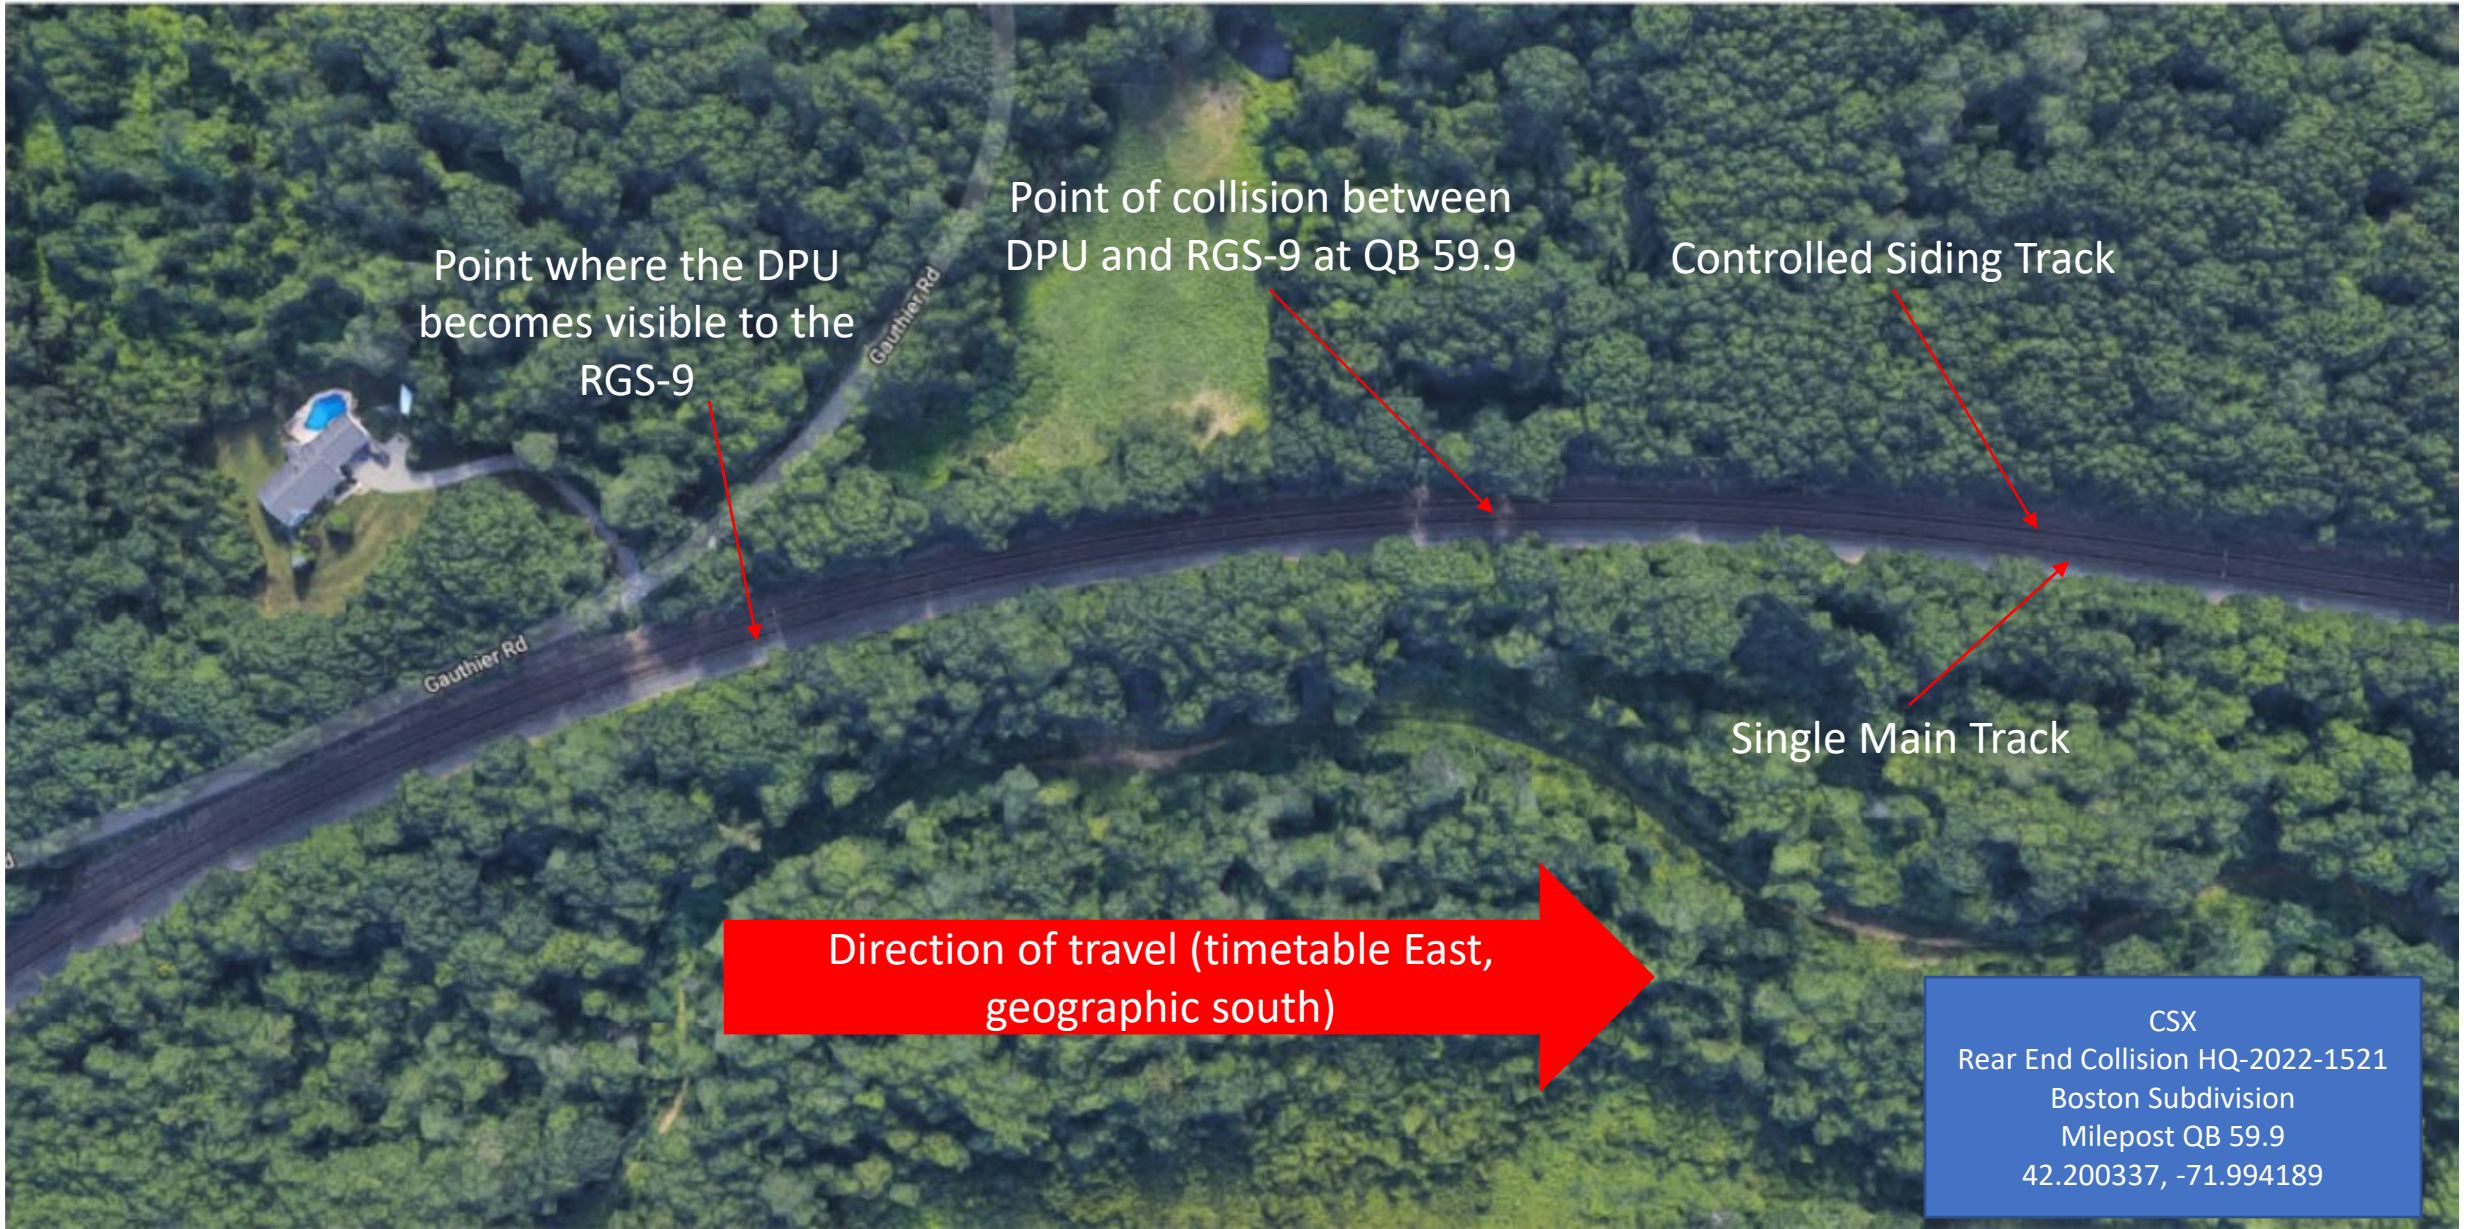
Point where the DPU becomes visible to the RGS-9

Point of collision between DPU and RGS-9 at QB 59.9

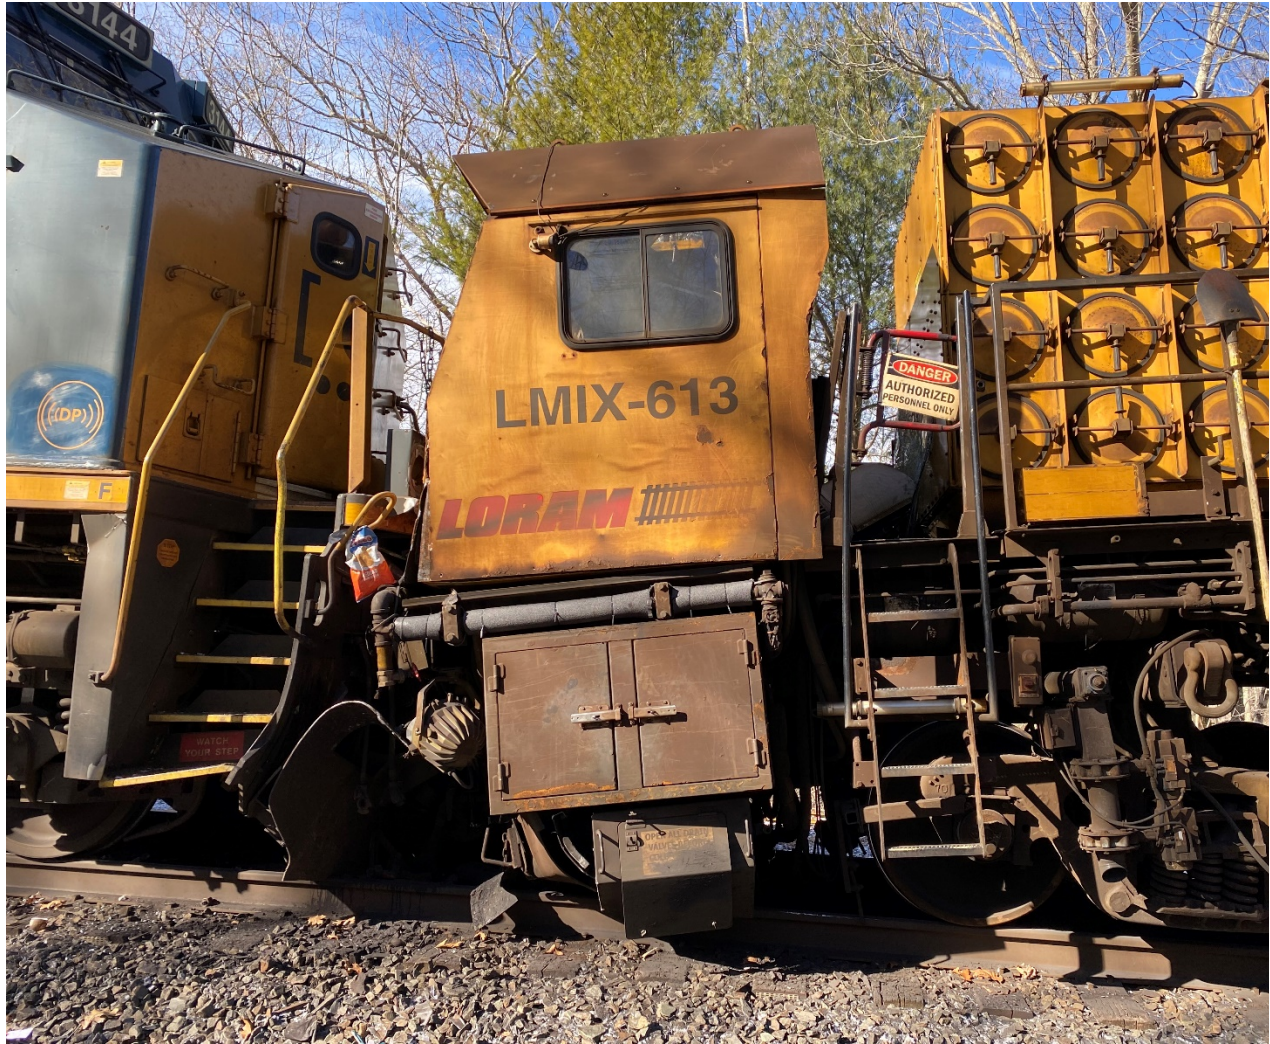
Description: Photograph showing damage to the right-hand side of the RGS-9. This is the rear operator's compartment of the machine. Photograph is looking timetable south.

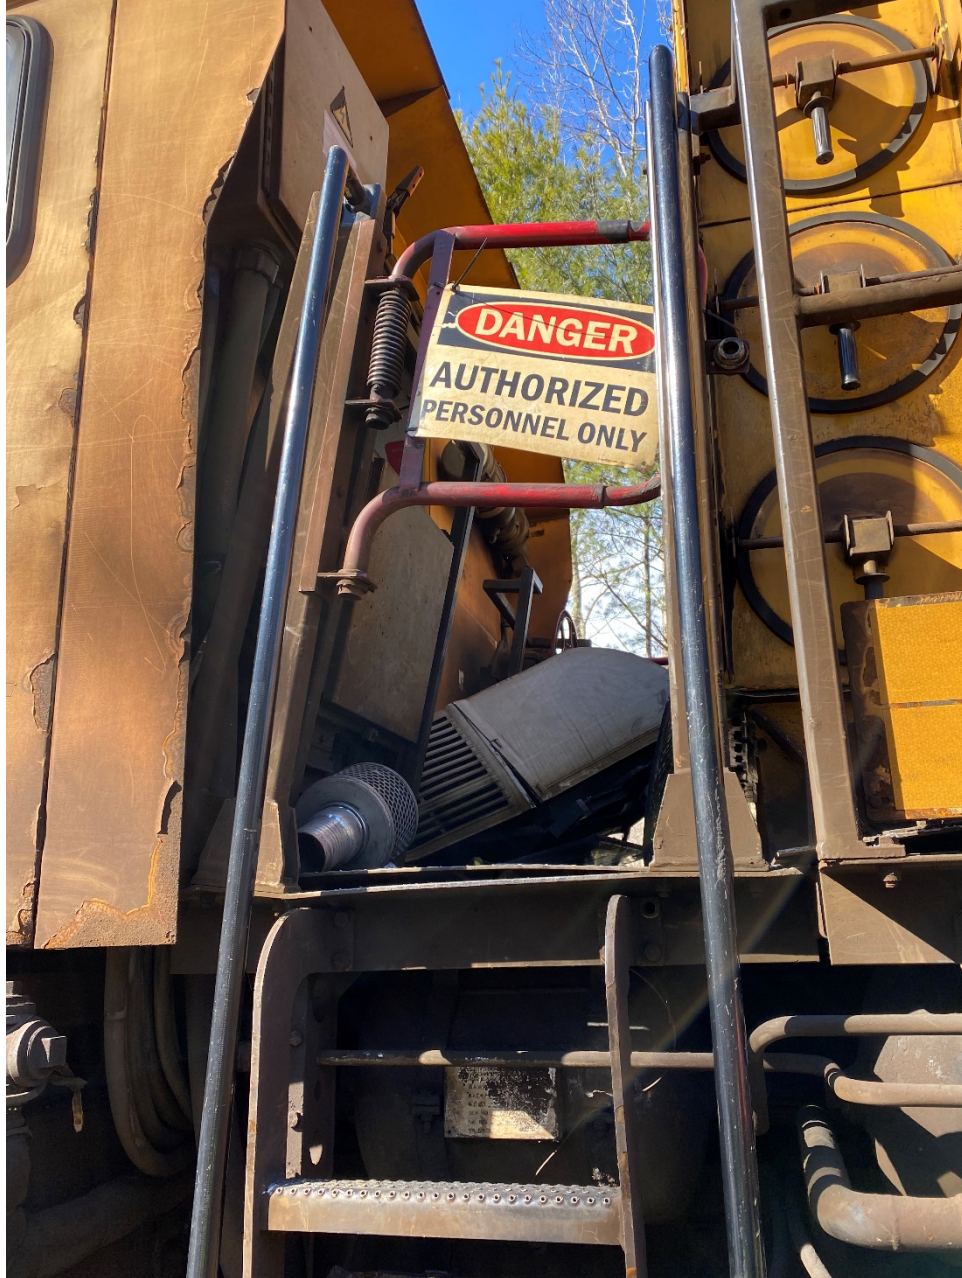
Description: Photograph showing the location the Operator and Pilot were extricated from. Damage to the machine's frame caused the door to become jammed.

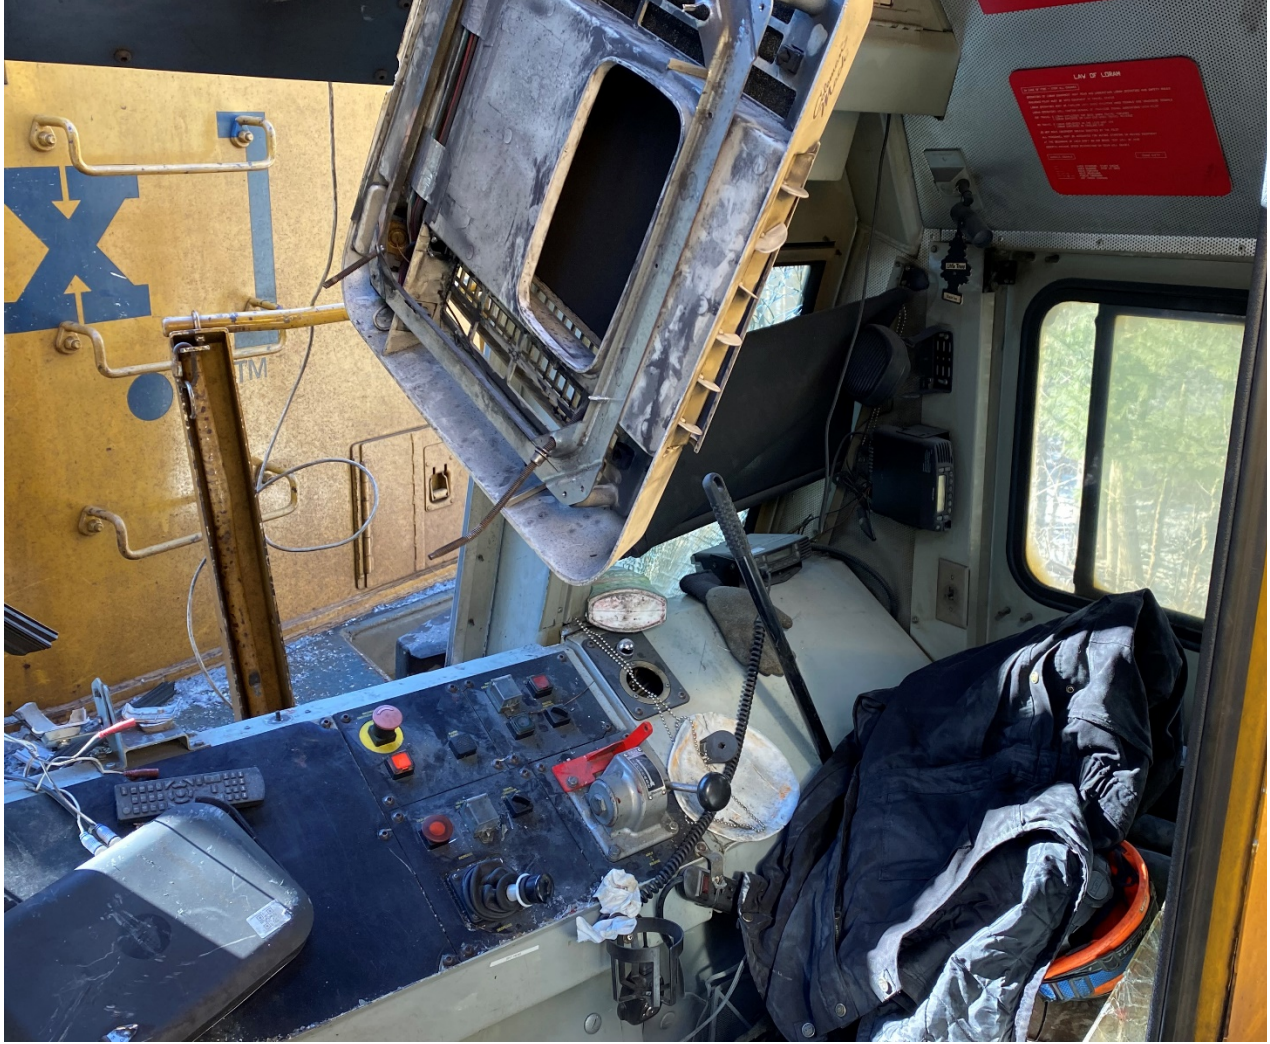
Description: Photograph showing interior damage of the Operator's work area. The Operator sustained injuries to their legs.

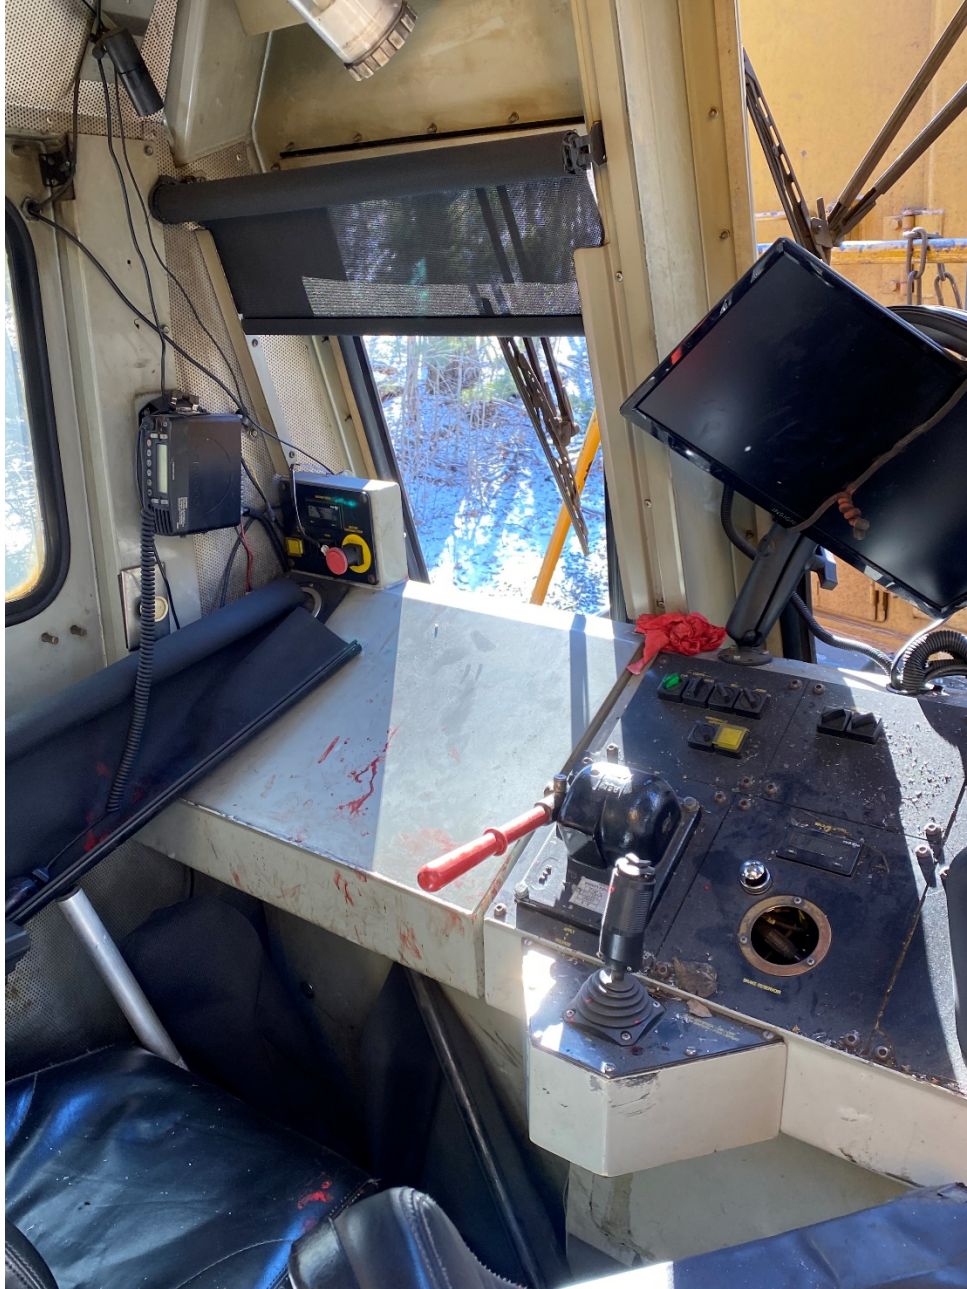
The RGS-9 was operating on an ascending 0.88 percent grade when it collided with the DPU. A review of the RGS-9 event recorder showed that no brake was applied and that the throttle was engaged at the time of the collision.

Description: Photograph showing interior damage of the Pilot's work area. The Pilot sustained injuries to their head. Note that the brake handle was not engaged.

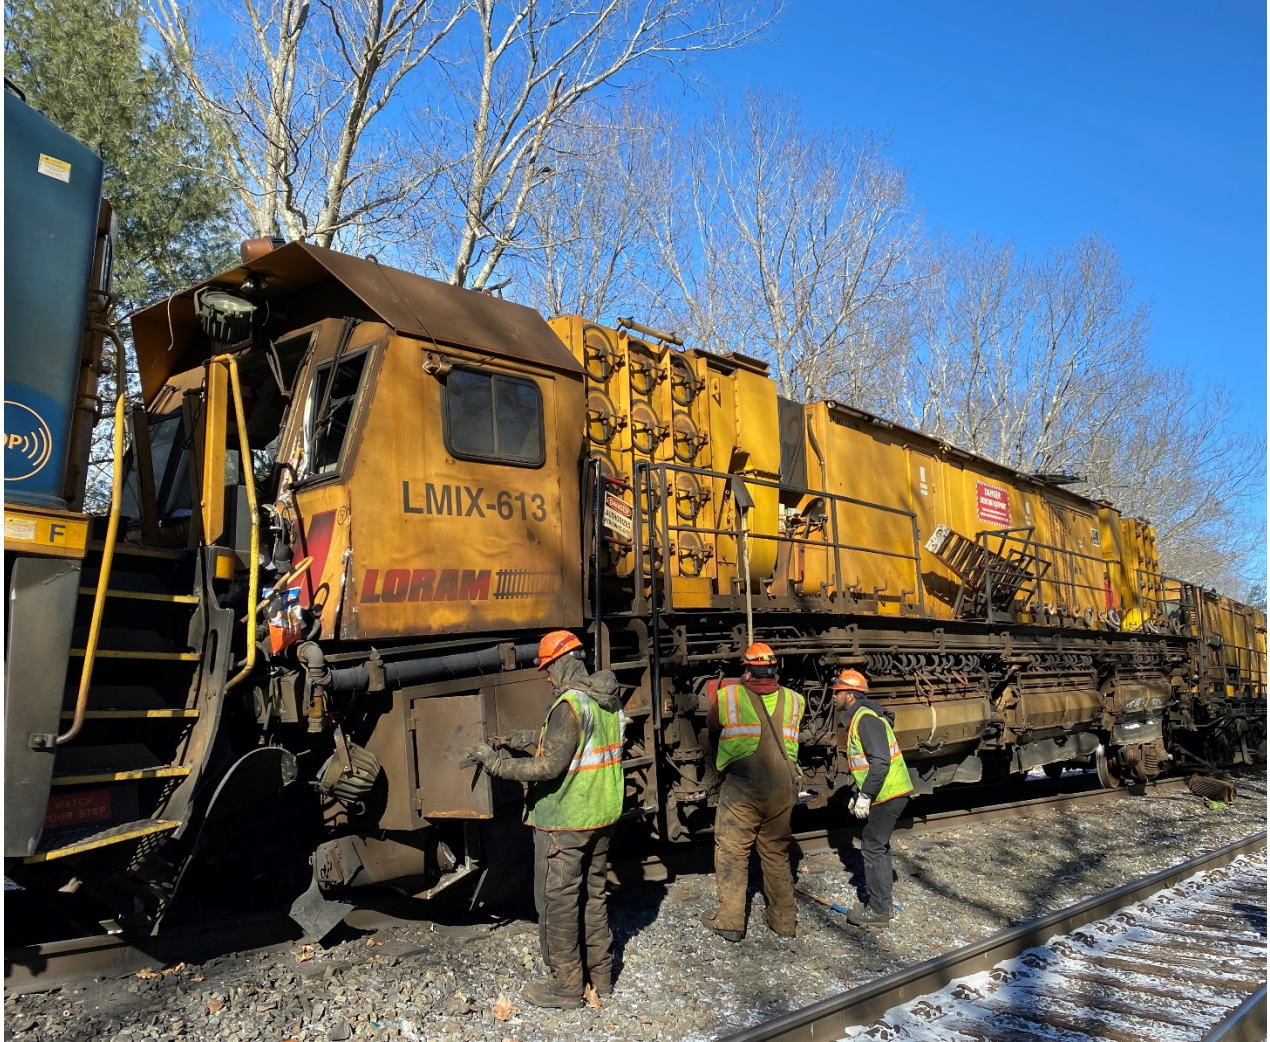
Description: Photograph of damage on the RGS-9. Note the extensive damage to the frame.

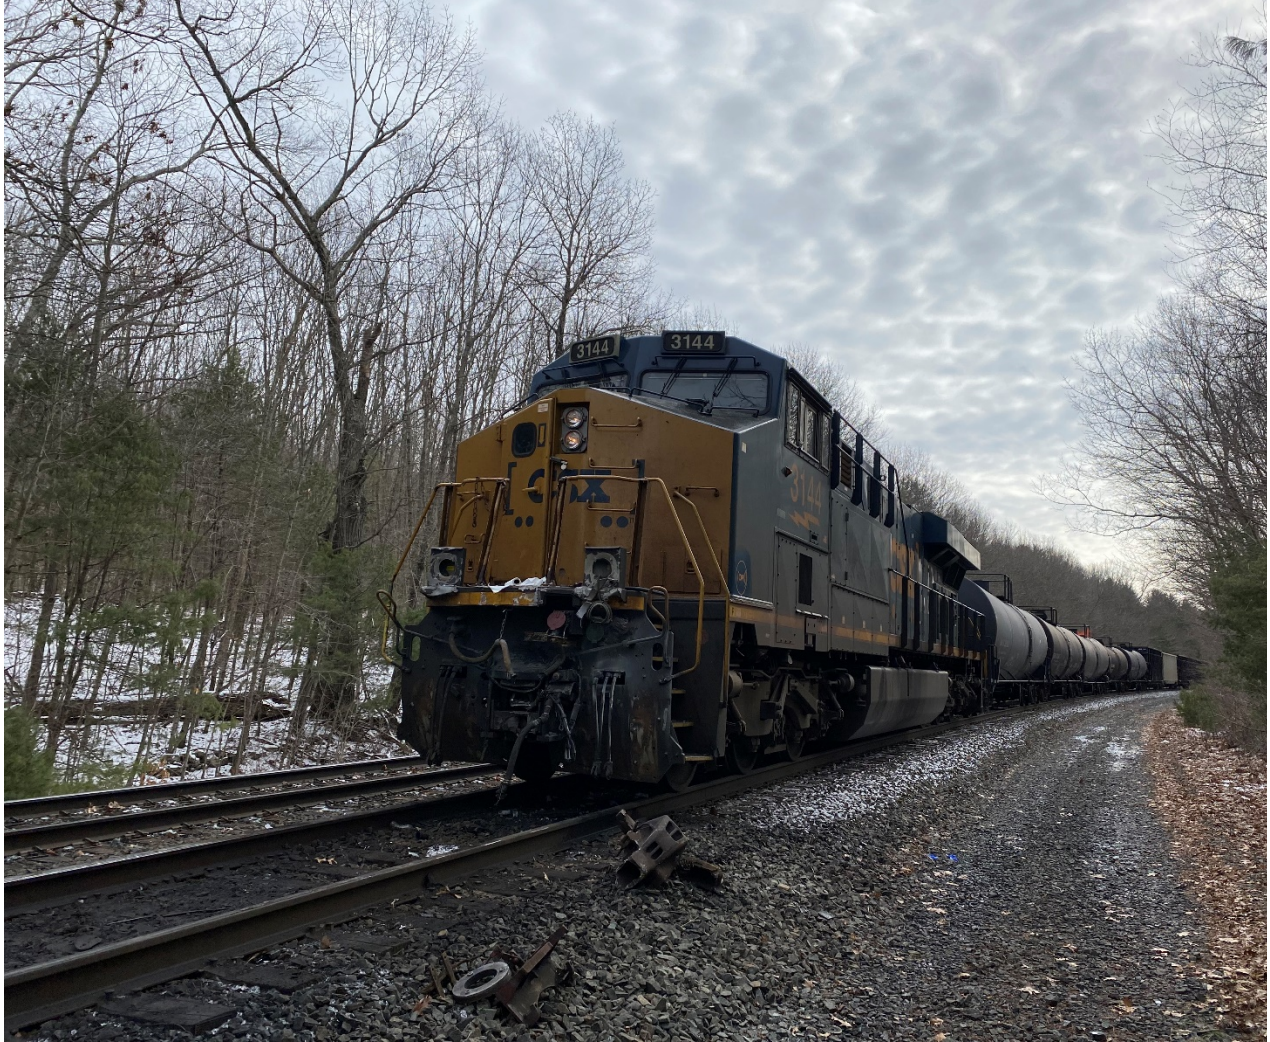
Description: Photograph showing damage to the pilot, auxiliary lights, knuckle, and steps of the DPU.

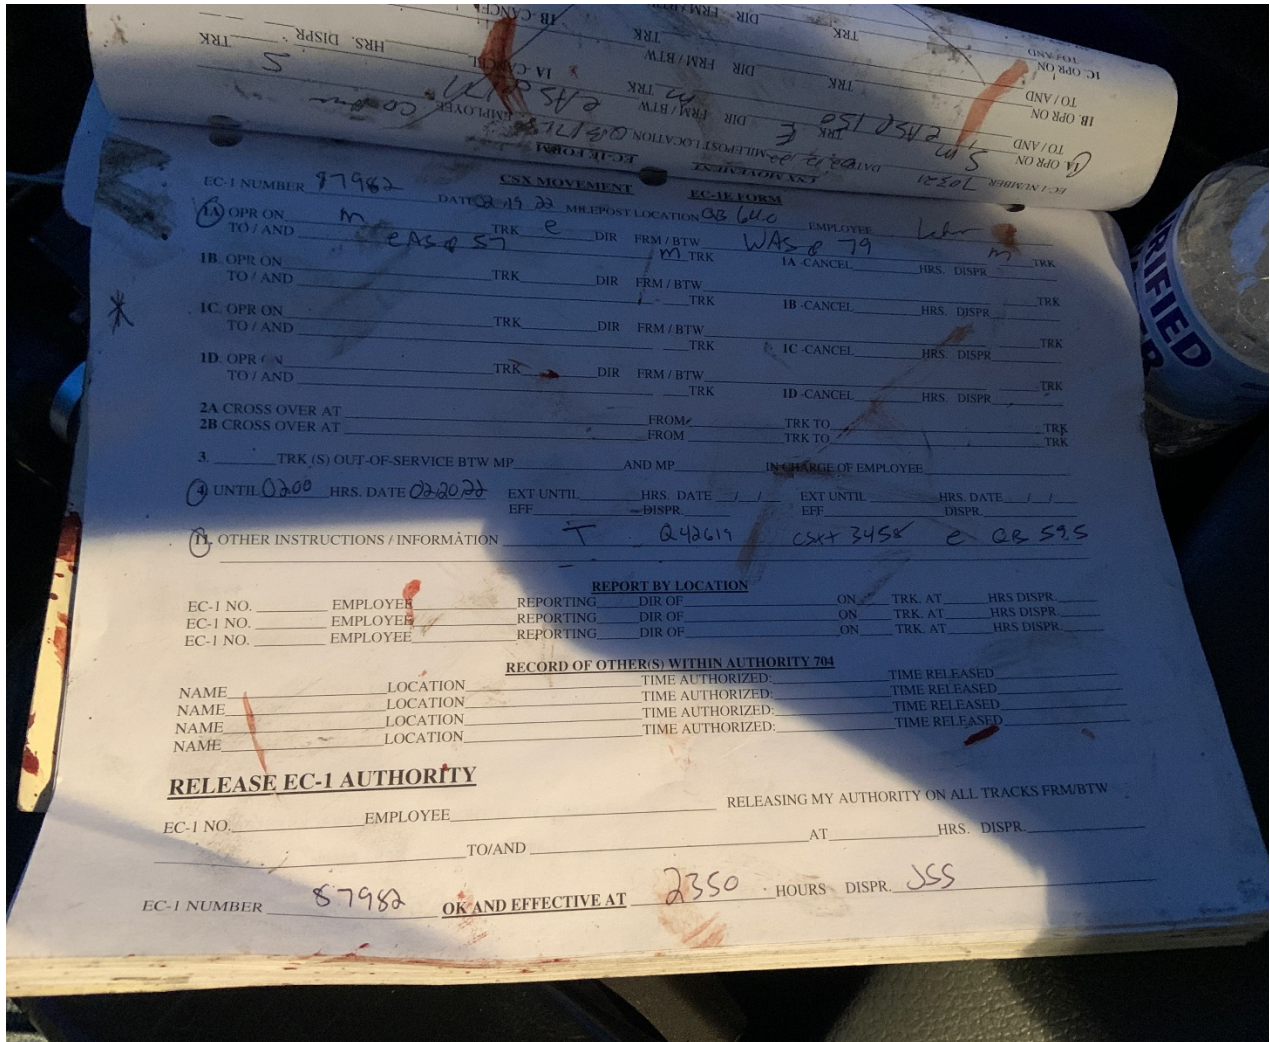
The RGS-9 had an inward facing camera at the front-end operator's compartment. The rear-end operator's compartment, which was where the roadway workers were at the time of the collision, did not have an inward facing camera. The RGS-9 had outward facing cameras on both ends. A review of the inward facing camera footage shows the Pilot and Operator present in the front-end operator's compartment when the EC-1e is being issued over the radio. The Pilot is observed to be copying the EC-1e. No communication between the Pilot and the RWIC is observed that would show acknowledgement of the understanding of the EC-1e authority. Additionally, the Operator did not initial the EC-1e as required by On-Track Safety Rule No. 704.6.4. After the EC-1e authority is issued over the radio, the Pilot is observed to be manipulating an electronic device while the Operator is reading the limits of the EC-1e authority to the Laborer who was in the rear operating compartment. While the Operator read back the contents of the EC-1e authority, they failed to note the information on Line 11 stating that there was a train ahead of their location.

Description: Photograph of the Pilot's copy of EC-1e No. 87982. Note the information on Line 11 stating that Train Q426-19 was ahead. This copy was recovered by the CSX Roadmaster.

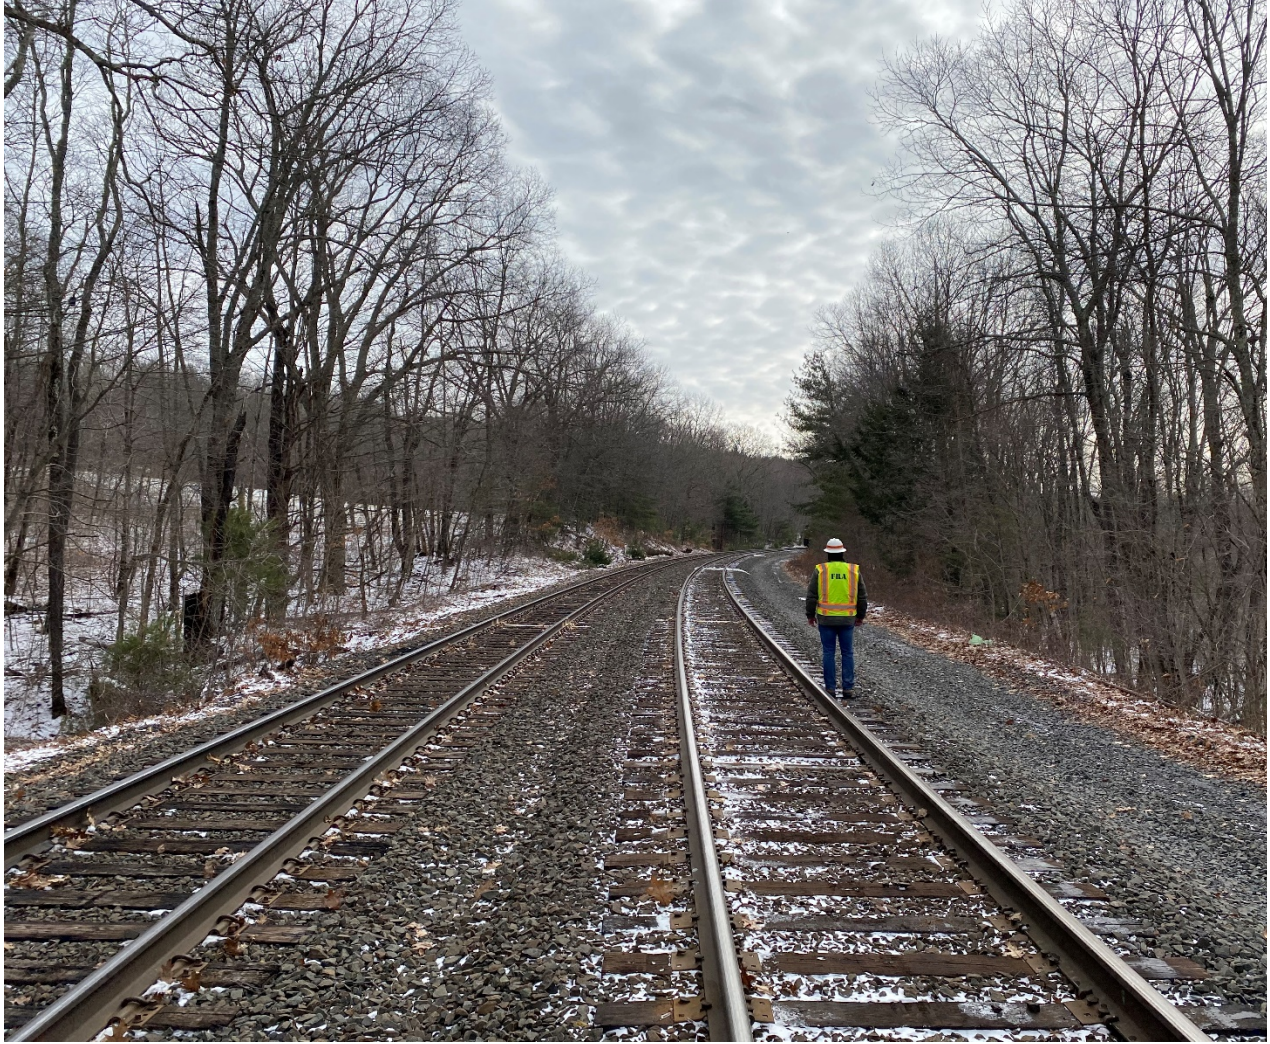
FRA investigated the collision at MP QB 59.9 and observed significant damage to the leading-end of the RGS-9. Impact damage was observed on the F-end of the DPU. FRA measured the sight distance and determined that there was approximately 650 feet of visibility at the location of the collision. FRA photographed two copies of an EC-1e form. One copy was recovered from the leading-end of the RGS-9 and contained blood droplets. A second copy was obtained from the CSX Roadway Worker in Charge (RWIC), who was riding on the trailing-end of the Rail Grinder. Both copies of the EC-1e matched and contained information on Line 11 that Q426 was east ahead at MP QB 59.5.

Description: Photograph showing the approximate sight distance in daylight conditions. Note the difference in measurements based off an observer's position in the operator's compartment. The distance was determined to be approximately 650 feet. Based on ambient light conditions, the headlight was less apparent than it would be at night.
