**Federal Railroad  
Administration**

## Broken Rims in Railroad Wheels

6. AUTHOR(S) and FRA COTR Scott Cummings			8. PERFORMING ORGANIZATION REPORT NUMBER	
7. PERFORMING ORGANIZATION NAME(S) AND ADDRESS(ES) Transportation Technology Center, Inc. 55500 DOT Rd. Pueblo, CO 81001			10. SPONSORING/MONITORING AGENCY REPORT NUMBER  DOT/FRA/ORD-14/41

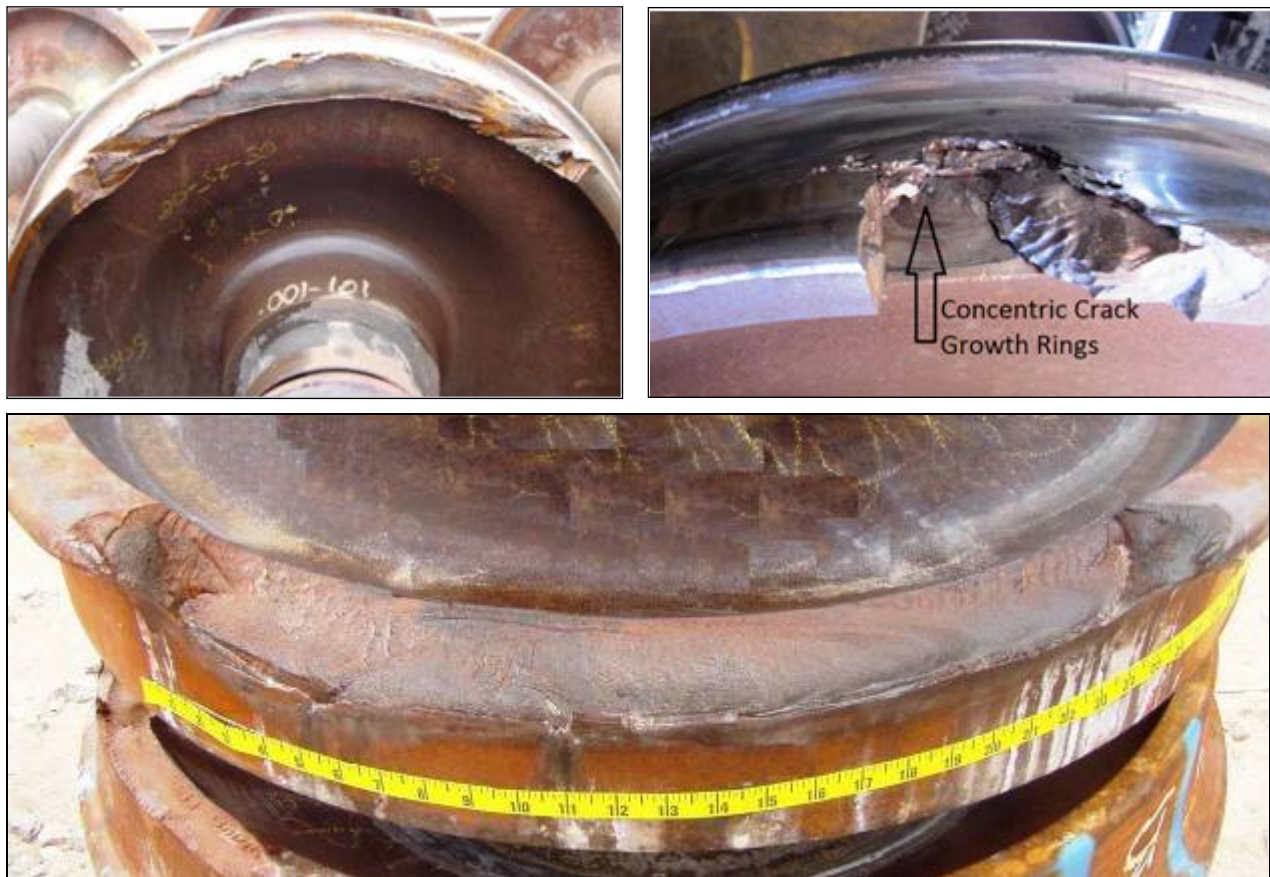
Broken rim wheel failures generally fall into one of two categories: shattered rim or VSR. VSR cracks usually propagate to the front rim fillet, but can sometimes propagate to the back rim fillet resulting in a broken flange. Figure 1 shows an example of a typical VSR wheel with a crack roughly parallel to the bearing end cap, a shattered rim wheel with concentric crack growth rings roughly parallel to the tread surface, and a wheel with a VSR crack that propagated to the back rim fillet resulting in a broken flange. Much of the focus of this research will be on VSRs.

**Figure 1. Typical VSR (Top Left), Shattered Rim (Top Right), and VSR Crack Resulting in a Broken Flange (Bottom)**

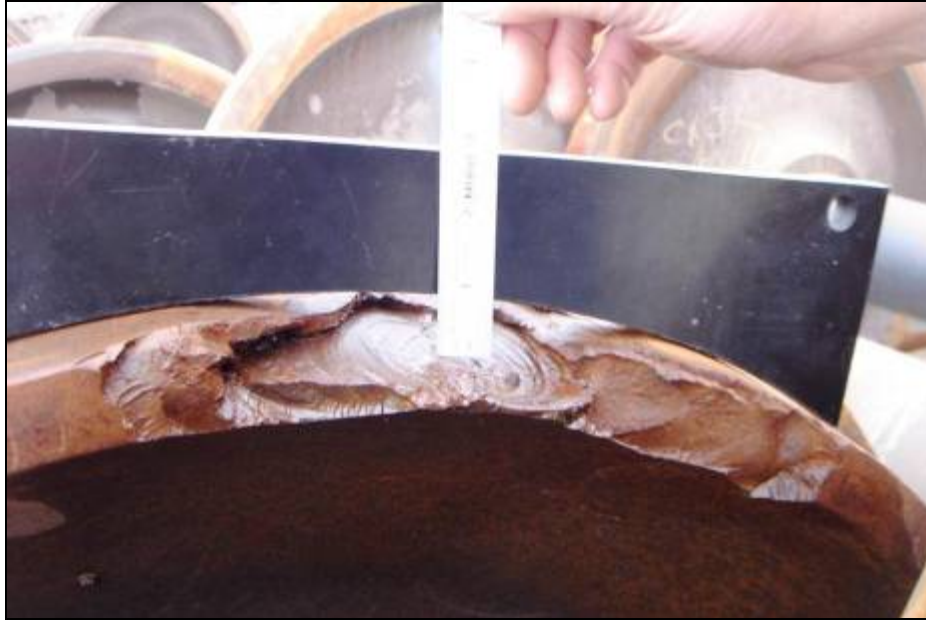
Shattered rims can sometimes result in a combination shattered rim and VSR due to a final brittle fracture of the front rim face following consistent shattered rim fatigue crack growth in a deep horizontal plane (Stone, Tournay, and Cummings 2008). Such wheels should be considered shattered rims due to the root cause. Figure 5 shows a wheel with VSR crack that occurred long after the shattered rim defect had initiated and propagated.

**Figure 5. Shattered Rim Wheel with VSR in Combination**

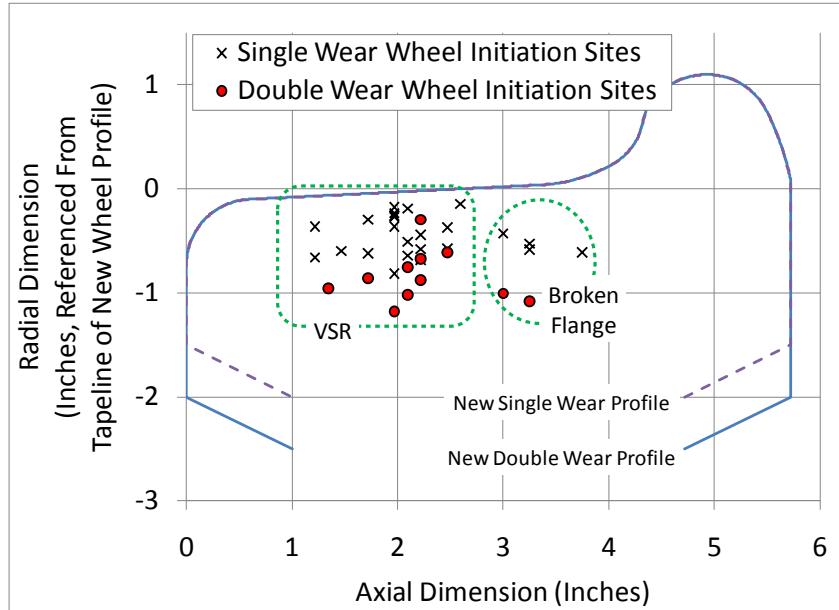
Figure 7 shows the axial and radial locations of the failure origins. The radial dimensions of this figure have been referenced to the tapeline of a brand new wheel by incorporating the origin radial depth below the worn tread surface and the tread wear as determined by the difference in rim thickness from the nominal rim thickness. Although the origins are at a consistent radial depth from the worn tread surface, the radial depth varies considerably when referencing the new wheel tread surface. This is an indication that broken wheels are not typically the result of microstructures such as bainite or martensite formed near the tread surface from the quenching operation during the manufacturer’s heat treatment.

TTCI noted shells on the tread surface in close proximity to the origin point for 23 of 29 VSR wheels and all 6 broken flange wheels. Usually, when tread damage is the result of a wheel-sliding event, martensite is present on the tread surface. Etching the tread surface near the shells of the broken wheels did not reveal any martensite, implying that the shells were not the result of a wheel-sliding event. Rolling contact fatigue and thermal mechanical shelling are the likely causes.

**Figure 7. Origin Locations Relative to New Wheel Profiles**

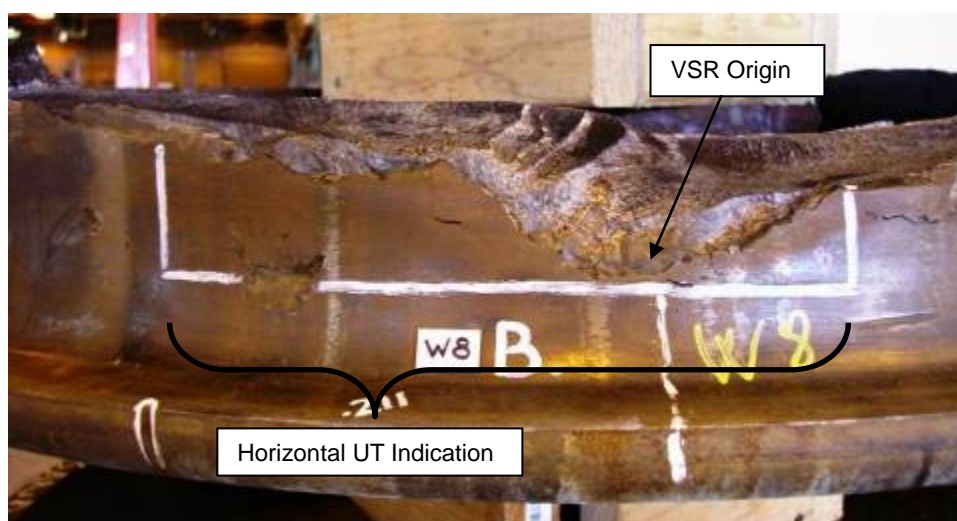
Horizontal UT indications were found in the immediate vicinity of the failure origin on 13 of the broken wheels. Figure 11 shows an example of a broken wheel with a large horizontal UT indication (outlined in white paint) marked around the VSR origin.

**Figure 11. VSR Wheel with a Large Horizontal UT Indication Surrounding VSR Origin**

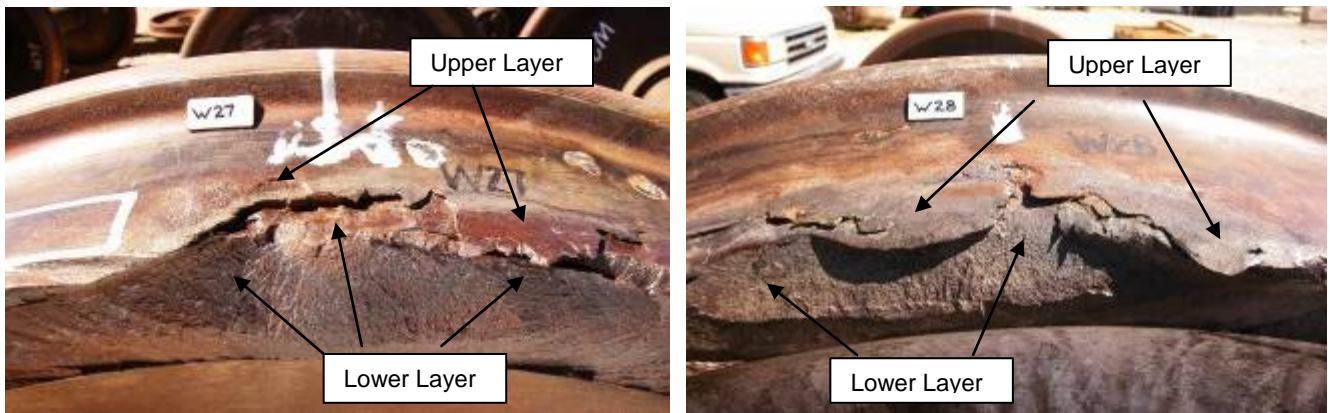
A common feature found on many of the broken wheels was a horizontal (approximately parallel to the tread surface) separation between two visually distinct layers in the wheel rim. Figure 12 shows examples of two VSR wheels with distinct upper and lower layers in the rim. The upper layer is typically no more than 0.25 in thick and the lower layer is comprised of the remainder of the rim thickness. The upper and lower layers frequently have different axial widths. In some wheels, the upper layer extends axially past (overhangs) the VSR crack in the lower layer. In other broken wheels the opposite is found: the horizontal surface of the lower layer is exposed because the upper layer has shelled out or broken off above it. For both wheels pictured in Figure 12, the upper layer overhangs the VSR crack in some circumferential locations and has broken off the lower layer at other locations.

**Figure 12. Examples of VSR Wheels with Two Distinct Horizontal Layers in the Rim**

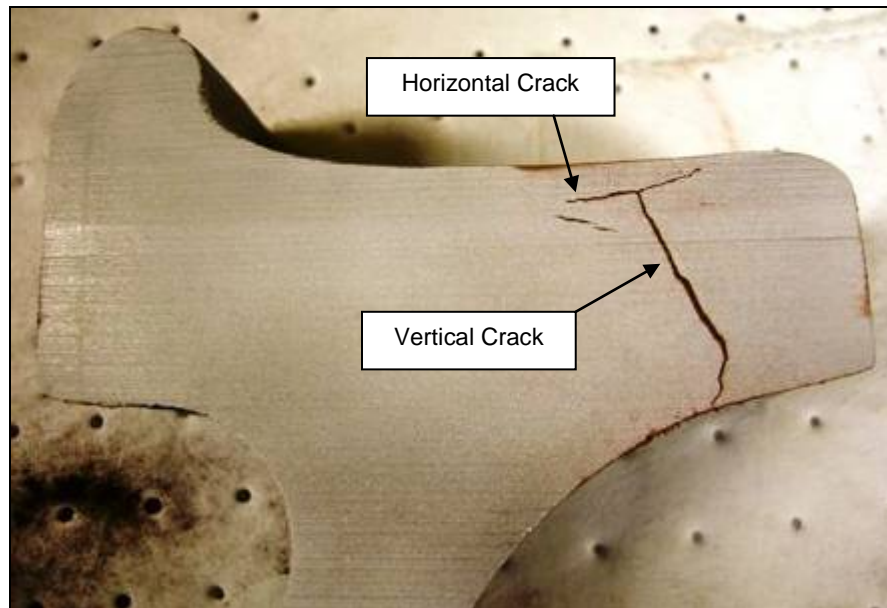
Figure 13 shows a wheel section with a horizontal crack that ranges in radial depth from about 0.1 to 0.25 in below the tread surface and a vertical crack that intersects the horizontal crack at a 0.18-inch radial depth. These dimensions are typical of most of the horizontal UT indications on the broken wheels and the radial depths of the VSR origins (where the horizontal crack turned into a vertical crack). The horizontal crack in this wheel separates the upper and lower layers of the rim.

**Figure 13. Branching between a Horizontal Subsurface Crack and a Vertical Crack**

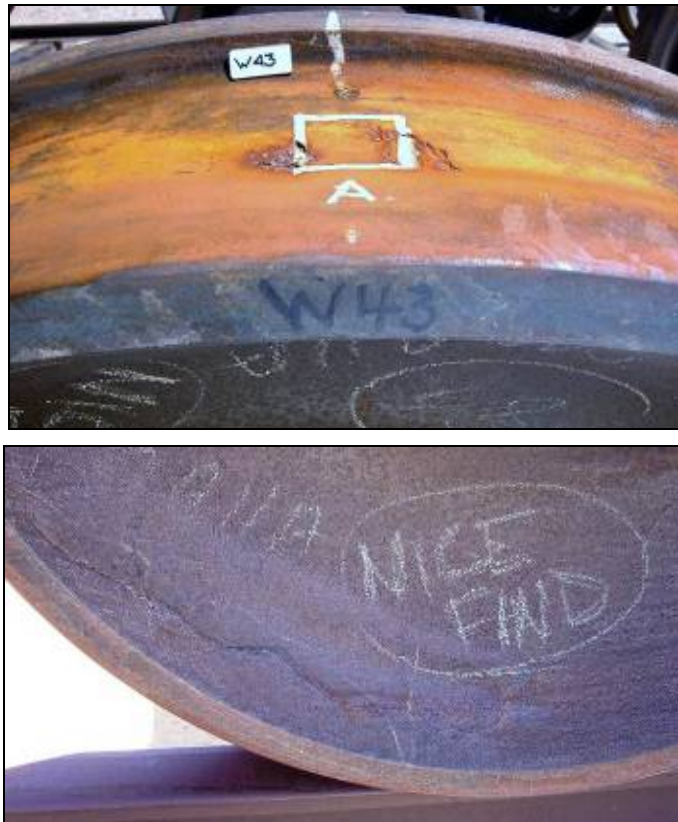
One of the VSR wheels provided for the inspection (assigned identification of “W43”) was removed from service prior to the crack causing complete separation of the rim. A portion of the crack had propagated to the rim fillet allowing for discovery by visual inspection. Although the crack faces had rubbed against each other while the wheel was in service, the damage from this rubbing was somewhat less than a typical VSR wheel that has propagated to rim separation. Figure 15 shows the tread surface and plate of the wheel. White paint lines on the tread identify the approximate outline of a subsurface horizontal crack found using UT equipment. Figure 16 shows one side of the cracked rim after it had been extracted from the wheel and the crack had been opened to expose both surfaces. Two potential crack origins were identified as indicated with arrows marked A and B in Figure 16.

**Figure 15. VSR Wheel W43 Tread (Top) and Plate (Bottom) Prior to Opening Crack**

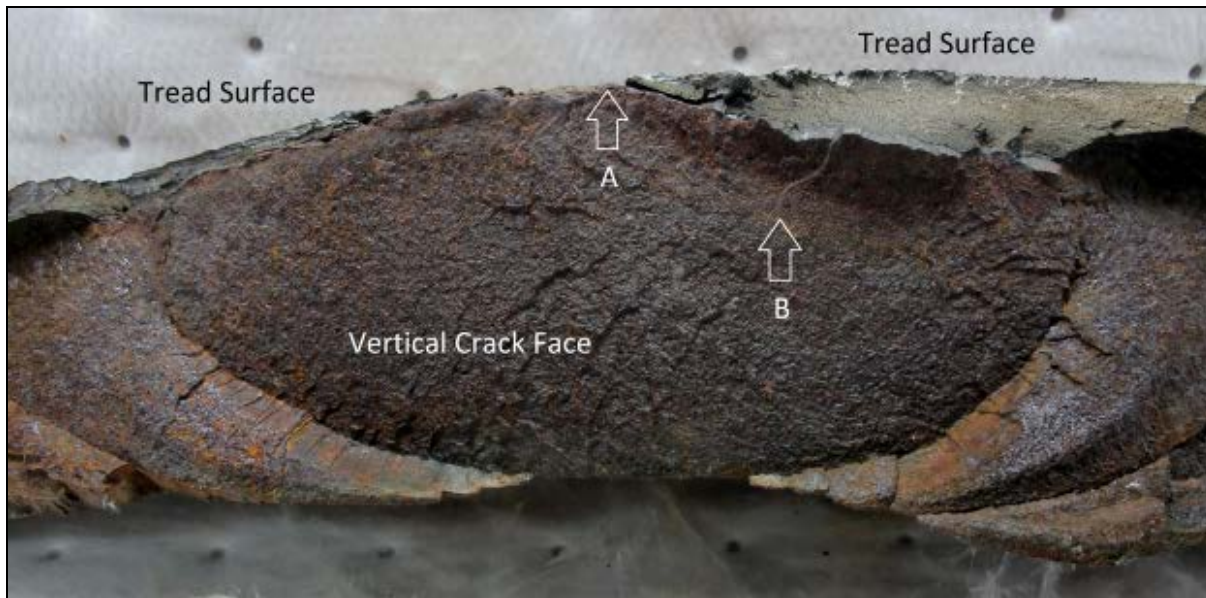
**Figure 16. Potential Crack Original Locations on W43 after Opening Crack**

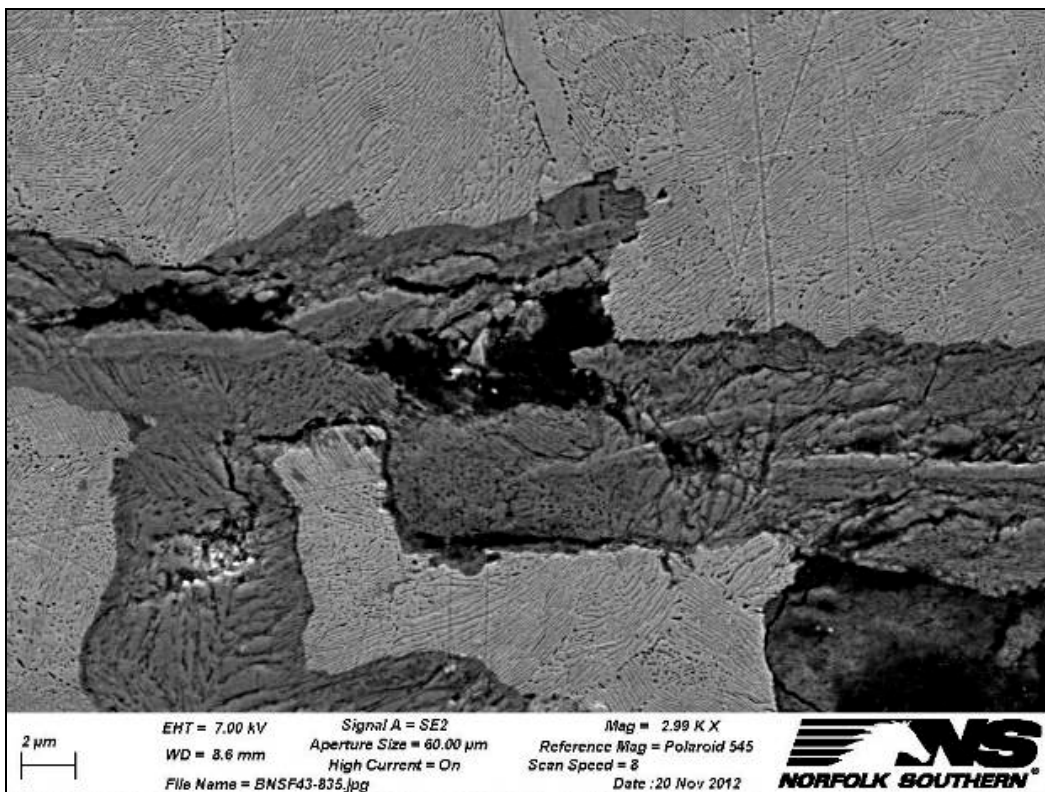
Understanding the propagation path of a crack can help define the relative influence of high stress levels and localized material weaknesses. Nonmetallic inclusions act as stress concentrators and tend to solidify at the grain boundaries as ingots solidify and cool. The vertical crack faces from W43 were investigated using Norfolk Southern's scanning electron microscope (SEM). Samples from each side of the crack near the two potential initiation sites were extracted perpendicular to the crack plane, polished, and etched with a saturated solution of picric acid to show the microstructure, including the boundaries between prior-austenite grains. These samples were then viewed using the SEM. The crack appeared to propagate through the middle of grains (transgranular) rather than between prior-austenite grain boundaries (intergranular) indicating that high stress levels rather than material weakness were likely the main driving force in the crack propagation. However, during SEM analysis, it was difficult to identify the exact location of the potential vertical crack initiation sites. Once the crack had grown to a sufficient size, it was expected that the stress concentration created by the crack would increase the probability of transgranular propagation. Separating the rim material at the crack was necessary to examine the morphology of the crack surfaces and identify potential crack initiation sites. However, this required that the mating crack surfaces be viewed separately under the SEM, which made it difficult to confidently match crack asperities between the surfaces. This further reduced confidence in the finding that the crack experienced transgranular propagation. The ideal specimen for this type of analysis would be extracted from a wheel rim at the initiation site of a VSR crack at the initial stage of growth. Unfortunately, identifying such a wheel and extracting a sample at the VSR crack origin location is improbable. Figure 17 shows an example of some transgranular crack branches on one side of the W43 VSR crack surface.

**Figure 17. Transgranular Crack Branching (image courtesy of Norfolk Southern)**

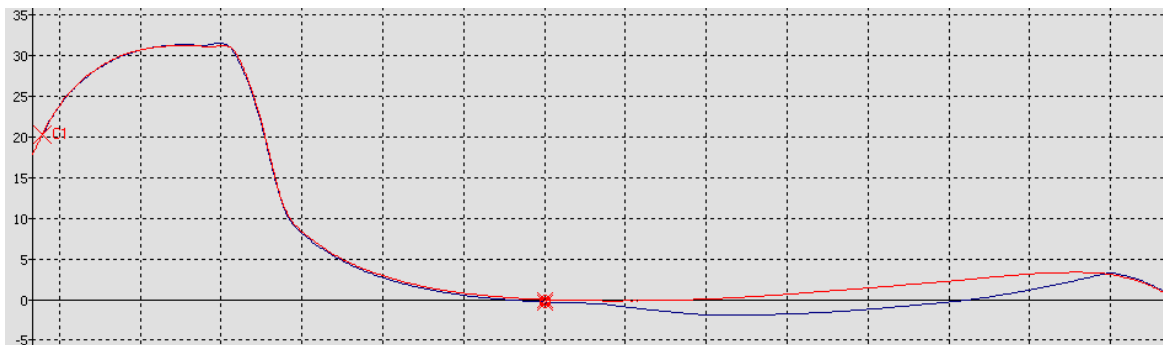
Significant runout of 0.110 in developed on the wheel tread from deformation and wear, forcing the rolling load machine to work harder on every load cycle. After approximately 6.8 million load cycles, the test was stopped because the machine was no longer able to cycle the rail because of the combination of large contact force and radial runout on the wheel. Figure 28 shows the effect of wear and deformation on the transverse wheel profile. Figure 29 shows the crack area and the wheel-rail contact force from this test as a function of the number of load cycles.

**Figure 28. Transverse Wheel Profiles at the Location with Maximum Radial Runout (blue) and at a Circumferential Location that did not Contact the Rail during the Rolling Load Test (Red)**

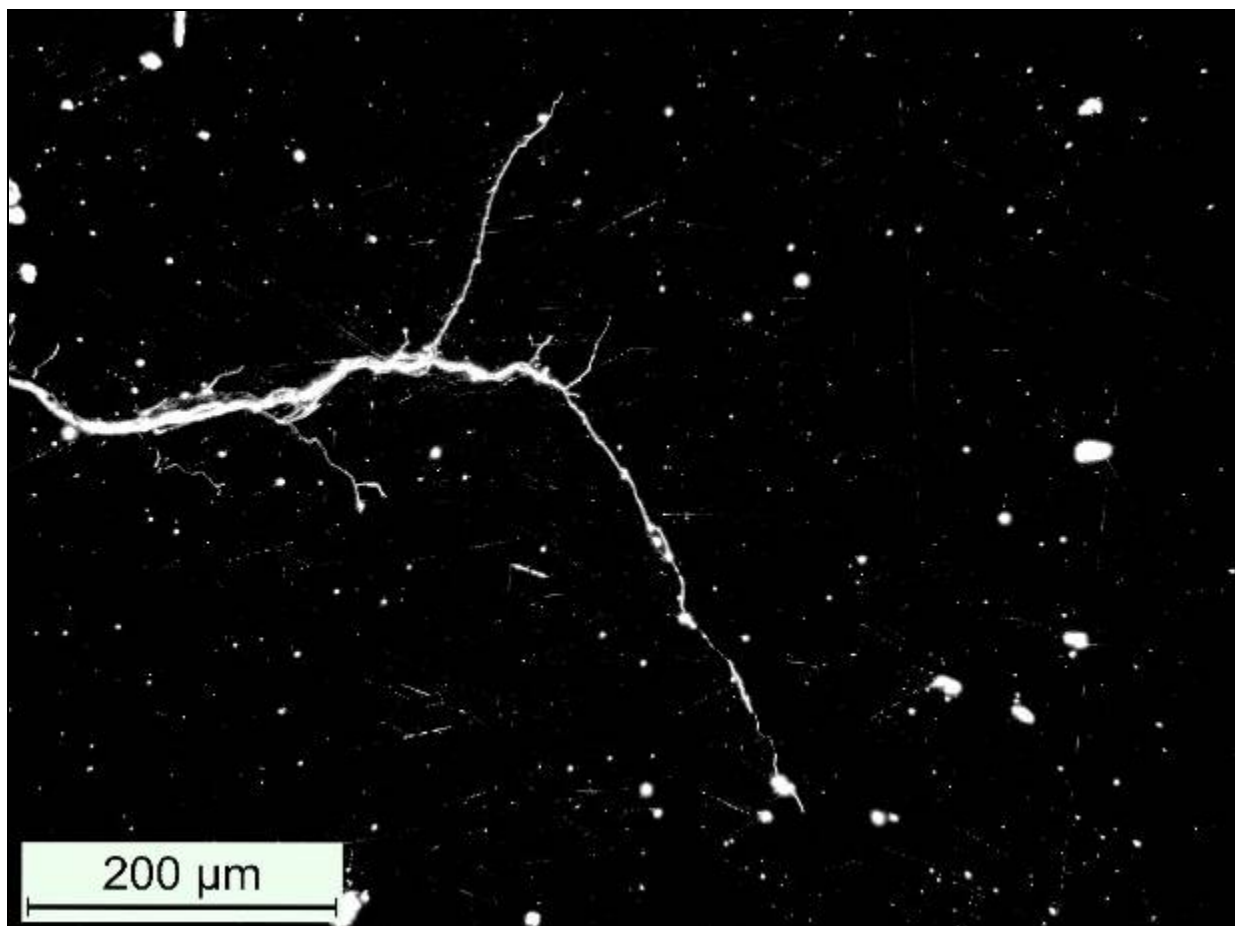
Following the tests on the rolling load machine, each wheel was sectioned and the cracks were viewed under a microscope. The horizontal cracks were found to be between 0.08 and 0.20 in below the tread surface with a typical depth of 0.15 in. Multiple short vertical branches stem from the main horizontal cracks. Figure 31 shows the longest vertical branch found, about 350  $\mu\text{m}$ , at the end of a horizontal crack. This vertical branch is linking a number of small inclusions, and numerous other smaller vertical branches can be seen growing toward the tread surface (top of photo) and further into the rim (bottom of photo). Interestingly, the majority of the vertical crack branches found in these two wheels through optical microscopy were on the flange side of the horizontal cracks, even though the wheel-rail contact during the rolling load test was on the field side of the horizontal cracks. This may be an indication that the bending moment generated in the rim by wheel-rail contact is more critical to producing vertical crack branching than localized stresses nearest to the contact patch.

**Figure 31. Dark Field Optical Microscopy Shows a Horizontal Crack with Multiple Vertical Branches**

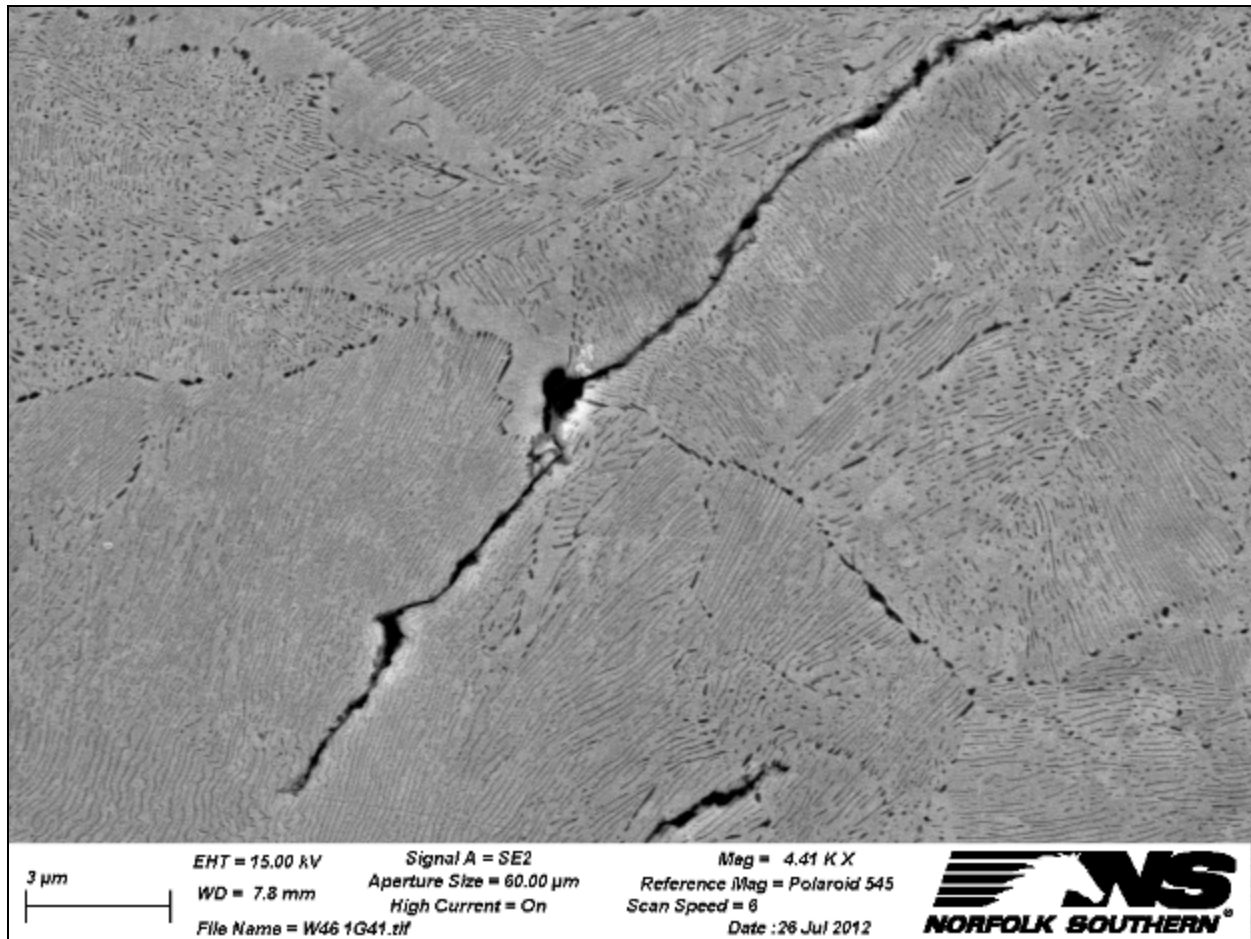
load test wheels were further investigated using Norfolk Southern's SEM. The polished samples were etched with a saturated solution of picric acid to show the microstructure, including the boundaries between prior austenite grains. The horizontal cracks and the vertical crack branches examined in the samples removed from the two wheels that failed to develop VSR cracks all showed crack propagation through the middle of grains (transgranular) rather than between prior austenite grain boundaries (intergranular). This is a strong indication that high stress levels were the main driving force in the crack propagation of these two wheels. If the cracks had followed prior austenite grain boundaries, it would have been an indication that material weakness played a large role in the crack development. Figure 32 shows a typical example of a crack in one of the test wheels as viewed through the SEM.

**Figure 32. Transgranular Crack Propagation (image courtesy of Norfolk Southern)**
