**Federal Railroad
Administration**

Tread Buildup on Railroad Wheels

1. AGENCY USE ONLY (Leave blank)	2. REPORT DATE April 2015	3. REPORT TYPE AND DATES COVERED Technical Report – May 2013	
4. TITLE AND SUBTITLE Tread Buildup on Railroad Wheels		5. FUNDING NUMBERS Task Order 253 Contract DTFR53-00-C-00012

9. SPONSORING/MONITORING AGENCY NAME(S) AND ADDRESS(ES) U.S. Department of Transportation Federal Railroad Administration Office of Research and Development Washington, DC 20590		10. SPONSORING/MONITORING AGENCY REPORT NUMBER DOT/FRA/ORD-15/06

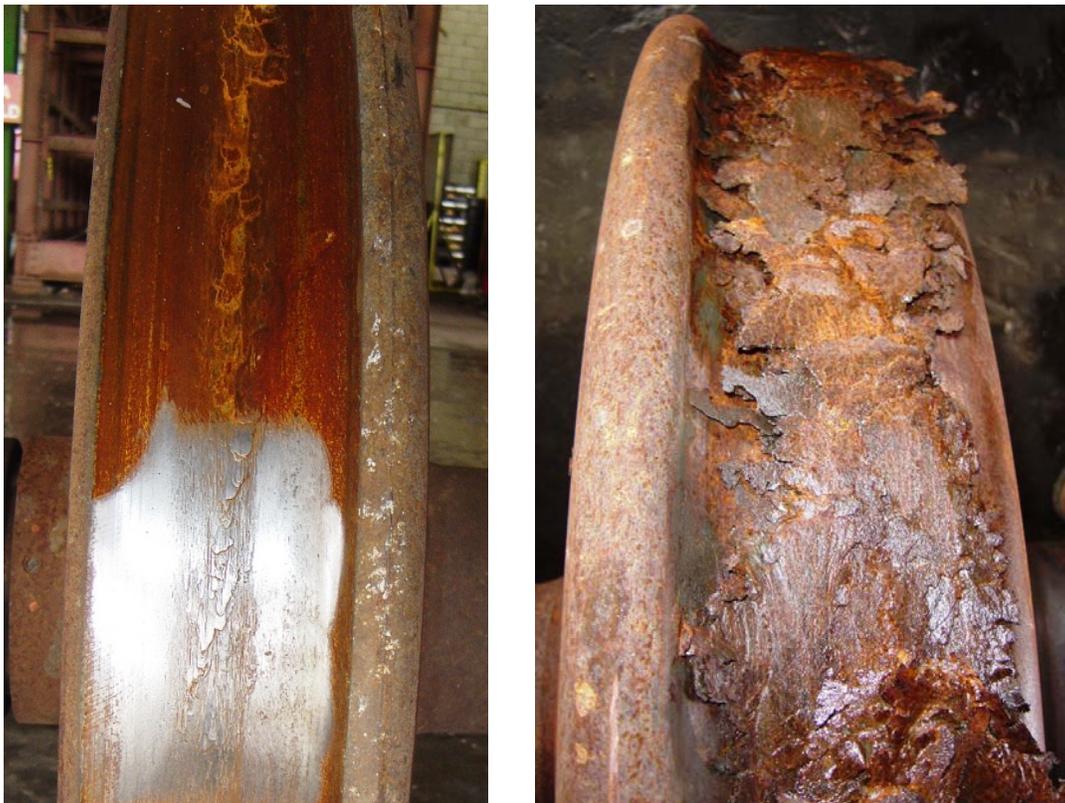
Buildup of material on wheel treads is not uncommon, but it is usually benign from a safety standpoint. However, in extreme cases it can result in train accidents and derailments. The built-up material effectively produces a change in wheel radius, either at a specific circumferential location (resulting in an impact force once per wheel revolution), or around the entire circumference of the wheel (resulting in a reduction in relative flange height). Figure 1 shows photographs of two wheels with TBU around the entire wheel circumference. The left photograph shows a typical TBU appearance in both the rusted and nonrusted conditions. The right photograph shows an unusually severe case of TBU. The TBU in the right photo has clearly reduced the relative flange height, making a flange climb derailment more likely.

Figure 1. Typical TBU appearance on a rusted wheel tread with a portion wire-brushed clean (Left) and severe TBU (Right)

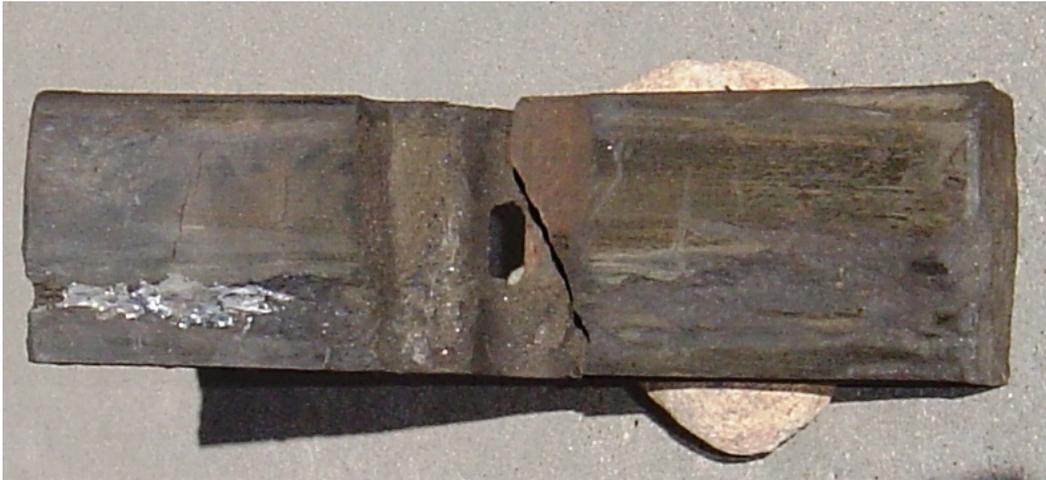
example of a brake shoe with metal pickup composed of metallic wear particles that have become embedded in the composition material.

Figure 4. Composition Brake Shoe with Metal Pickup

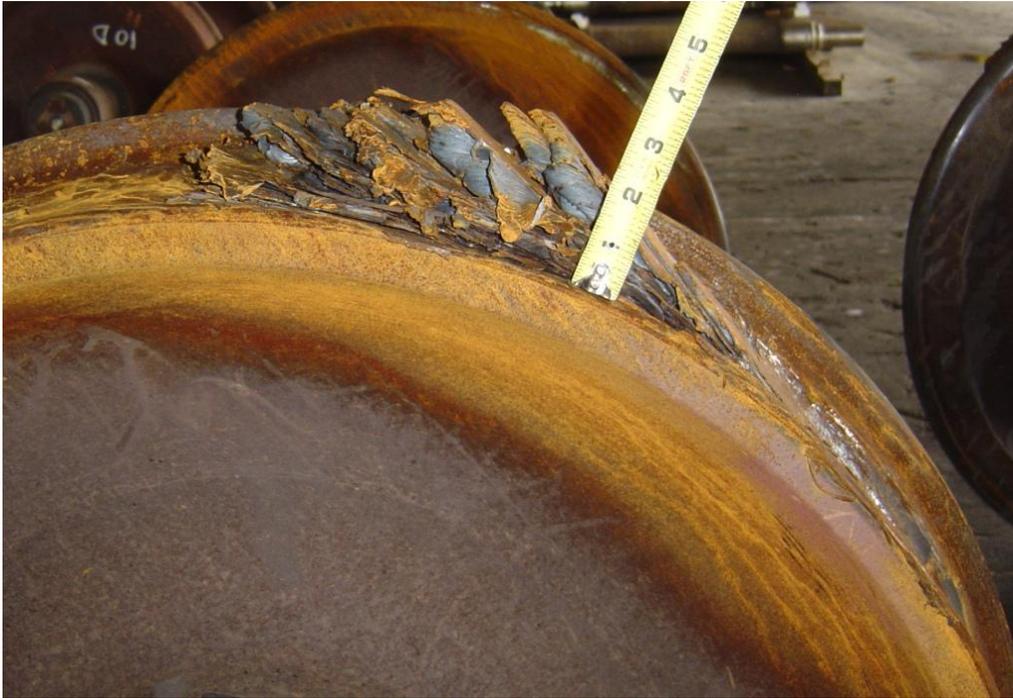
Varying amounts of TBU were found. Three wheelsets had TBU heights greater than 1 inch; the highest measured 3 inches radially off the tread surface. Figure 5 shows this wheel. The wheels with the highest TBU measurements were also the wheels with some of the shorter TBU lengths. Figure 6 shows the circumferential length and radial height of the TBU on each wheel. From a safety standpoint, the radial height of the TBU material is of primary concern. The three wheels with a TBU radial height of more than 1 inch and a circumferential TBU length less than 20

inches showed obvious signs of a wheel slide immediately adjacent to the TBU. Heat discoloration on the rim, flange, and plate of these three wheels was concentrated near the flat spot and TBU. The root cause of the TBU on these three wheels was clearly a wheel slide event.

Figure 5. Wheel with 3-Inch TBU

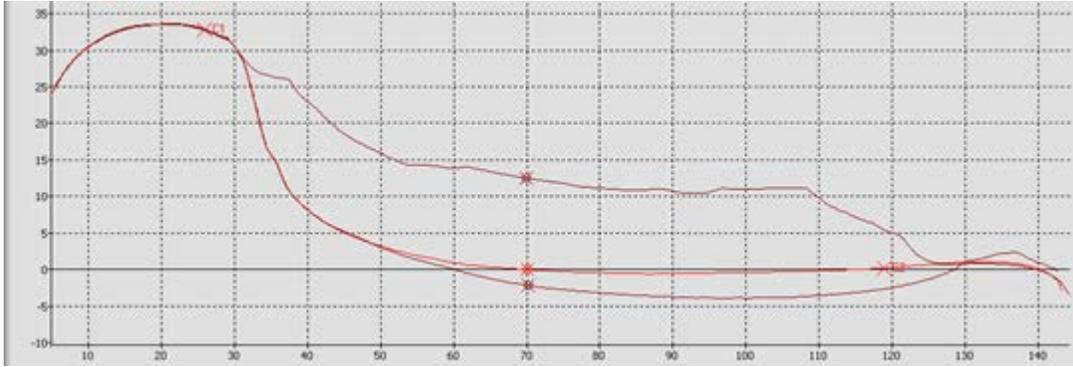
Wheel profile readings were captured on select wheels. Figure 7 shows three overlaid wheel profiles from the same wheel taken at a flat spot, at the TBU, and at a circumferential location with no damage. This figure illustrates how TBU wheels can generate large impact loads because of changes in the wheel radius and how the TBU can reduce the effective wheel flange height and angle.

Figure 7. Three Wheel Profiles from the Same Wheel

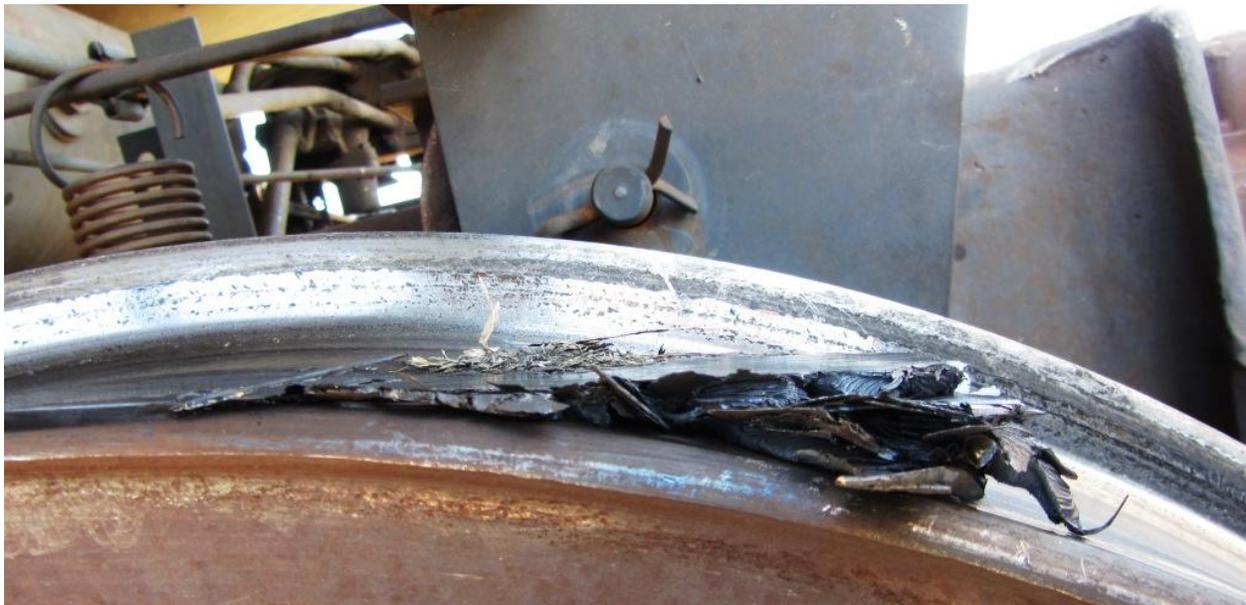
Figure 12 shows the average TBU height for the four sliding wheels from each of the long slide tests. As was the case with the short slide tests, the long slide data showed much variation. In general, TBU accumulated to the greatest heights under dry conditions and at longer slide distances. Train speeds between 20 and 30 mph appeared to optimize TBU height. Figure 13 shows a photo of the highest TBU created during the tests, measuring 1 inch high after a 27-mile slide at 30 mph in dry conditions.

Figure 13. 1-Inch High TBU Created During Slide Tests
