RESEARCH RESULTS
FRA OFFICE OF RAILROAD POLICY & DEVELOPMENT

RR 15-13 | May 2015

HIGH-SPEED PASSENGER RAIL TIE-BALLAST INTERACTION

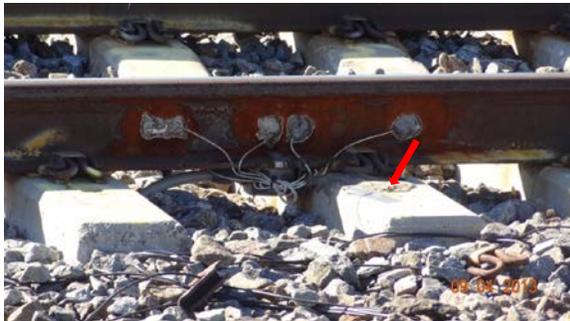
Figure 1. Photograph showing strain gages on rail and LVDT location on tie (see arrow)

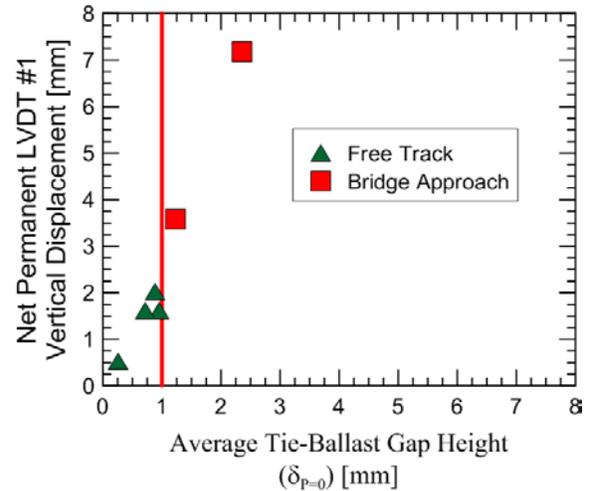
Figure 4 shows a strong correlation between the average tie-ballast gap ($\delta_{p=0}$) obtained during four different data recordings and the accumulated permanent vertical displacement measured over the same time period. This data implies the tie-ballast gap is the primary cause of the observed permanent vertical displacements because the two bridge approach sites (red squares) exhibit excessive permanent vertical displacements while the four free track sites (green triangles) do not. As a result, the red vertical line separates sites with low and high permanent vertical displacements, which suggests a tie-ballast gap ($\delta_{p=0}$) greater than about 1.0 mm can lead to excessive permanent vertical displacements because of load redistribution among adjacent ties. While a gap of 1.0 mm seems unrealistically too small, this behavior of increased permanent vertical displacements from tie-ballast gaps of greater than 1.0 mm is also reported by Selig and

Waters (1994) using experimental ballast box testing and field data from near Aberdeen, Maryland.

Figure 4. Correlation between tie-ballast gap height and permanent tie displacement.
