U.S. Department
of Transportation
**Federal Railroad
Administration**

Safety Testing of Intermodal Hazmat Configurations, Summary Report

George Kachadourian

1. Report No. DOT/FRA/ORD-88/04	2. Government Accession No.	3. Recipient's Catalog No.	
4. Title and Subtitle Safety Testing of Intermodal Hazmat Configurations, Summary Report		5. Report Date March 1988

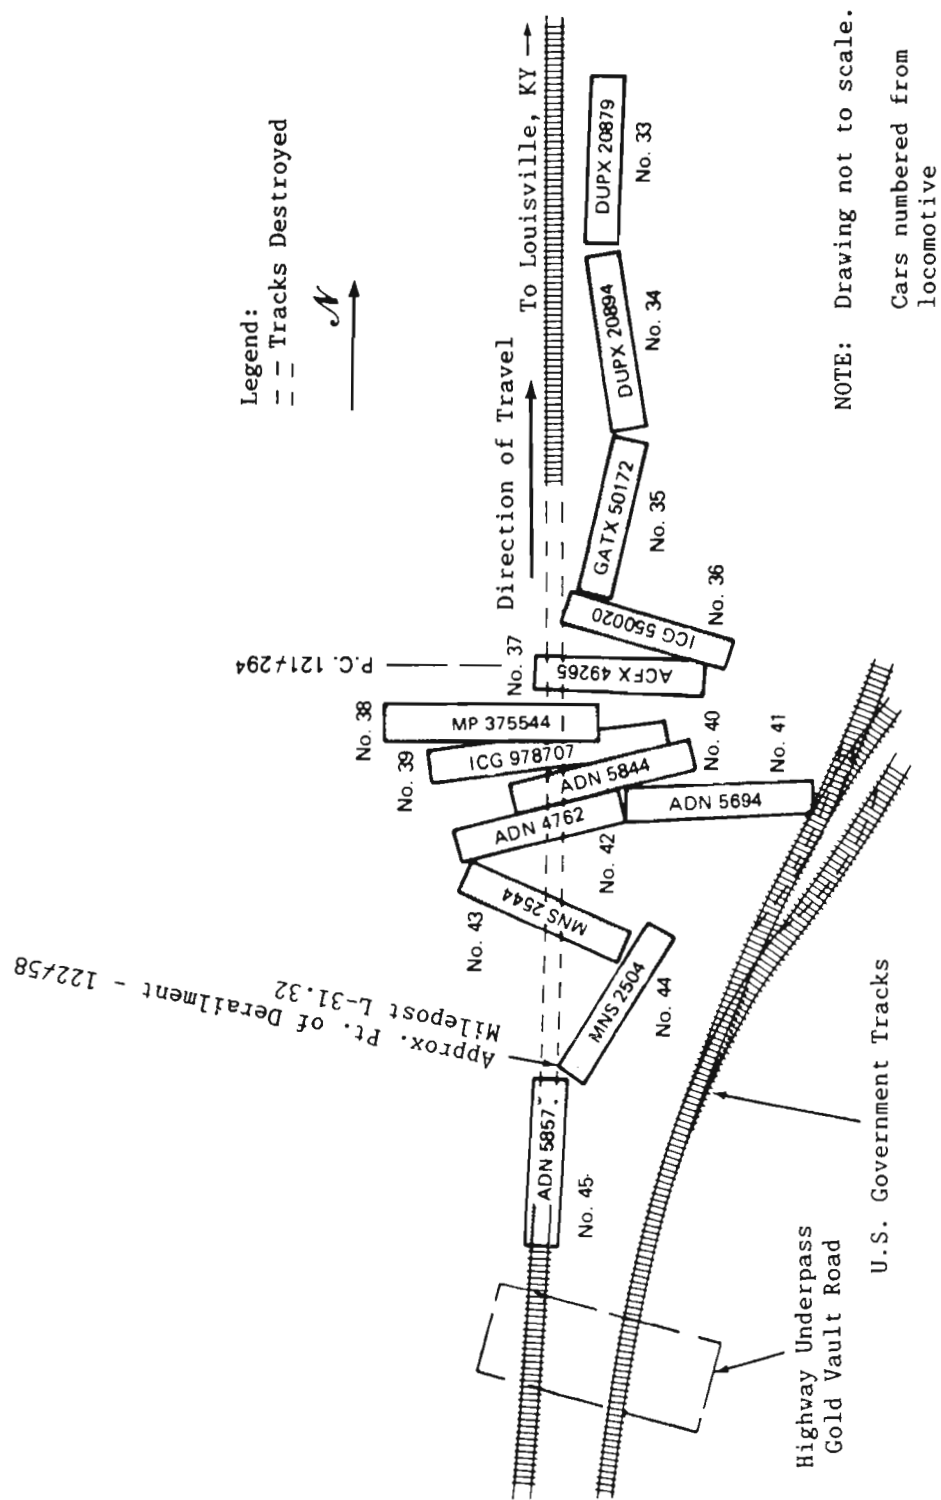
FIGURE 5-1
 DERAILMENT OF ILLINOIS CENTRAL GULF FREIGHT TRAIN,
 LST NO. 64, AT FORT KNOX, KENTUCKY ON MARCH 22, 1983

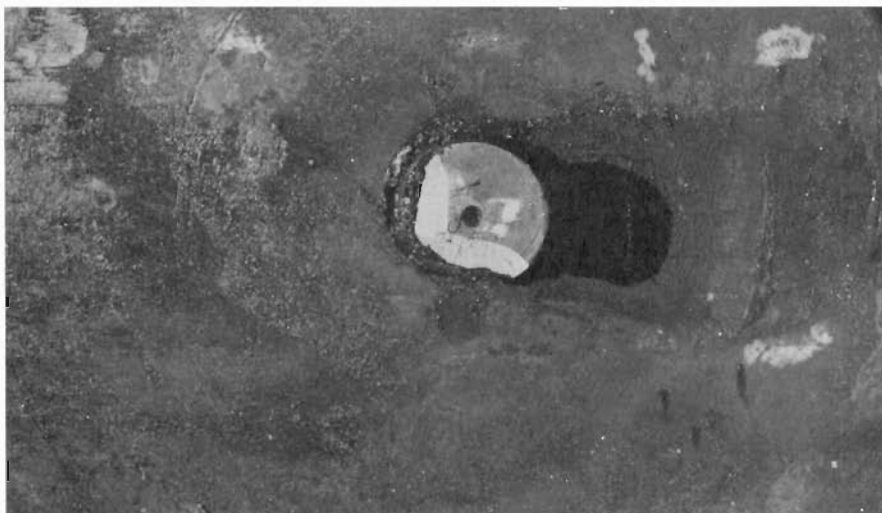
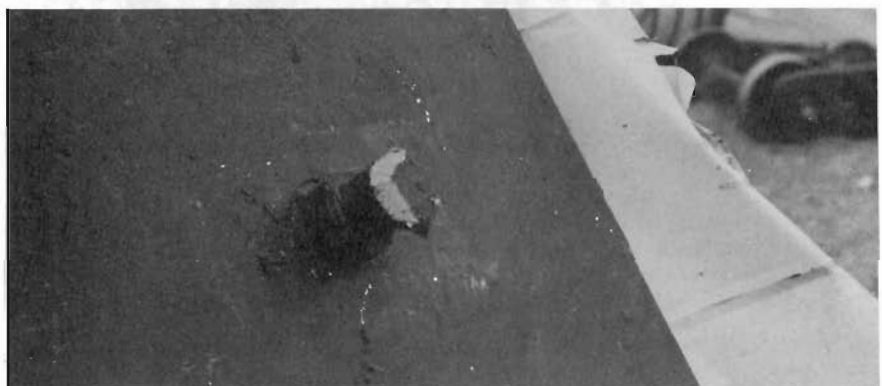
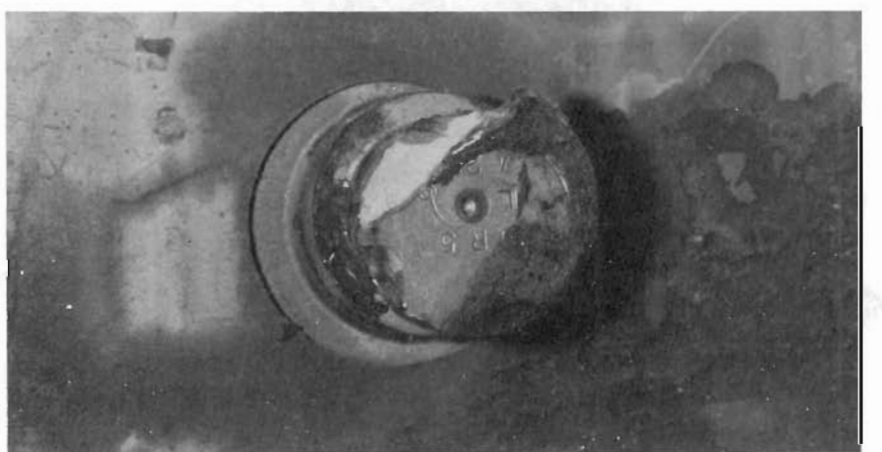
FIGURE 5-7
MC 307 FAILED KINGPINS

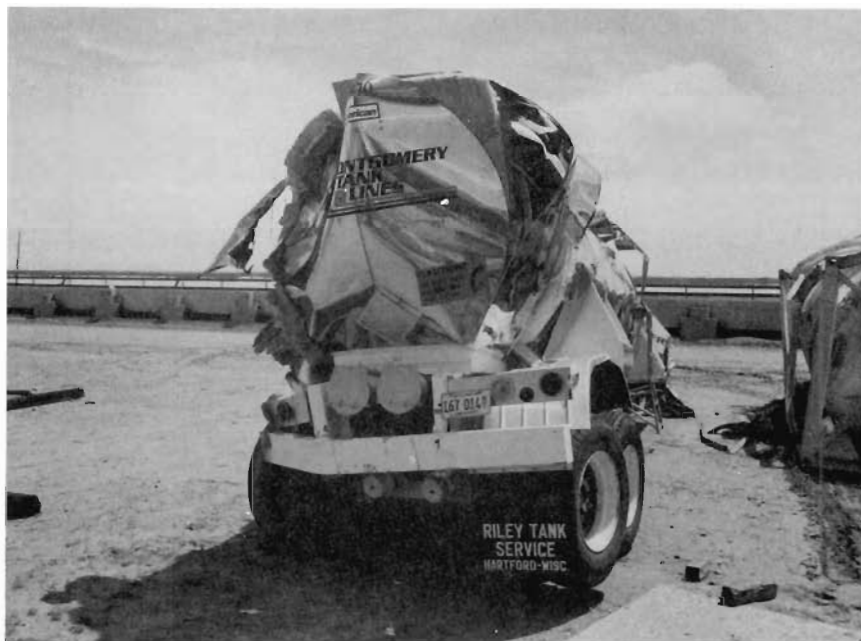
FIGURE 5-8
MC 307 MTLZ 6970 TANDEM END VIEWS OF DAMAGE AFTER
THREE BROKEN RAIL DERAILMENT TESTS

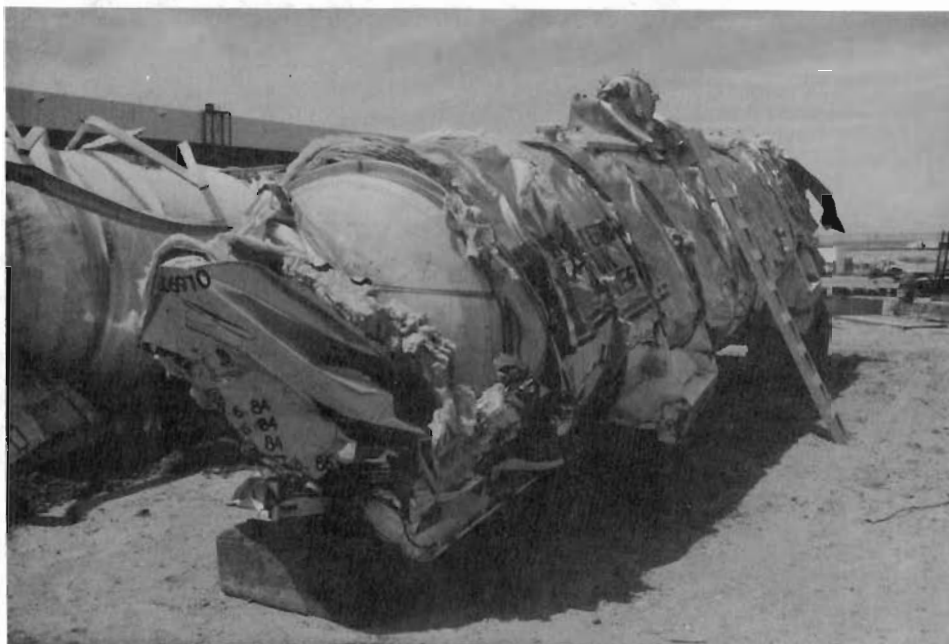
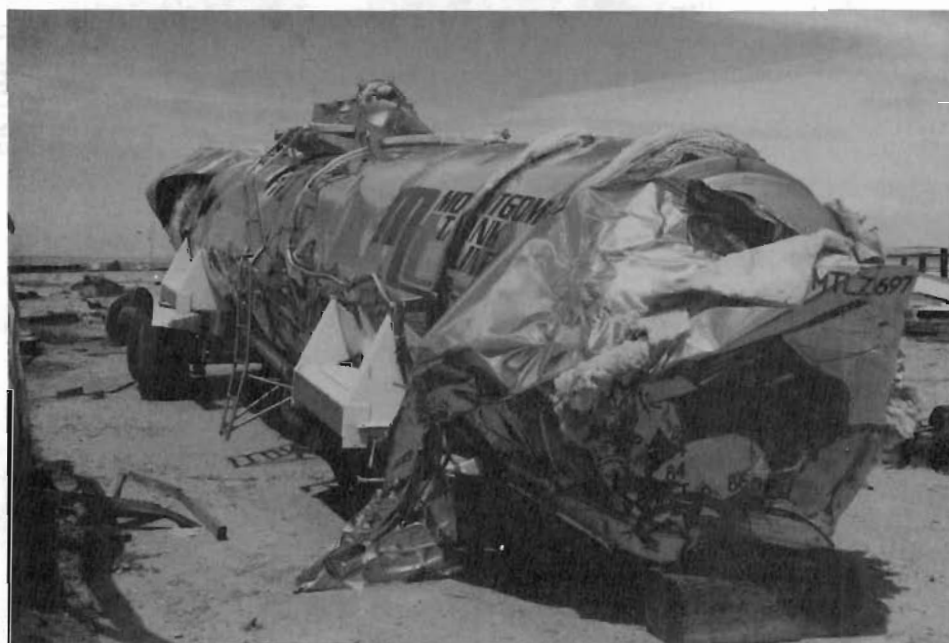
FIGURE 5-9
MC 307 MTLZ 6970 HITCH END VIEWS OF DAMAGE AFTER
THREE BROKEN RAIL DERAILMENT TESTS

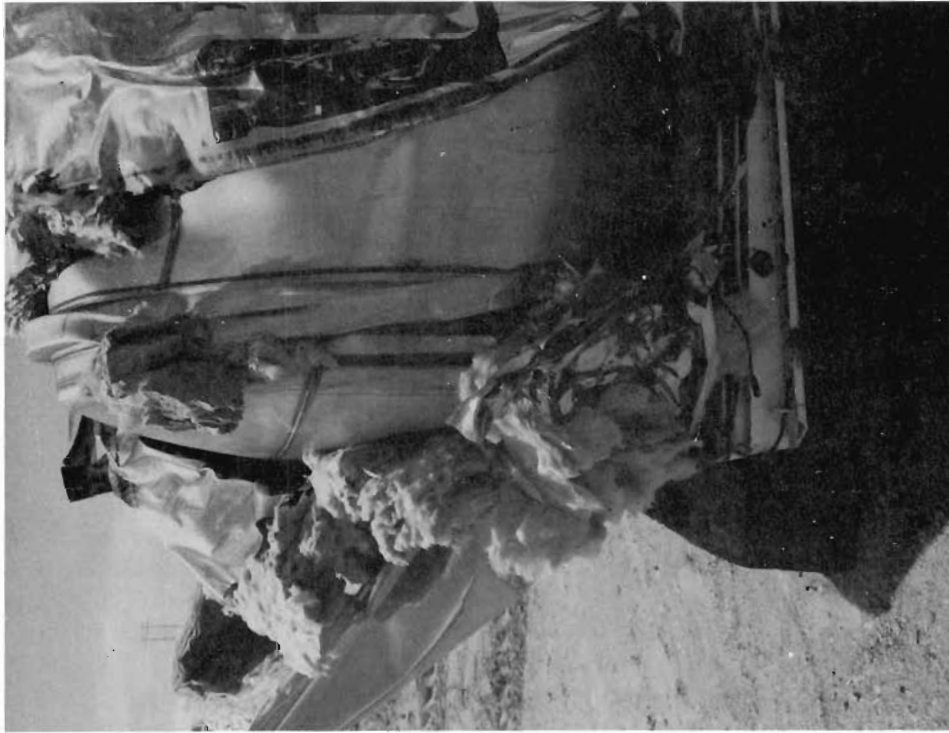
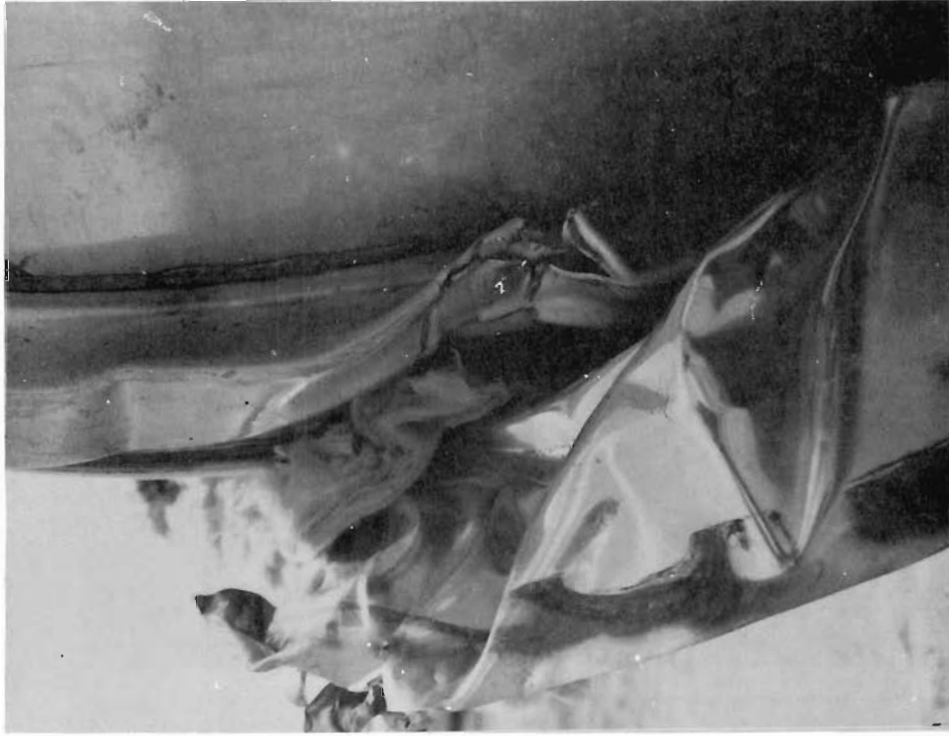
FIGURE 5-10
MC 307 MTLZ 6970 DAMAGE AT TANDEM END OF TANK AFTER
THREE BROKEN RAIL DERAILMENT TESTS

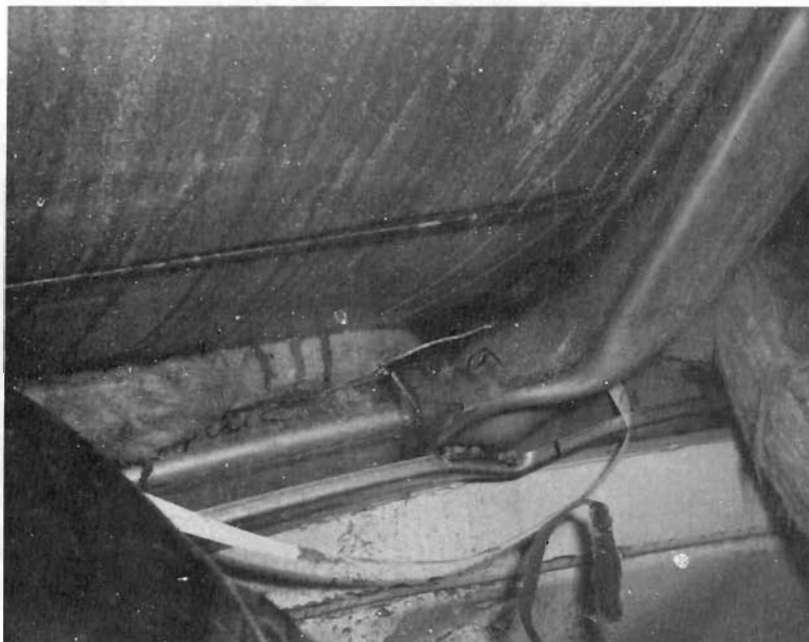
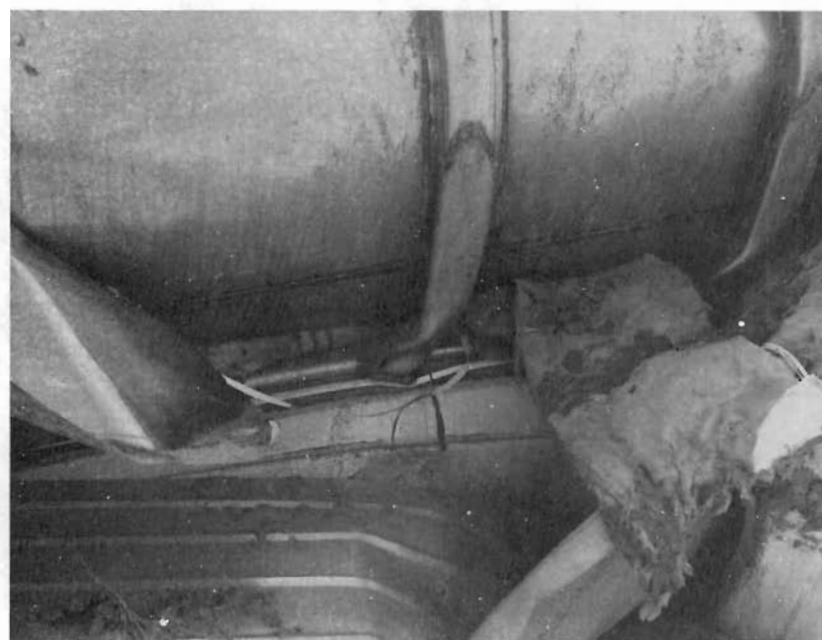
FIGURE 5-11
MC 307 MTLX 6970 DAMAGE IN LIFTING PAD AREA AFTER
THREE BROKEN RAIL DERAILMENT TESTS

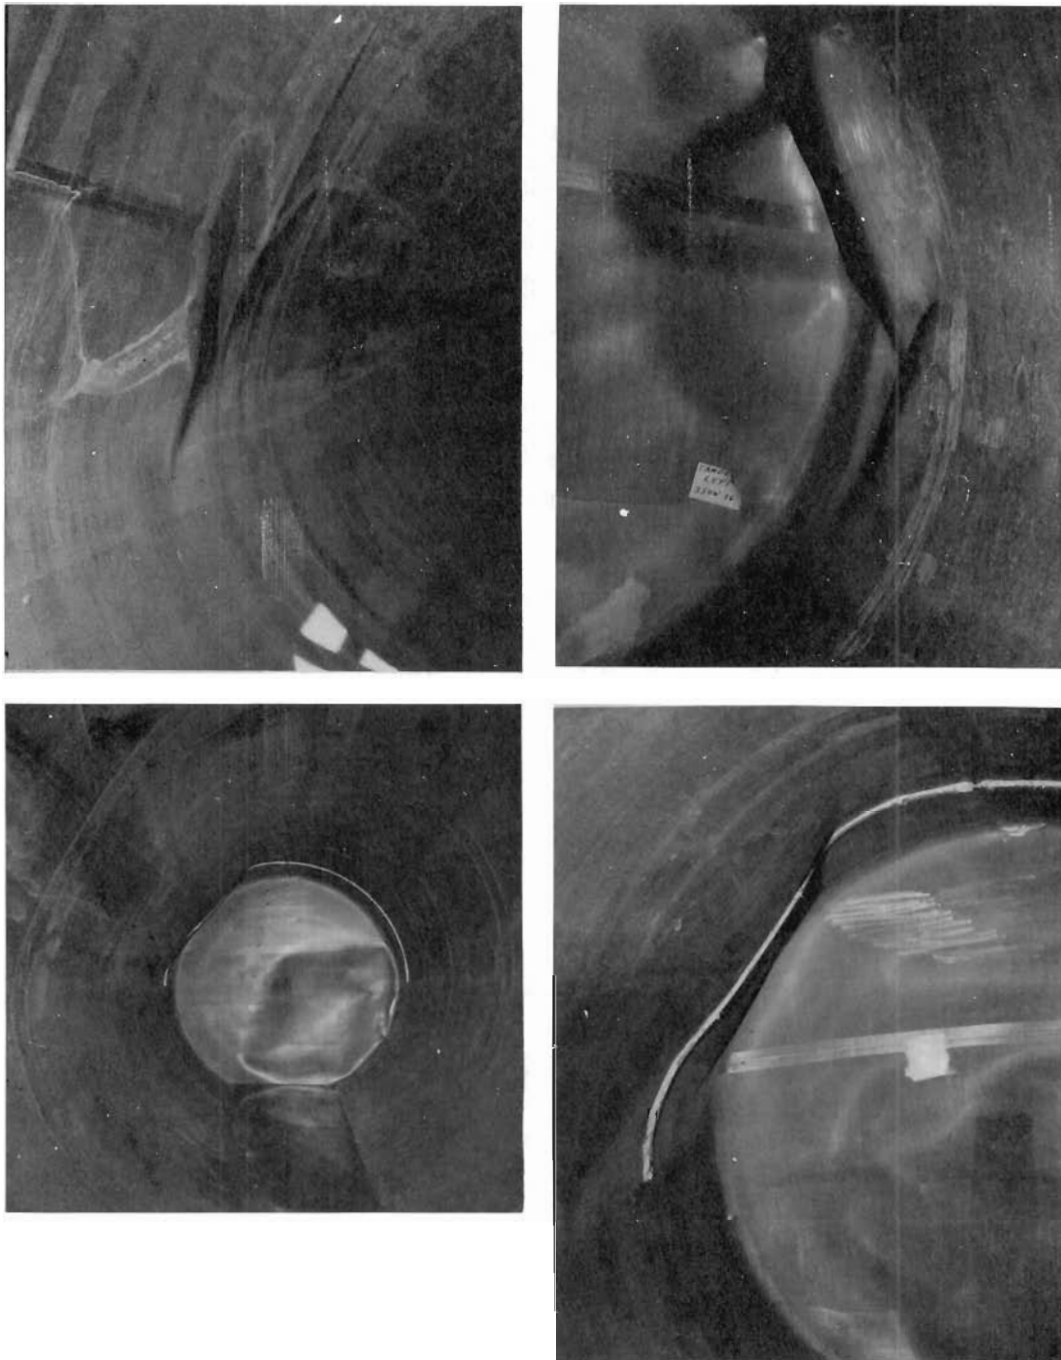
FIGURE 5-12
MC 307 MTLZ 6970 INTERNAL VIEW OF TANK DAMAGE AFTER
THREE BROKEN RAIL DERAILMENT TESTS

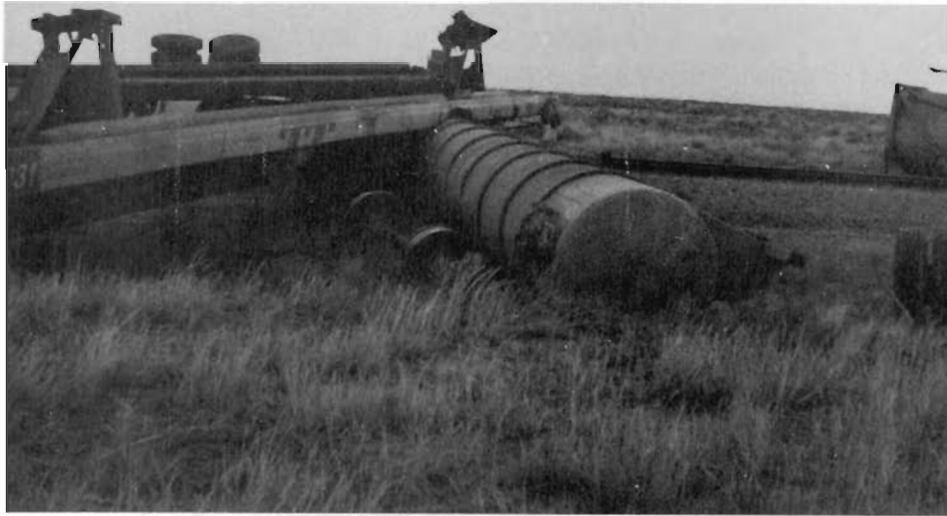
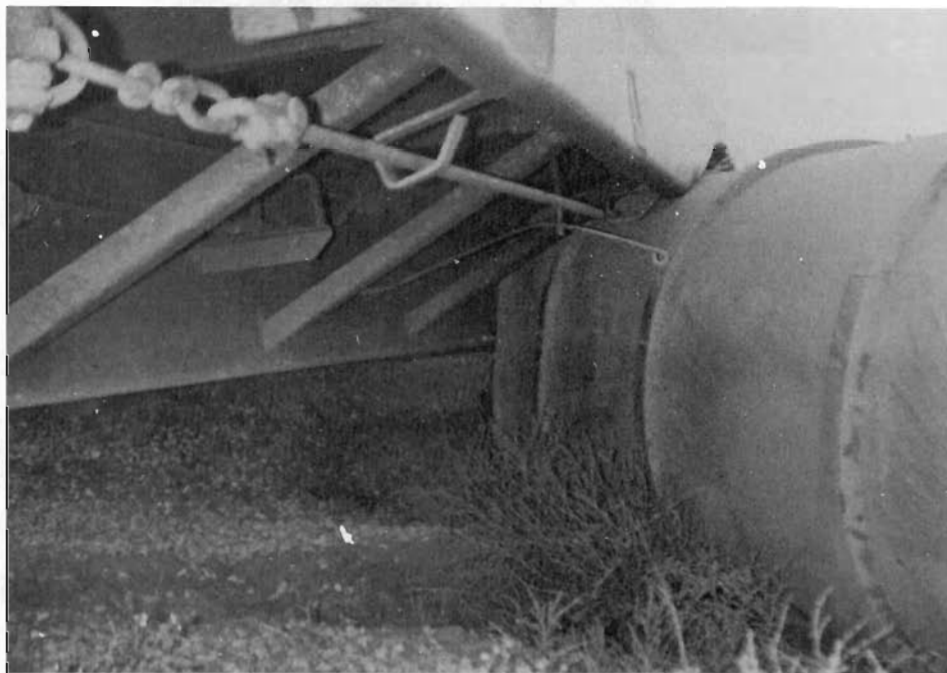
FIGURE 5-13
MC 312 TANK TRAILER FROM ACCORDION TEST
POSITION 1-A UNDER FLATCAR

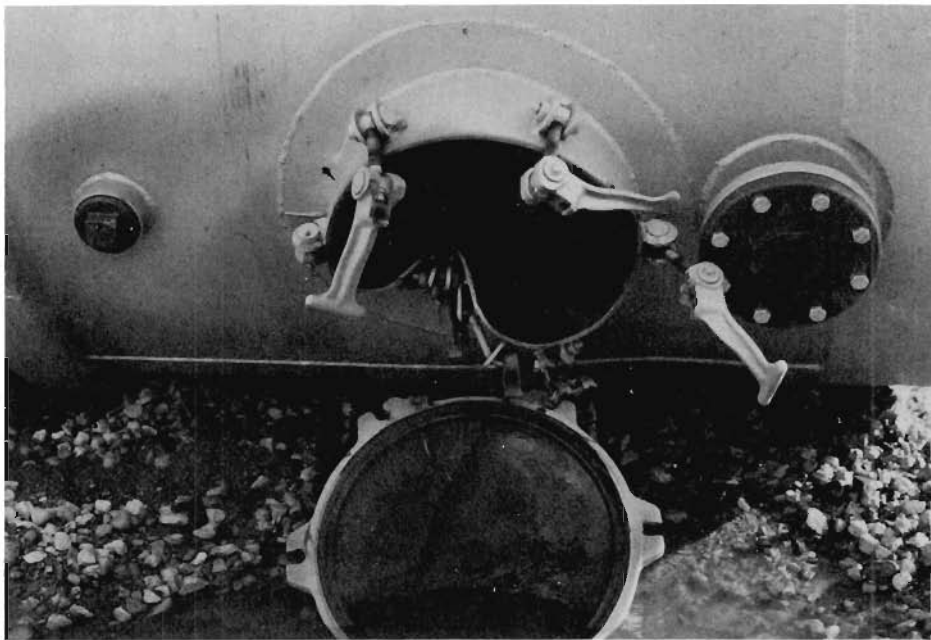
FIGURE 5-14
MC 312 FROM ACCORDION TEST POSITION 3B
SHOWING DAMAGE TO TANK AND MANHOLE

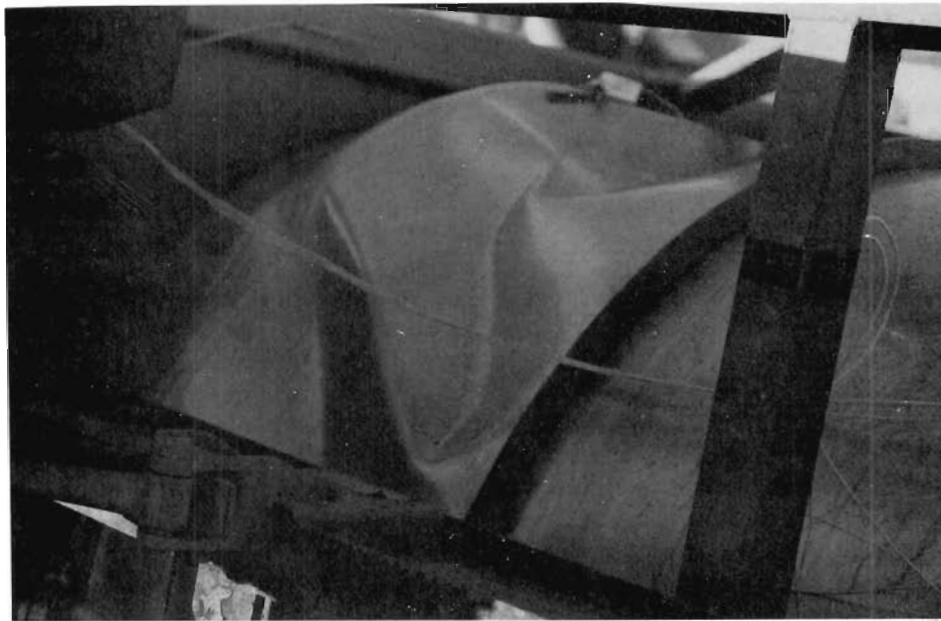
contact. The tank remained attached to the trailer. There was some bending of the frame structure but the most significant damage was deep buckling at one end of the tank shell. Two photographs of these buckles are shown in Figure 5-19. There were no leaks other than through an opening used for wiring to the slosh gages inside the tank.

FIGURE 5-19
BLSU 300019 BUCKLED TANK, FROM BROKEN
RAIL DERAILMENT TEST 1 AT 23.4 MPH

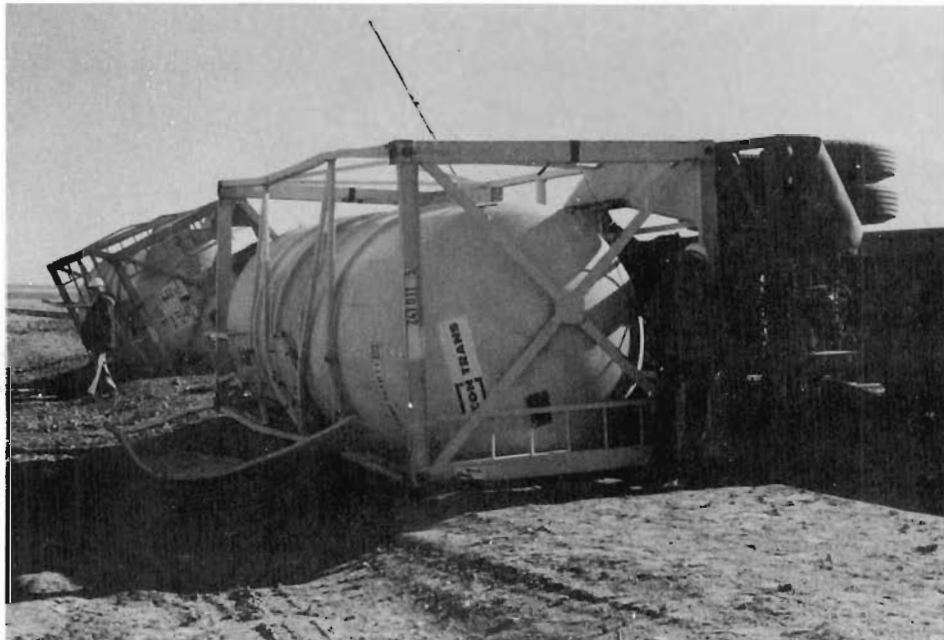
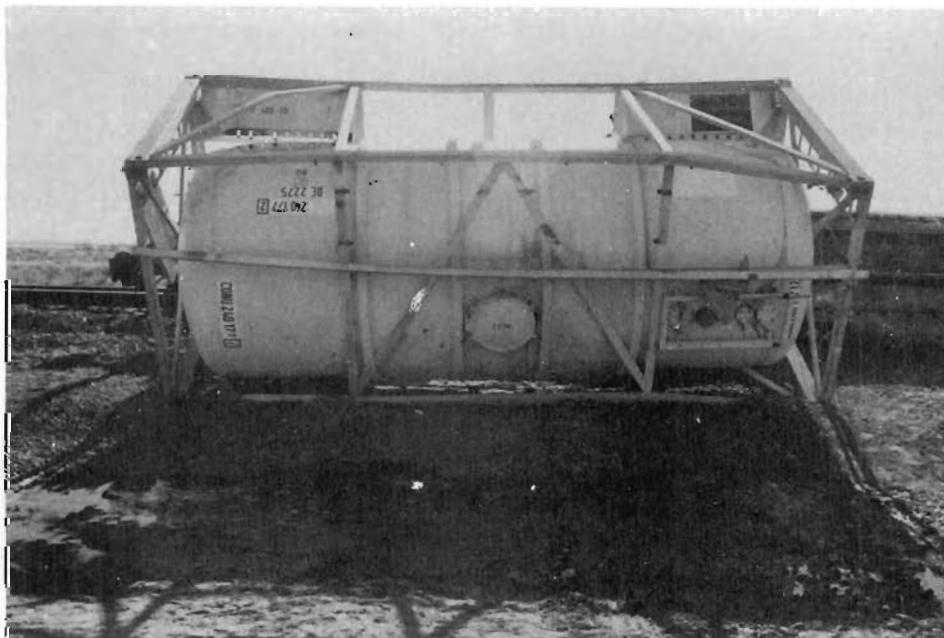
**FIGURE 5-20
DAMAGE TO PORTABLE TANKS IN BROKEN
RAIL DERAILMENT TEST 2 AT 19.0 MPH**

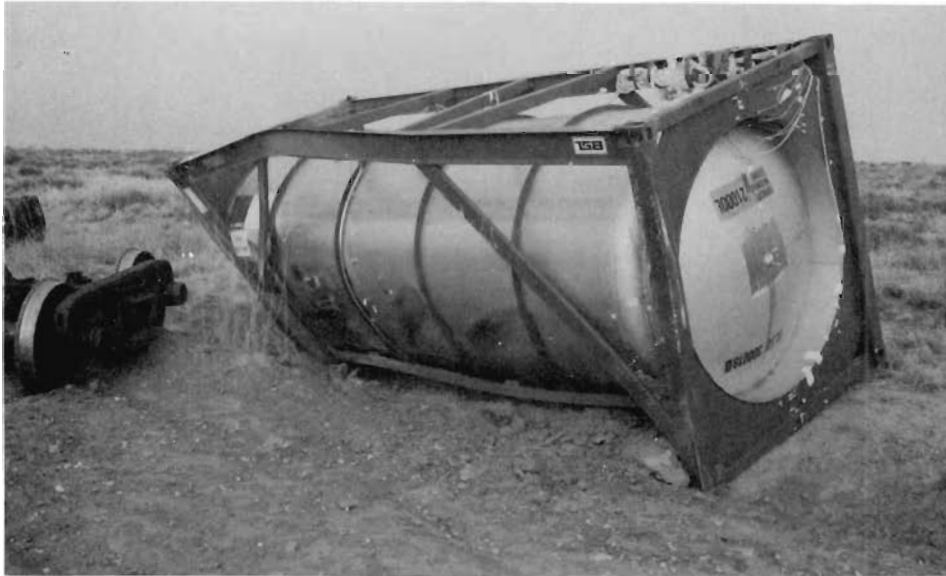
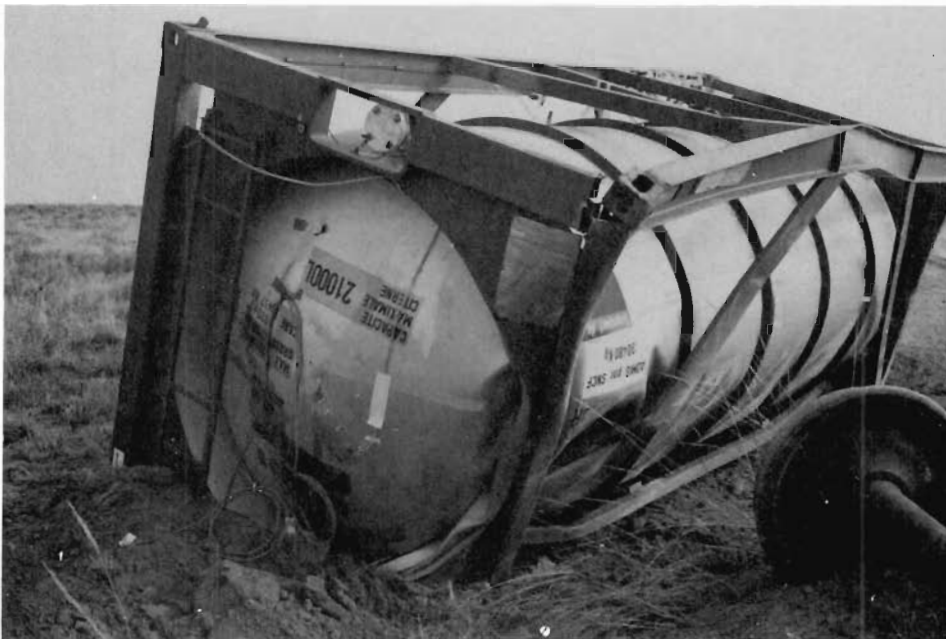
FIGURE 5-21
DAMAGE TO BLSU 300019 AFTER BROKEN RAIL
DERAILMENT TEST 3 (ALSO USED IN TEST 1) AT 42.0 MPH

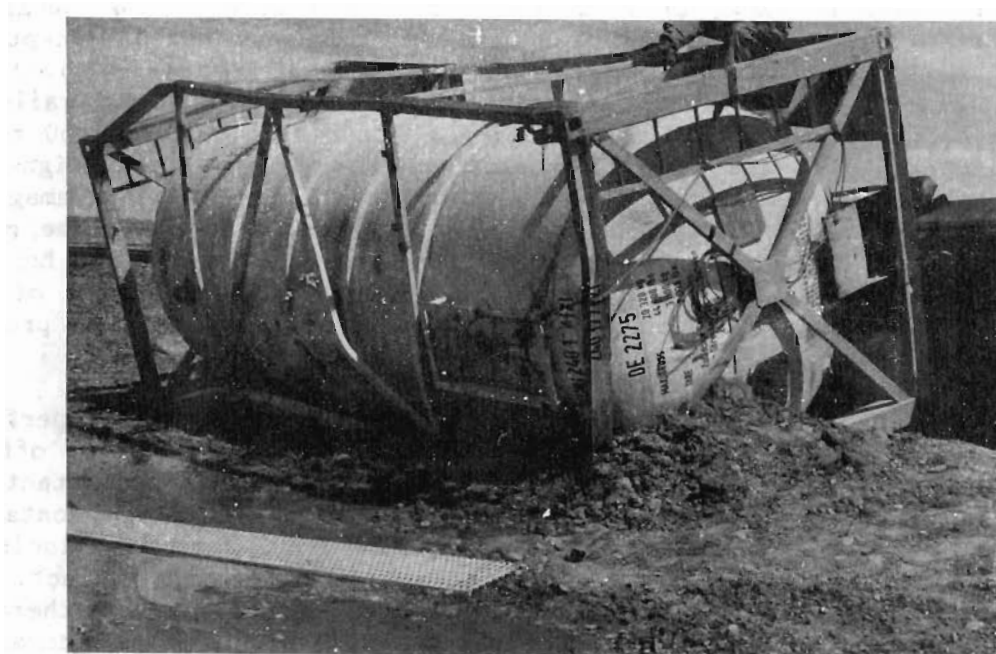
There was less damage to the tank support brackets in this test than in Test 2 but there were greater deformation and fracture of the frame structure. There was some additional buckling of the tank shells. There was no leakage except through an instrumentation port in DE 2275.

**FIGURE 5-22
DAMAGE TO PORTABLE TANKS IN BROKEN RAIL
DERAILMENT TEST 4 AT 40.0 MPH**

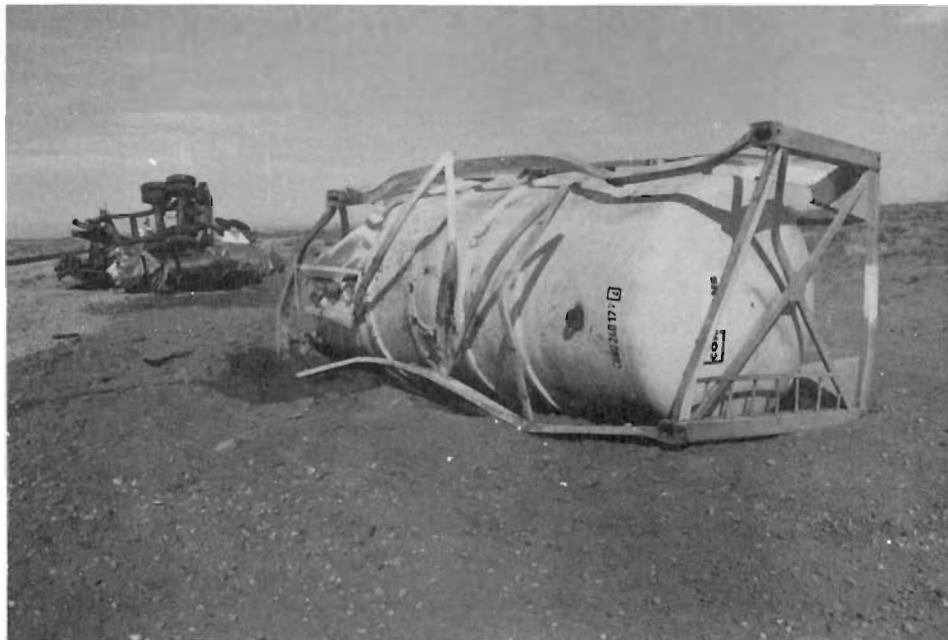
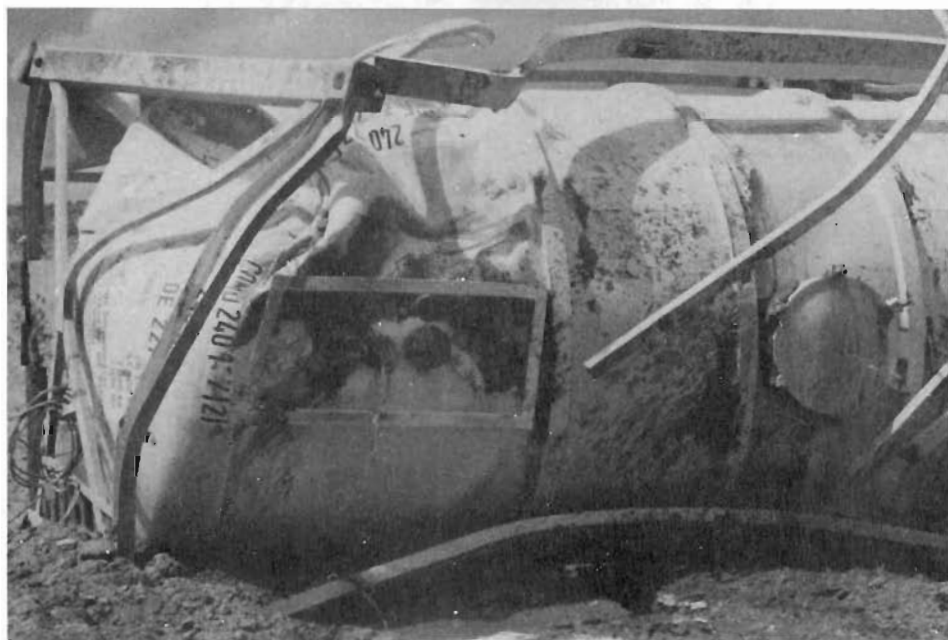
Broken Rail Derailment Test 5 was performed at 64.5 mph with DE 2275, an IM 102 portable tank, on a 20-foot chassis trailer. The damage to DE 2275 from Tests 2 and 4 had been repaired prior to Test 5, except that the tank buckles and some bends in the frames could not be removed. In this derailment the portable tank separated from the chassis trailer as the flatcar tilted. The forward velocity of the tank was about 50 mph at ground impact. The tank first contacted the ground on its top, right hand forward corner and continued to roll, bounce and slide. Major damage was done to the frame structure and tank on the first impact with the ground with bending and fracturing of the frame and large buckles in the head and shell of the tank. The photographs in Figure 5-23 show some of this damage. The bottom photograph also shows the water leak from the pressure relief valve.

FIGURE 5-23
DAMAGE TO PORTABLE TANK IN BROKEN RAIL
DERAILMENT TEST 5 AT 64.5 MPH

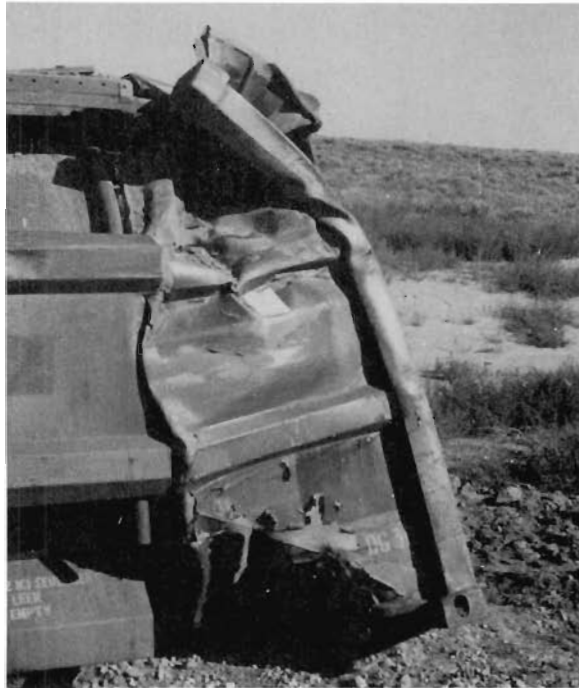
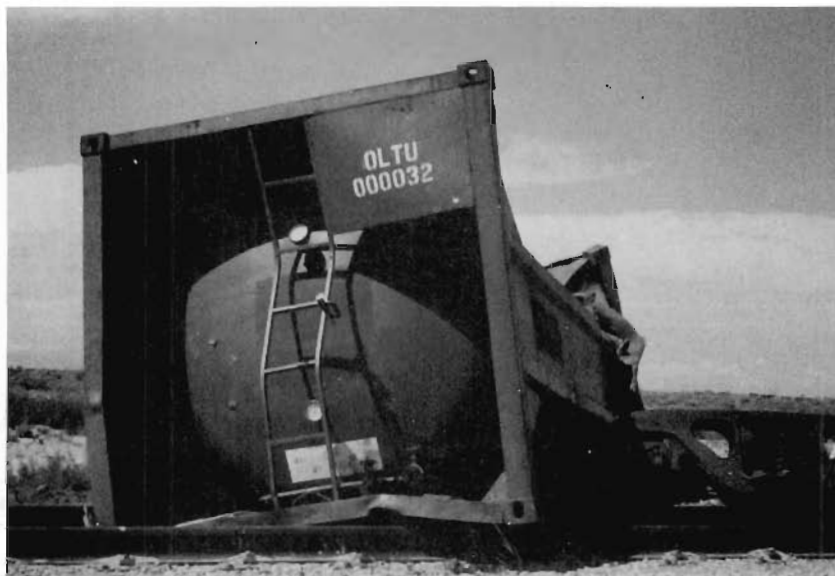
FIGURE 5-24
DAMAGE TO PORTABLE TANKS IN BROKEN RAIL
DERAILMENT TEST 6 AT 59.5 MPH

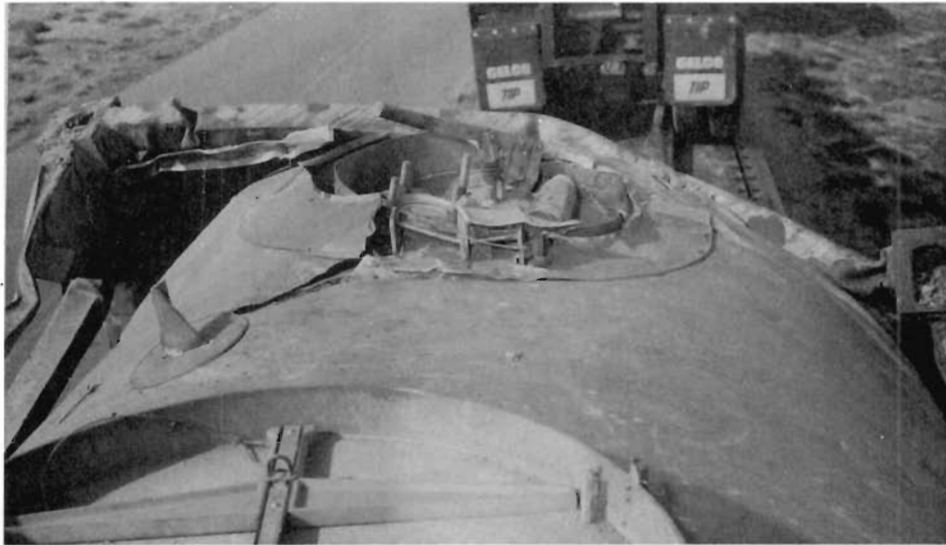
FIGURE 5-26
DAMAGE TO VENT COVER AND INSIDE TANK,
EMMU 234784-5, ACCORDION TEST

Two things are worthy of note in the photographs of the insulated IM 102 shown in Figure 5-26: (1) the protective cover and frame structure have been wiped clear of the valves and safety vents that access the tank, indicating how vulnerable to damage they are; and (2) the tank itself will withstand severe dents and crimps without fracture because of the tank material and thicknesses.

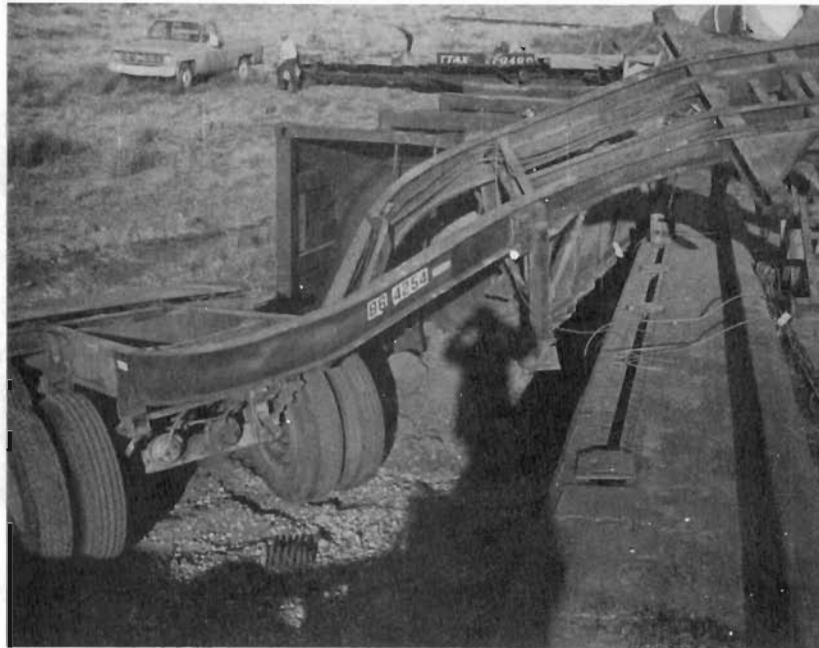
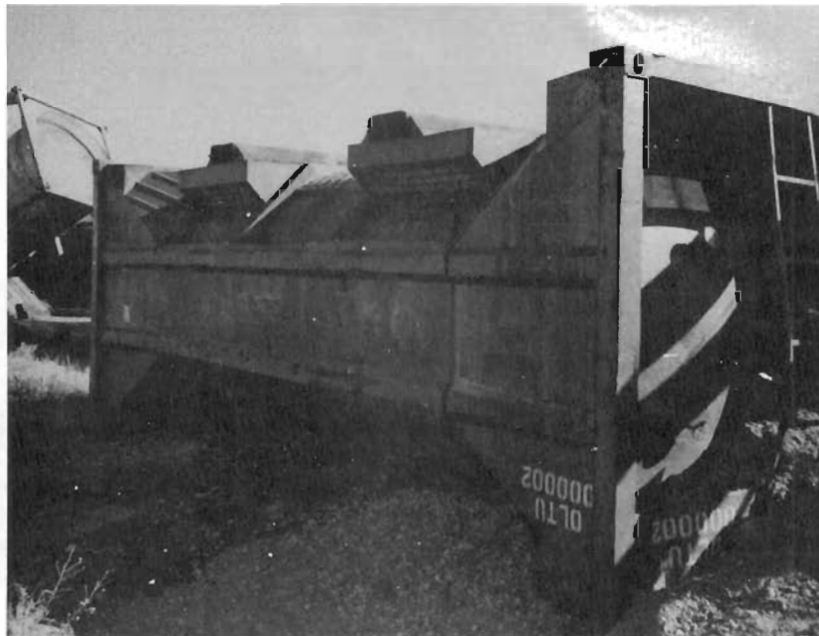
**FIGURE 5-27
DAMAGE TO IM 101, OLTU 000002, POSITION 2A (TOFC),
ACCORDION TEST**

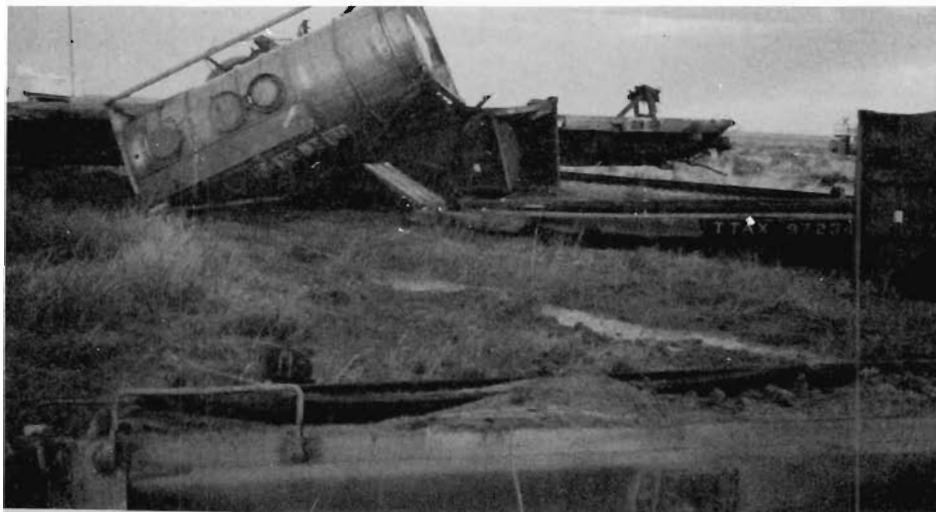
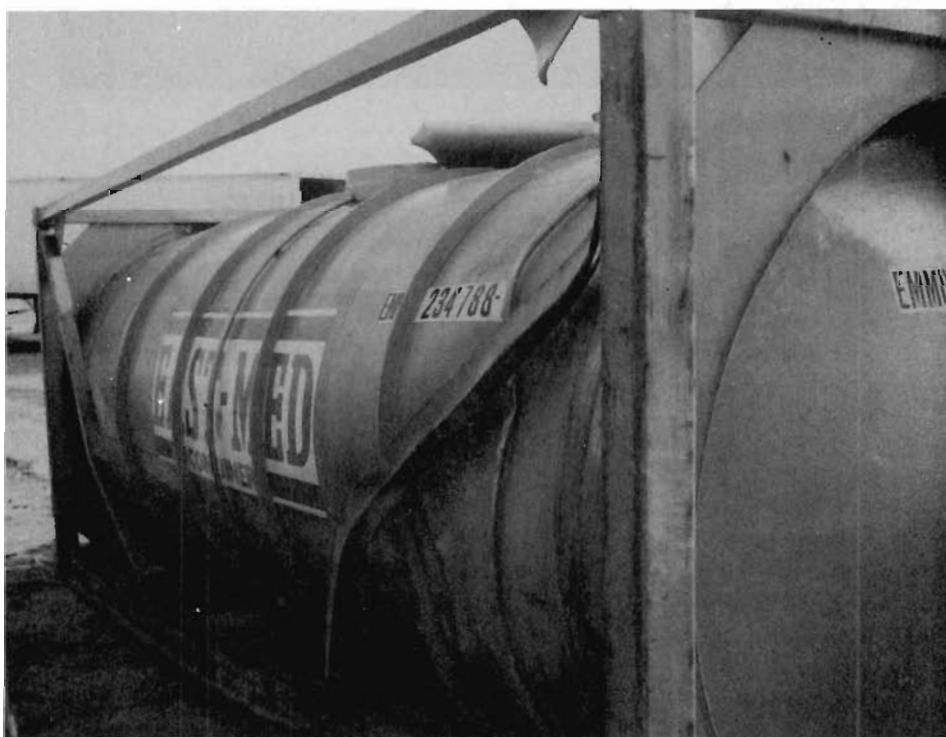
FIGURE 5-28
DAMAGE TO IM 102, EMMU 234788-7, LOCATION 2B (COFC),
ACCORDION TEST

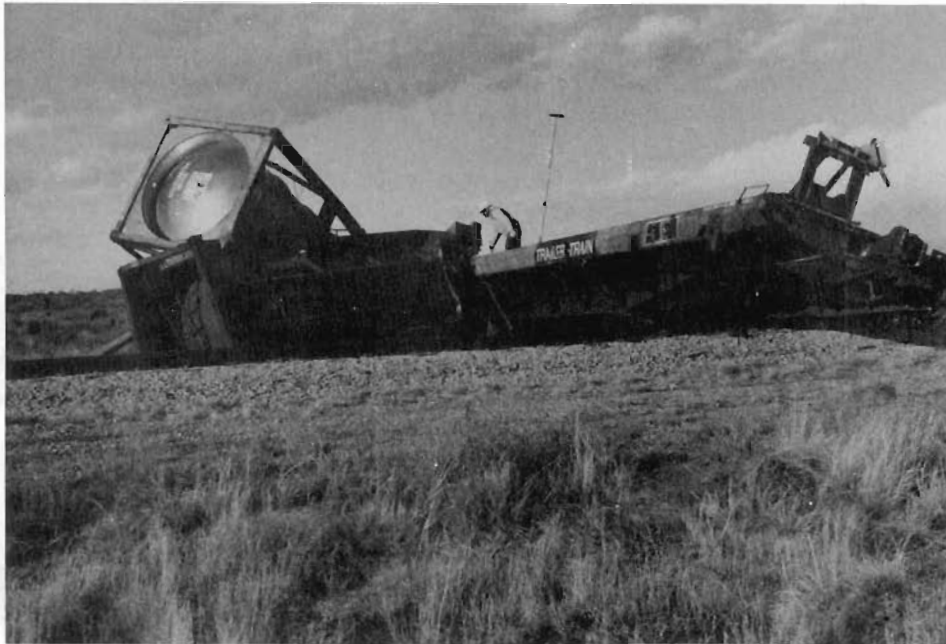
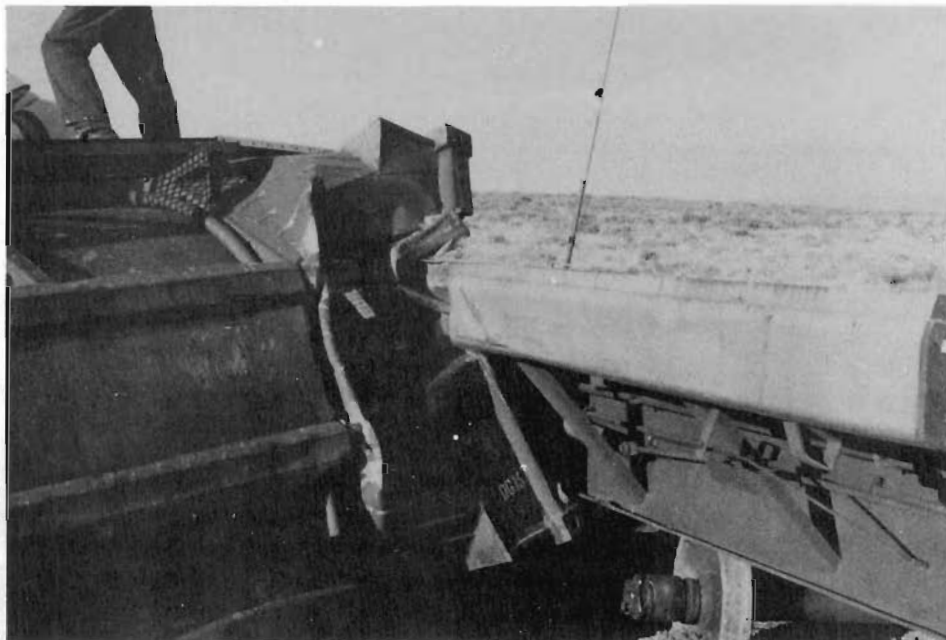
FIGURE 5-29
DAMAGE TO IM 101, OLTU 000003, POSITION 3A (COFC),
ACCORDION TEST

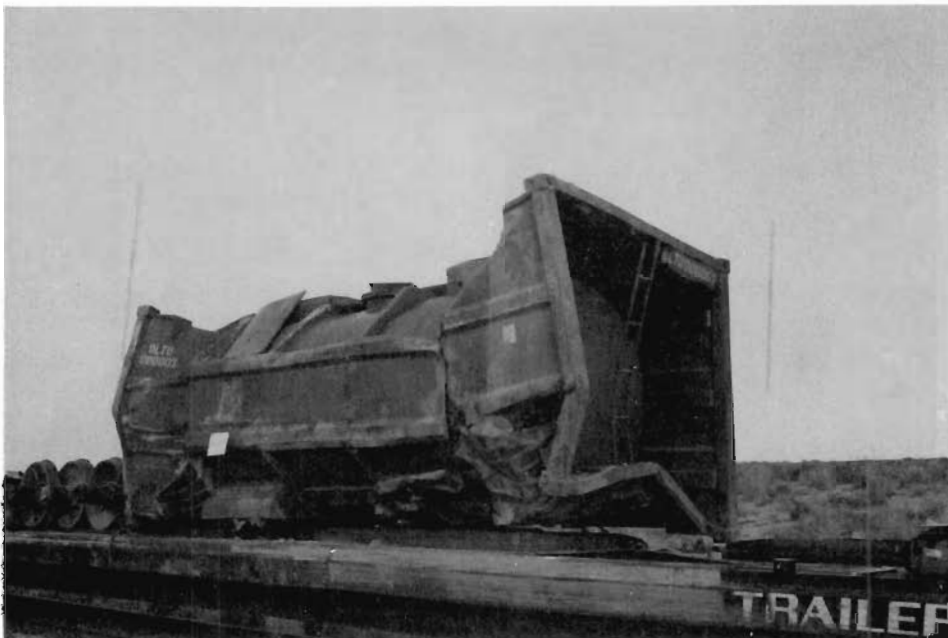
FIGURE 5-30
DAMAGE TO IM 101, OLTU 000003, ACCORDION TEST
