**Evaluation of Immediate Actions Taken to Deal with Cracking Problems  
Observed in Wheels of Rail Commuter Cars**

**(U.S.) John A. Volpe National Transportation Systems Center  
Cambridge, MA**

DOT/FRA/ORD-93/15  
DOT-VNTSC-FRA-93-3

Final Report  
July 1993

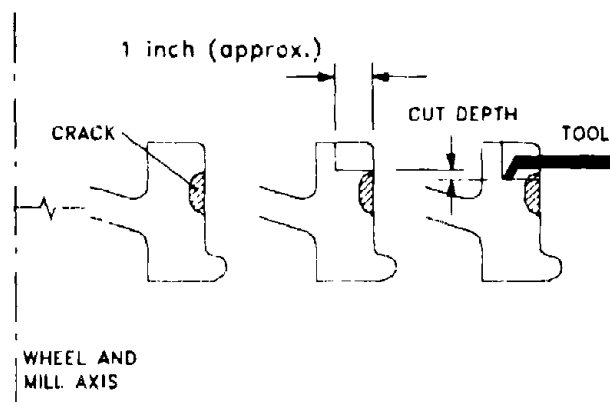
Figure 3. "Peeling" a Wheel to Expose Center Tread Thermal Cracks.

Two Class L straight plate wheels with thermal cracks provided by Railroad "C" were sacrificed to obtain quantitative data [3]. One wheel (from car # 1501) was selected from a group previously removed from service and had no history available. The second (from car #1419) was followed after re-truing and was removed three weeks after being returned to service. Each tread surface was first surveyed with the aid of fluorescent magnetic particle inspection to locate the cracks and measure their visible lengths. Each wheel was then mounted on a vertical boring mill, and the outer inch of rim was cut away from the front face toward the flange to expose the crack shape and maximum depth.<sup>3</sup> A schematic of the rim region of a wheel section profile illustrates the process (Figure 3). When the cut face approached the crack ends, as indicated by their visible lengths on the tread, the milling was restricted to 0.01 to 0.05 inch per cut, until the first visible indications were observed on the cut face. Milling was then continued, at 0.1 inch per cut, with fluorescent magnetic particle inspection between each cut, until the cut face was below the region of maximum crack depth.

A representative sample of the cracks was marked, the visible length of each was measured before milling, and the depth of each was measured between each cut in order to determine its maximum depth. The wheel from car #1419 was found to have 69 center tread thermal cracks with visible lengths averaging 0.92 inch, in a band centered at 1.53 inches from the front rim face. The wheel from car #1501 had 160 center tread thermal cracks, of which only 76 were surveyed. In this case, the visible lengths averaged 0.65 inch, and the cracks were

located in a band centered at 2.96 inches from the front rim face. All cracks were visible on the tread surface, and the visible length of each crack was also its maximum length. The cracks were well distributed around the circumferences of both wheels, although the car #1419 wheel had one 12-inch sector with no cracks. Heat checks, such as described in the 1984 edition of the AAR interchange rules (see Section 1.2) were generally visible between the thermal cracks. The combined populations included cracks with visible lengths ranging from 0.5 inch<sup>4</sup> to 1.15 inches. From the combined populations, 22 cracks marked and measured in the "peeling" process exhibited a rough proportionality between visible length and maximum depth, with no crack depth exceeding 1/3 inch (Figure 4).

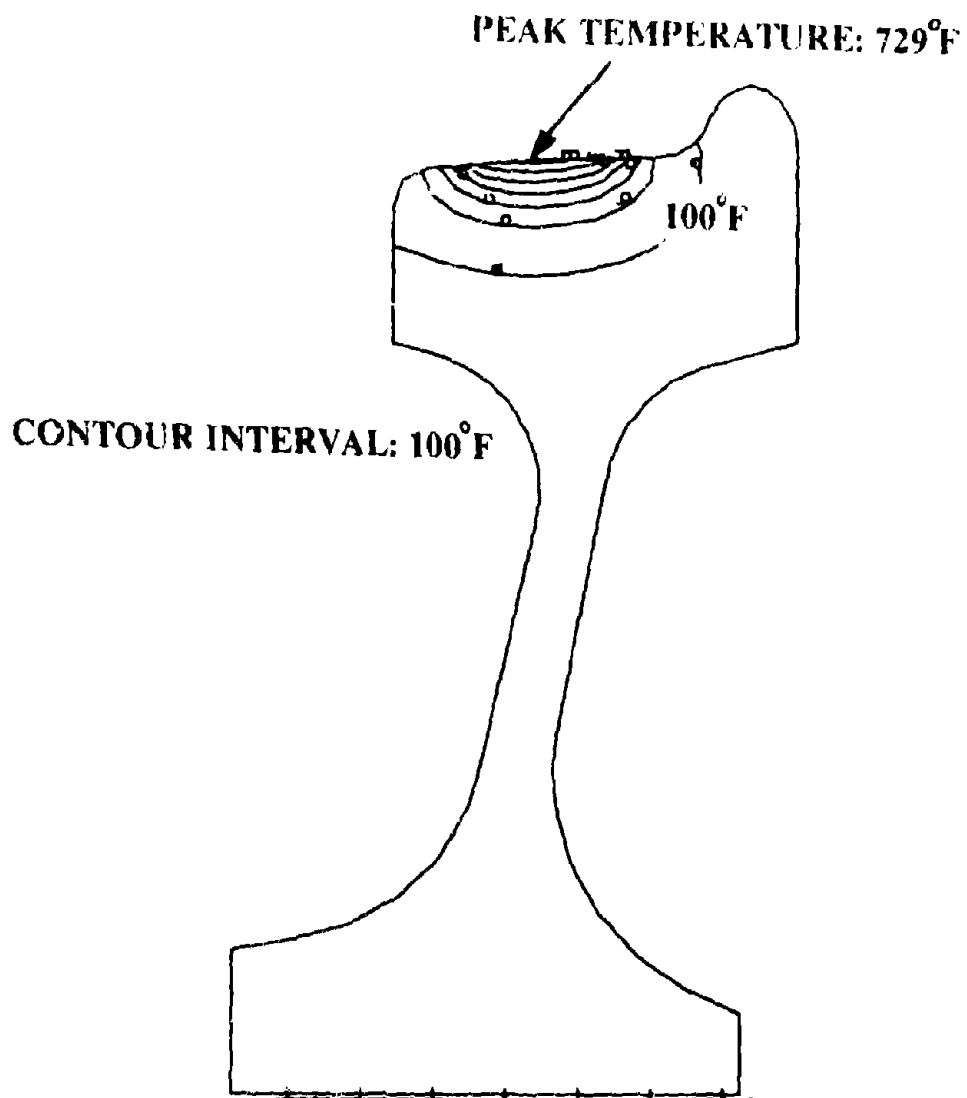
Figure 15. Temperatures Attained with Shoe Correctly Aligned.

Figures 15 and 16 illustrate the computed temperature distributions at the respective times when the peak tread temperatures are attained. Note that the peak value for the overhanging case is almost twice the nominal value. Note also that the overhanging case leads to temperatures which, according to the metallurgical investigation results, are high enough to spheroidize the microstructure.
