**ACCIDENT FINDINGS REPORT**  
For  
**Derailment of CSX Transportation, Inc.'s Unit Crude Oil Train K08014**  
**Transporting Crude Oil for Plains All American**  
**Mount Carbon, West Virginia**

**October 9, 2015**

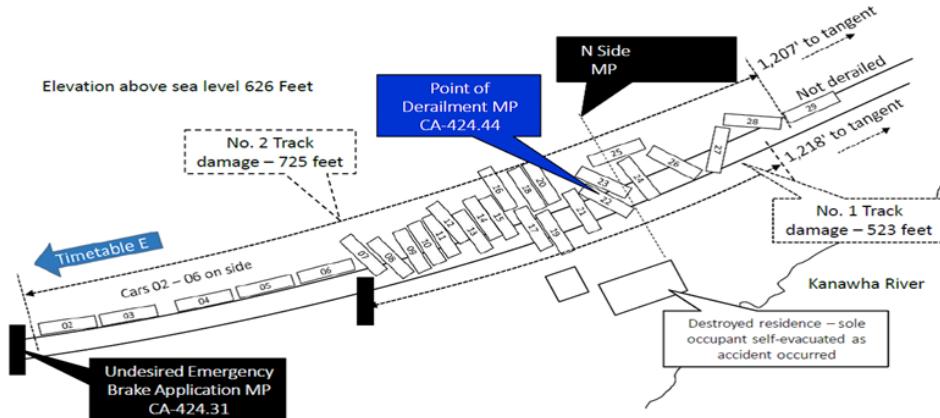
A total of twenty-seven tank cars derailed in the incident. Two tank cars were punctured, released crude oil, ignited, and caught fire. The fire spread quickly, resulting in a pool fire that eventually led to thermal tears in thirteen additional derailed tank cars. Ultimately, twenty-four of the twenty-seven derailed tank cars sustained significant damage in the incident and resulting fire. The fire injured one person (smoke inhalation), destroyed one home and one garage.

CSXT eventually determined the train released 378,000 gallons of crude oil during the incident—much of it lost to atmospheric burn, pool fires and ground absorption.
