FEDERAL RAILROAD ADMINISTRATION
1200 New Jersey Avenue SE, Washington, DC 20590

TECHNICAL ACCIDENT REPORT
Derailed of CSX Transportation, Inc.'s Unit Crude Oil Train K08014
Transporting Crude Oil for Plains All American
Mount Carbon, West Virginia

November 4, 2015

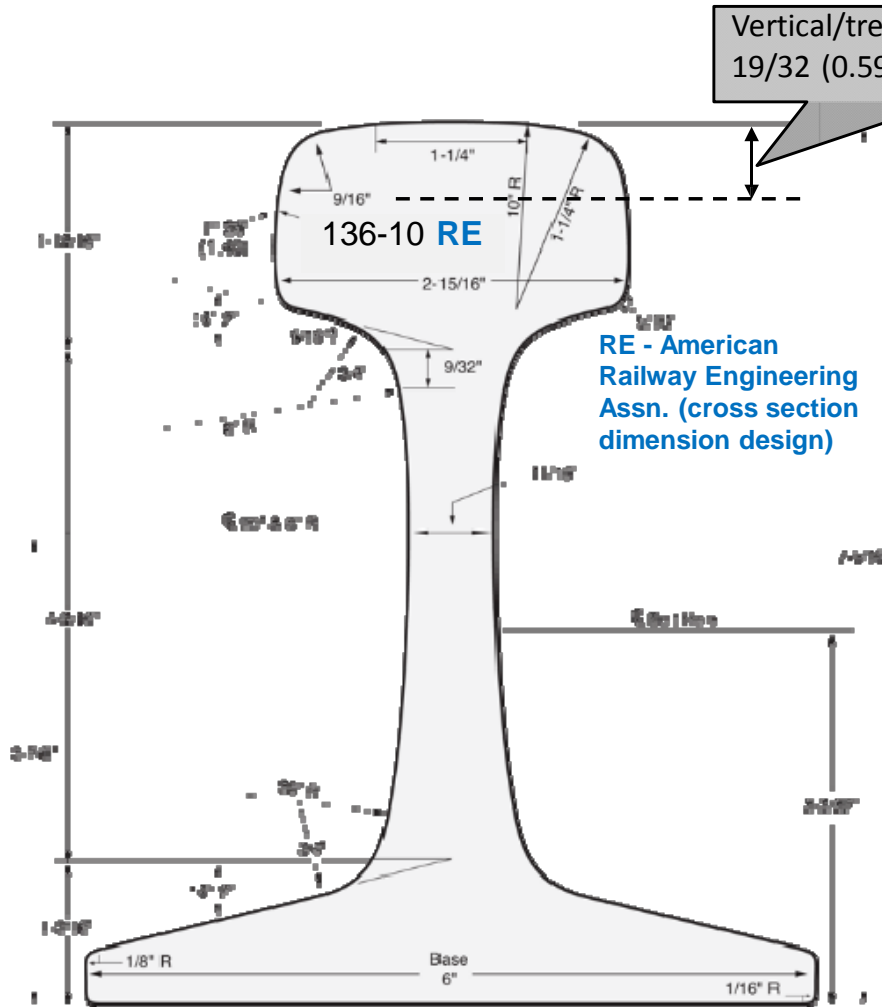
Appendix D: Rail Section Design

Vertical/tread wear on low/south rail 19/32 (0.59375)" is 30.6% head loss

CSX maintenance criteria for 136 RE top (tread) wear is 5/8" (0.625) - this rail 1/32 (0.01325)" shy of limit

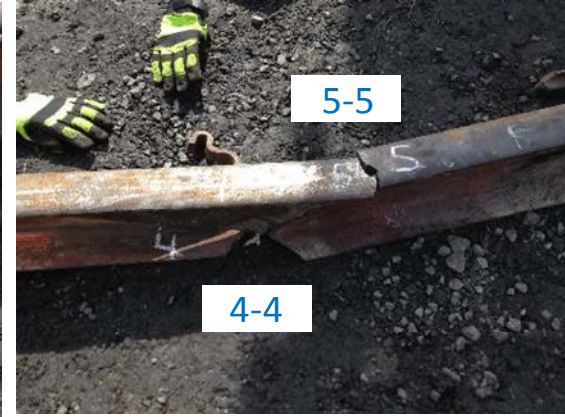
Specimen SC (off web upside down) probable cause rail breakout 5'2"

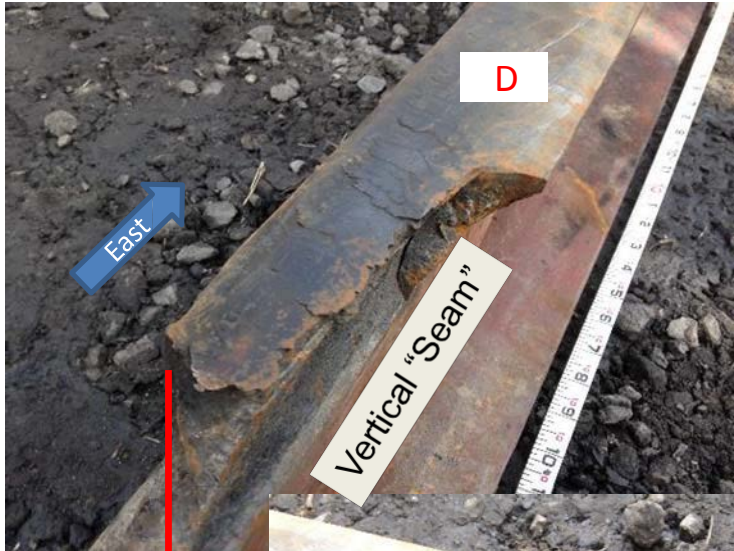
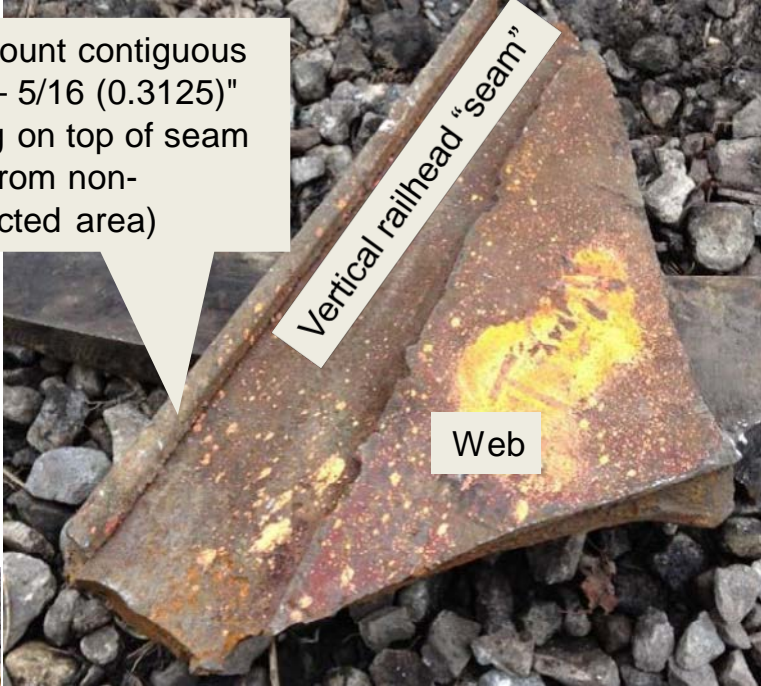
Forensic Reconstruction Failure Detail

Small amount contiguous railhead – 5/16 (0.3125)" remaining on top of seam (sample from non-reconstructed area)

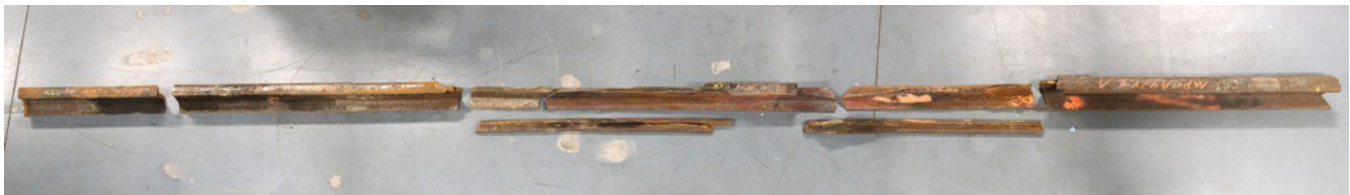
Figure 1: As received rail sections

Engineering Systems Inc. (ESI) received a total of twenty-feet of 136-pound rail sections from CSX (Figure 1). The rail sections collected at Mt. Carbon, West Virginia were reportedly involved in a derailment, which occurred February 16th, 2015 at 1:15 pm at milepost CA424.6. Markings on the rail indicate it was manufactured in March of 1994 by Beth Steelton (Bethlehem Steel). No indication or markings were found specifying grade or style of the rail. CSX requested ESI to determine if the rail was causative or failed during the derailment. The scope of ESI's investigation included visual examination, scanning electron microscopy, metallographic evaluation, chemical analysis, and mechanical testing.

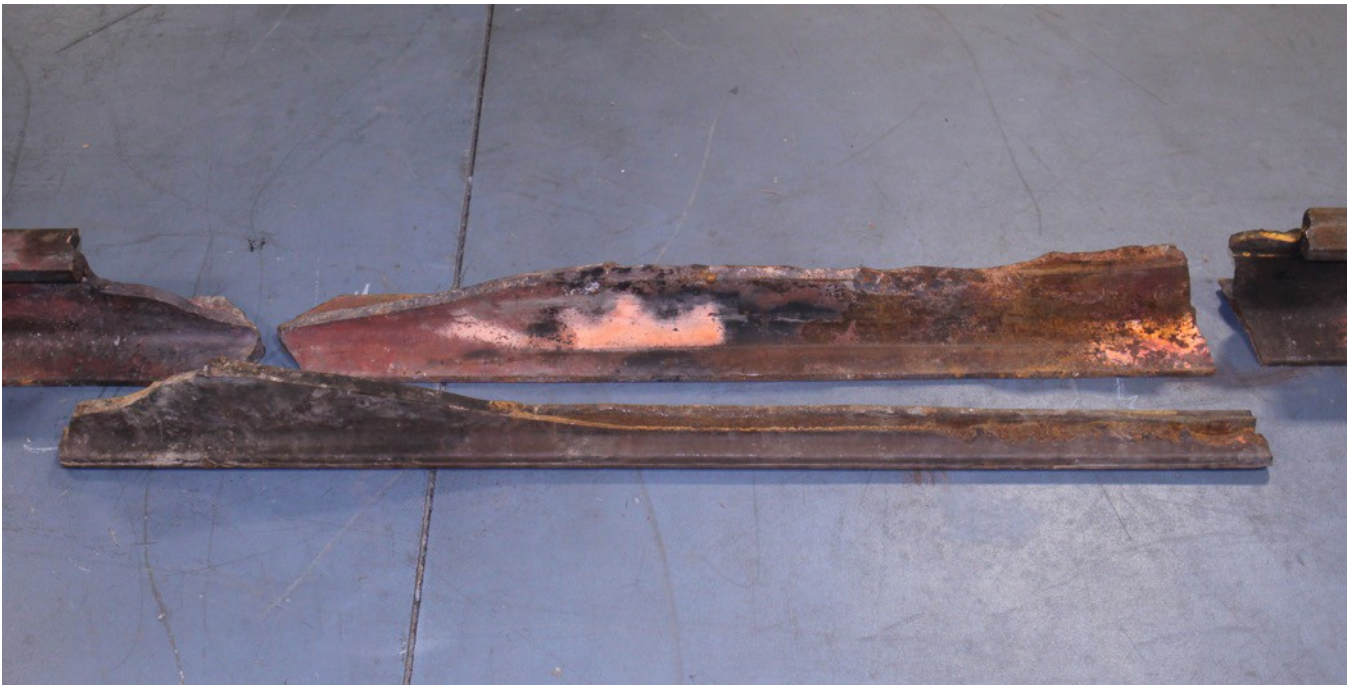
Figure 2: Photograph of the broken rail sections laid out end-to-end

Visual examination of the rail sections revealed evidence of progressive longitudinal crack growth through the head of the rail resulting in separation of the head and web (Figure 1 and Figure 2), otherwise known as Vertical Split Head (VSH). VSH originates at an internal defect and is normally attributed to manufacturing defects such as piping, segregation, or inclusions. VSH is not normally visible on the surface of the rail until it has grown several feet in length. At that point the railhead begins to widen and sag. Evidence of widening along with the vertical cracking in the railhead characterize VSH, and can be seen in Figure 3 and Figure 4. The VSH condition was evident in the entire length of submitted rail. VSH can cause wheels to climb on top of or drop inside the rail, resulting in a derailment.

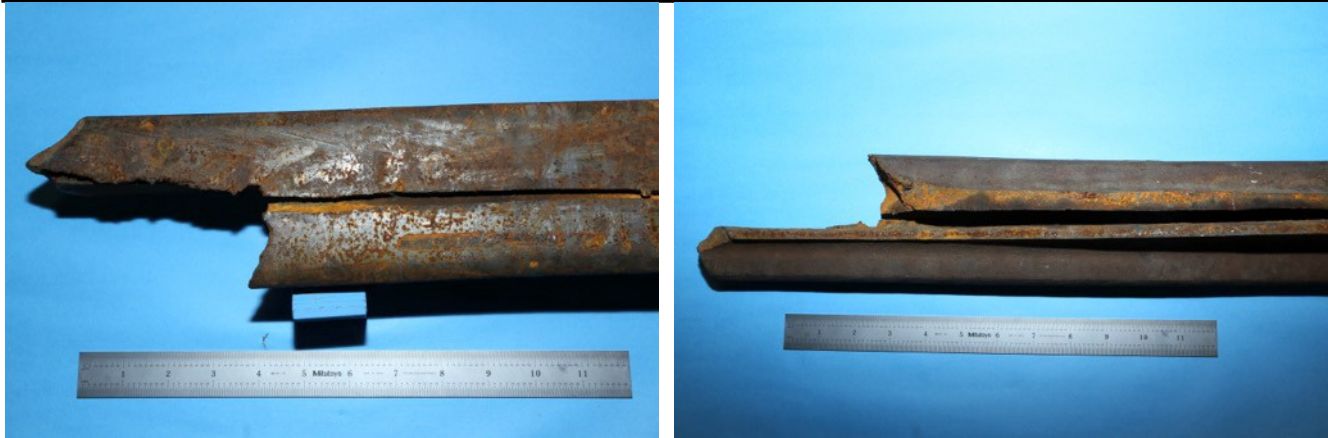
Figure 3: Photographs of a section of rail split vertically through the head.

In order to ascertain the origin of the VSH, one length of railhead that had broken at the web was sectioned transversely to separate the vertical fractures. Other regions of already exposed vertical fracture were also examined; however, no obvious vertical fracture origin was observed. Scanning electron microscopy of the exposed fracture surface revealed a transgranular cleavage fracture morphology, typical of rail steel (Figure 5).

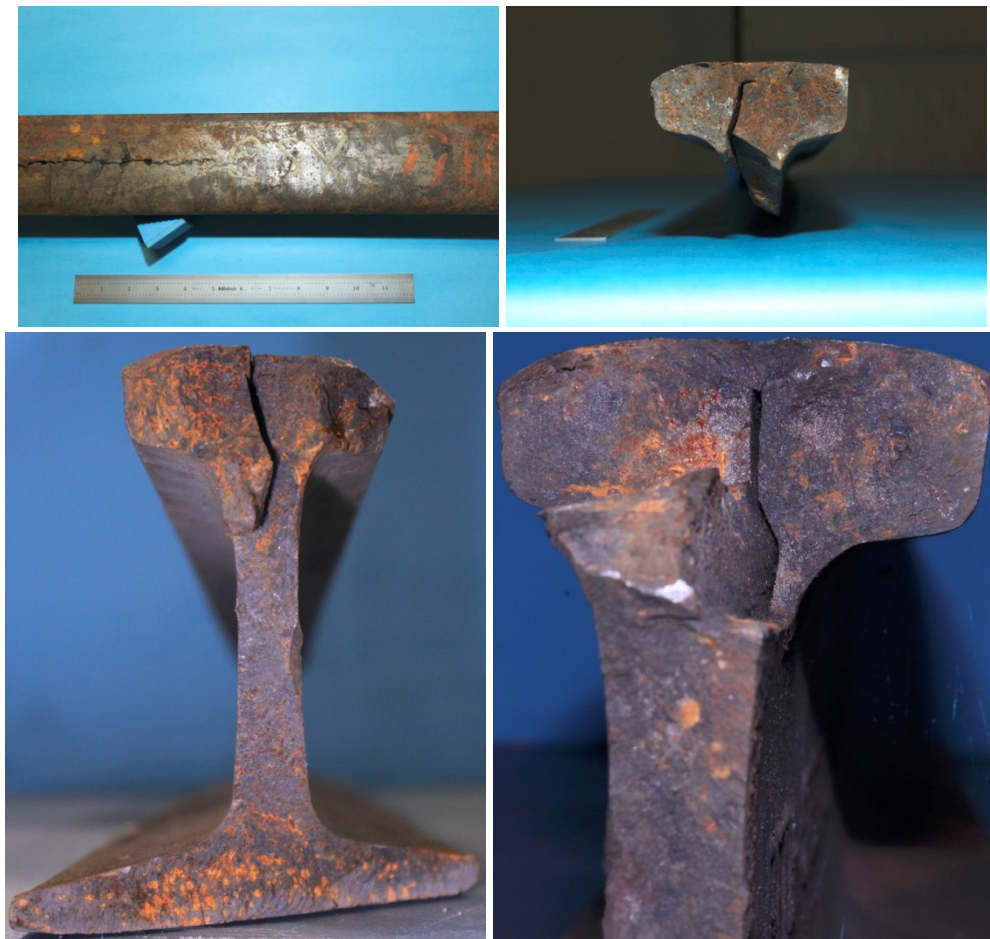
Figure 4: Head widening is visible near the right (Top Left) as a cross-sectional view of the VHS (Top Right and Bottom Left and Right)

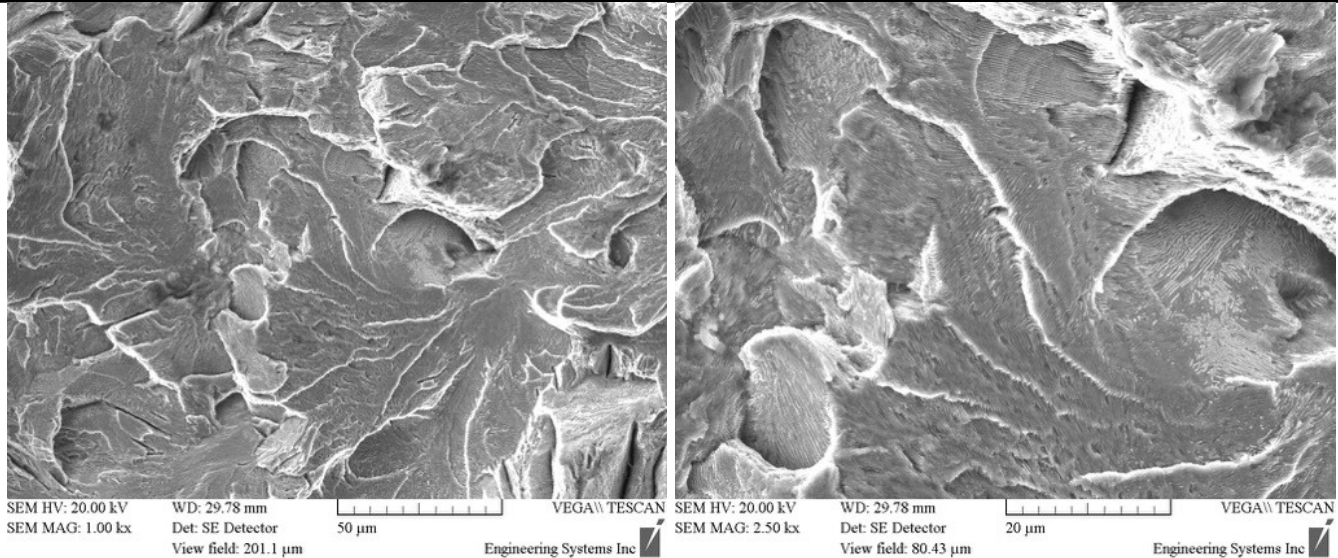
Figure 5: Representative fracture morphology on the exposed vertical fractures.

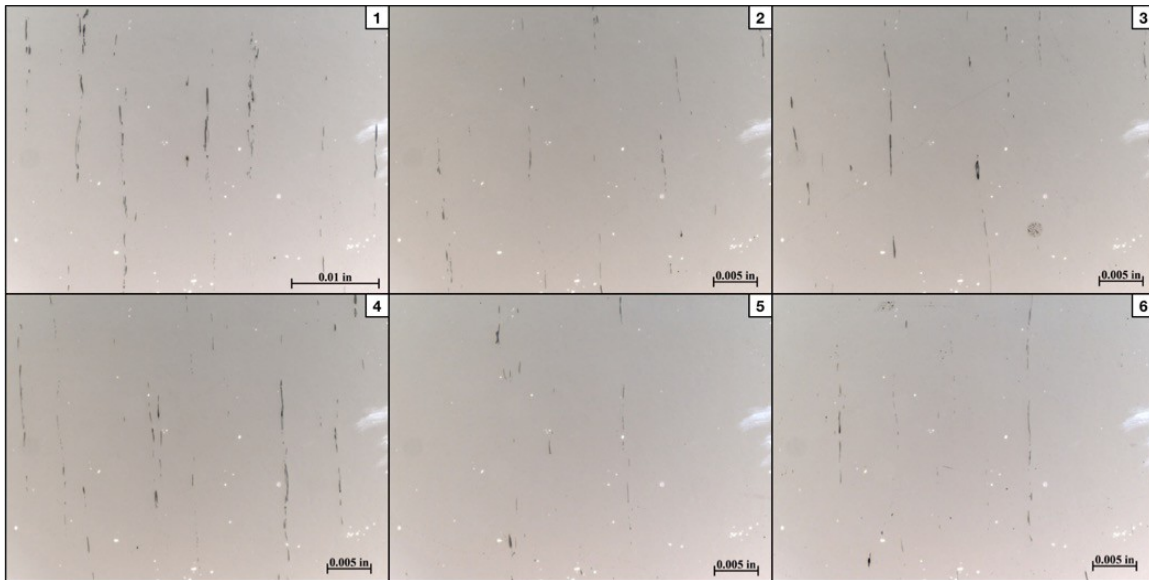
Figure 7: Worst fields 1-6

As per AREMA specifications¹ a sample was sectioned from the head of a section of rail (Figure 6). After sectioning the sample, it was then prepared and evaluated following the ASTM Standard Practice E45 for determining the inclusion content of steel using the worst fields method (Method A). Preparation included mounting and then polishing the sample to a fine finish. Evaluation of the sample revealed thin type A-Sulfide inclusions that can be seen as light gray when viewed under brightfield illumination. Surveying the polished sample under 100 times magnification revealed six worst field locations (Figure 7). Each of these fields were then compared to Plate I-A and rated on a scale from 0 to 5 (Table 1). According to the AREMA specification for microcleanliness, each sample shall have a maximum average rating of 2 and a maximum individual rating of 3. The average rating of all six samples is 2.5 and therefore does not meet the standard.

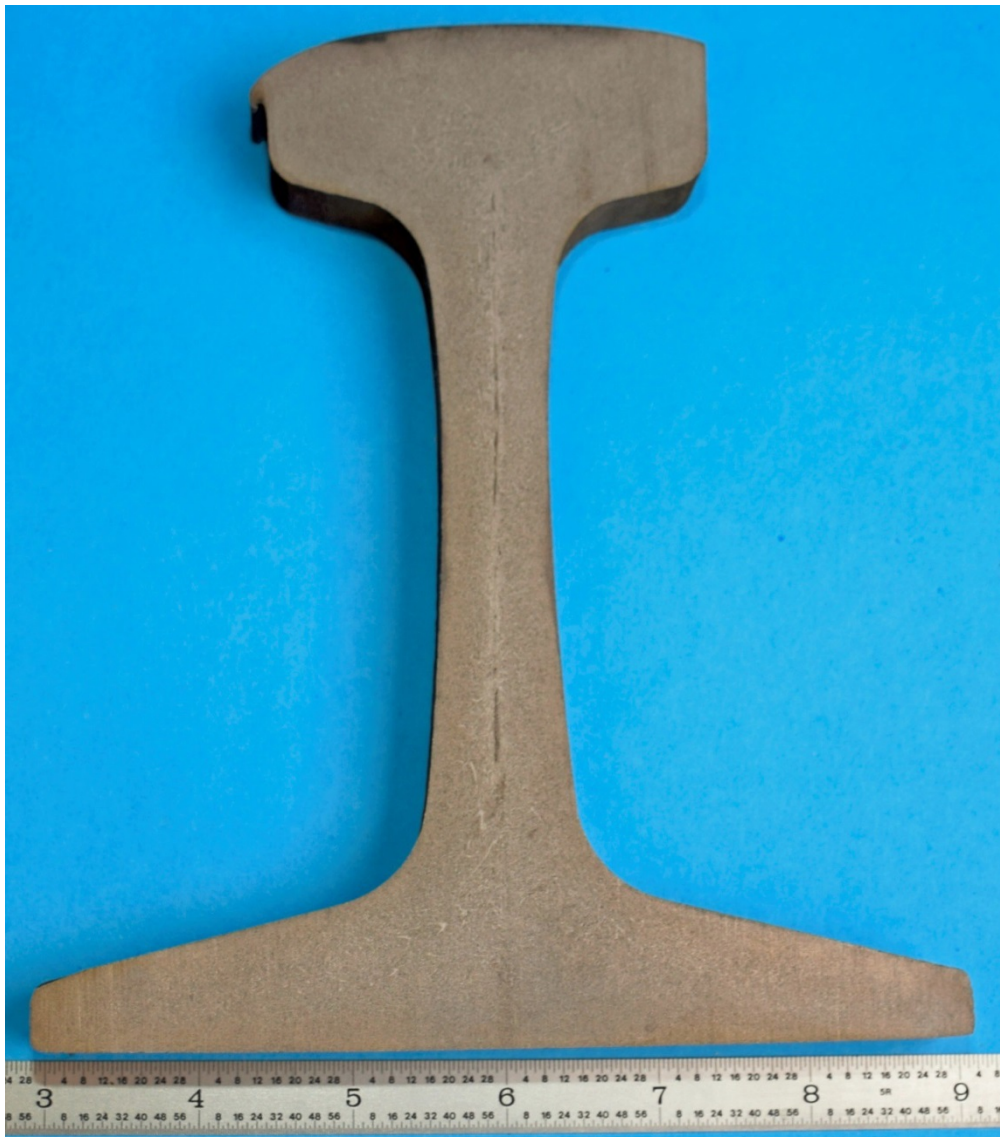
As per AREMA chapter 4 section 2.1.9.2, a full transverse section of the rail was removed and prepared for macroetch evaluation (Figure 8). Some signs of centerline segregation extending into the head are present. According to AREMA chapter 4 section 2.1.9.3.1, must extend at least one inch into the head or base to fail; therefore, this sample is within the specification.

Figure 8: Macroetch showing centerline segregation
