LOCOMOTIVE TO AUTOMOBILE  
BASELINE CRASH TESTS

1. Report No. FRA-OR&D-76-03		2. Government Accession No.		3. Recipient's Catalog No.	
4. Title and Subtitle LOCOMOTIVE TO AUTOMOBILE BASELINE CRASH TESTS				5. Report Date August 1975

6. Performing Orgn Code	
7. Author(s) R. L. Anderson*				8. Performing Orgn Rpt No. DOT-TSC-FRA-75-18	
9. Performing Organization Name and Address Dynamic Science - Division of Ultrasystems 1850 West Pinnacle Peak Road Phoenix AZ 85027				10. Work Unit No. RR502/R6330

11. Contract or Grant No. DOT-TSC-700	
12. Sponsoring Agency Name and Address U.S. Department of Transportation Federal Railroad Administration Office of Research and Development Washington DC 20590				13. Type of Report and Period Covered Nov 1973 - June 1974 Final Report

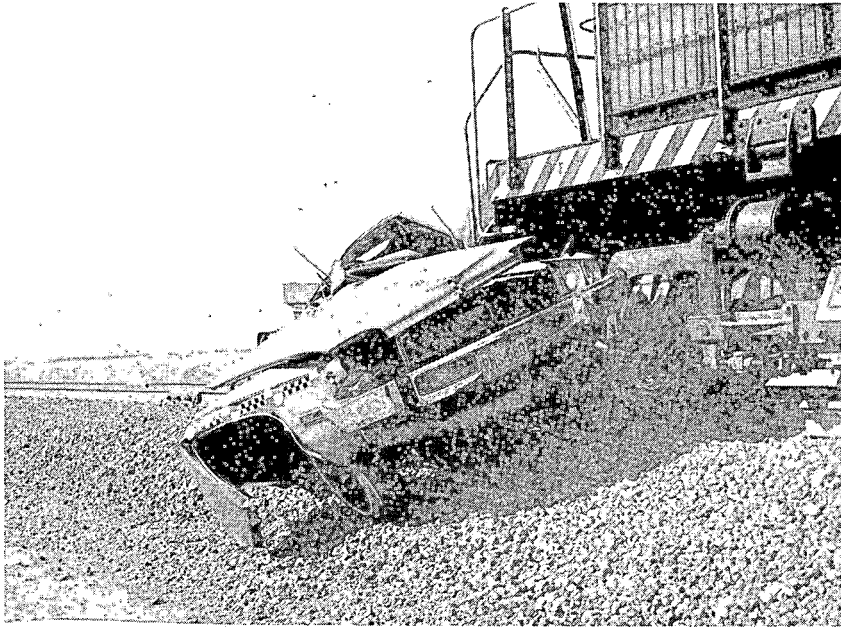
Figure 14. Post-test View of Automobile Front Section (Test TGB-1).

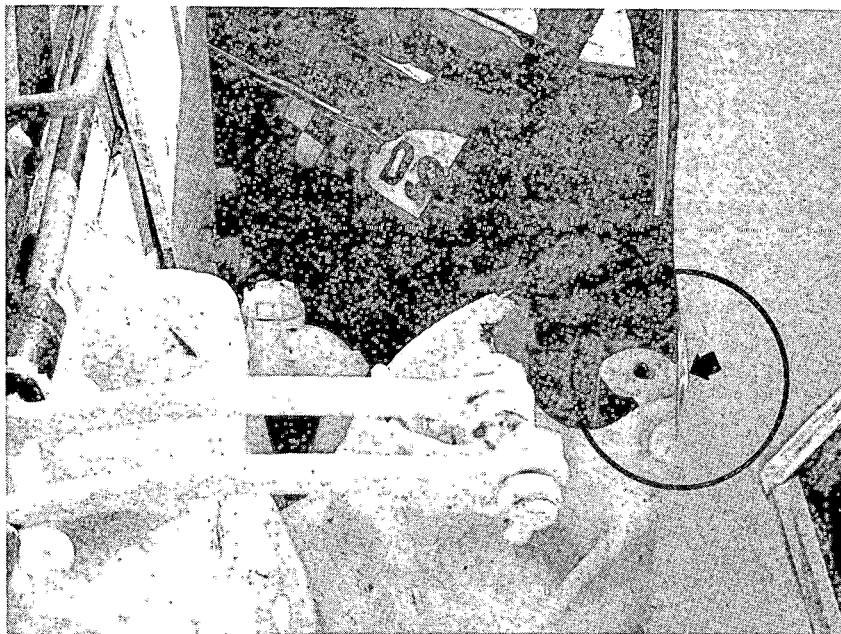
Figures 11 and 12 are overall and close-up views of the pre-test impact orientation for Test TGB-1. Figures 13 and 14 are post-test views of the locomotive and automobile. The coupler penetration is illustrated in Figures 15 and 16. During the impact, the fuel tank was damaged, causing a steady flow of the dyed water from near the top of the tank. The deformed tank is shown in Figure 17. During impact, the rear axle contacted the front plate on the train and was driven against the fender on the opposite side of the car. Figure 18 shows the deformation on the passenger side of the automobile due to the rear axle. The front section of the automobile from the firewall forward was broken loose, as mentioned earlier, but remained connected by the left front fender. Figure 19 shows how the engine compartment was opened up and how the transmission penetrated into the ballast at the side of the track during the stop. The front of the locomotive suffered significant deformation. The front plate was bent back as much as 11 inches at the lower right corner. The locomotive steps, which were part of the support of the front plate, sheared with permanent set are seen in Figure 20. Figure 21 shows a close-up of the broken pipe on the front of the locomotive. The post-test condition of the front of the locomotive is illustrated in Figure 22. The imprint of the left rear wheel can be seen on the lower left-hand side of the plate.

Figure 15. Overhead Post-test View of Automobile Showing Coupler Penetration (Test TGB-1).

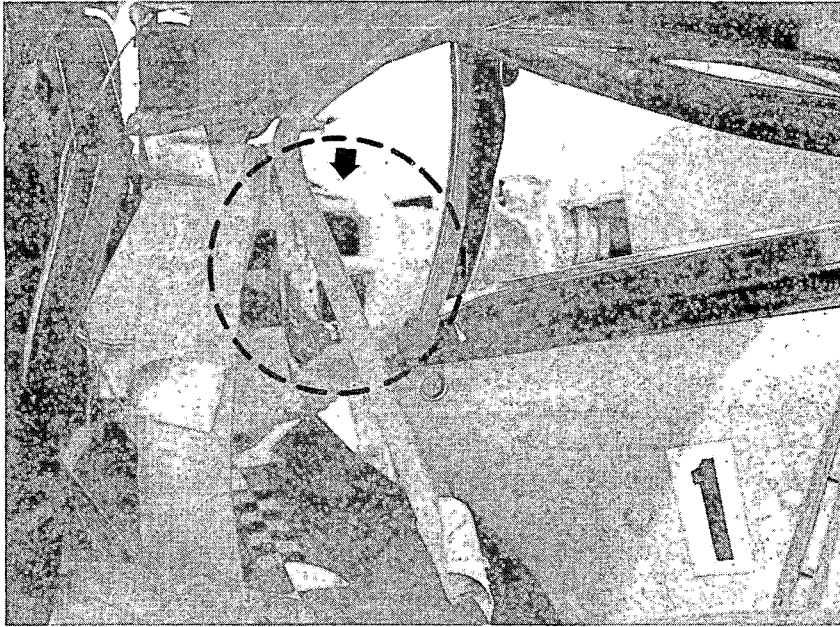
Upon impact, the coupler penetrated the automobile just behind the front door. Penetration was almost complete before any significant movement of the rest of the automobile occurred. After 84 msec the coupler was at maximum penetration and the occupant compartment was moving at the approximate velocity of the locomotive. The post-test speed of the locomotive and automobile combination, assuming conservation of linear momentum, is 51.1 mph for a locomotive speed reduction of about 0.8 mph. The front section of the automobile from the firewall forward broke loose and rotated into the side of the locomotive, held only by the sheet metal of the left front fender.

Figure 16. Post-test View of Coupler Penetration (Test TGB-1).

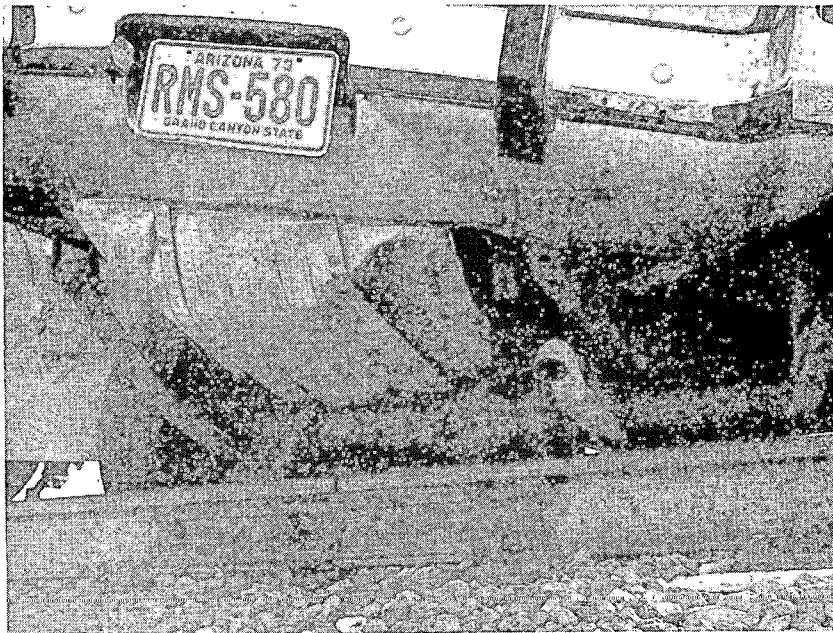
Fuel tank was ruptured

Figure 17. Post-test View of Fuel Tank (Test TGB-1).

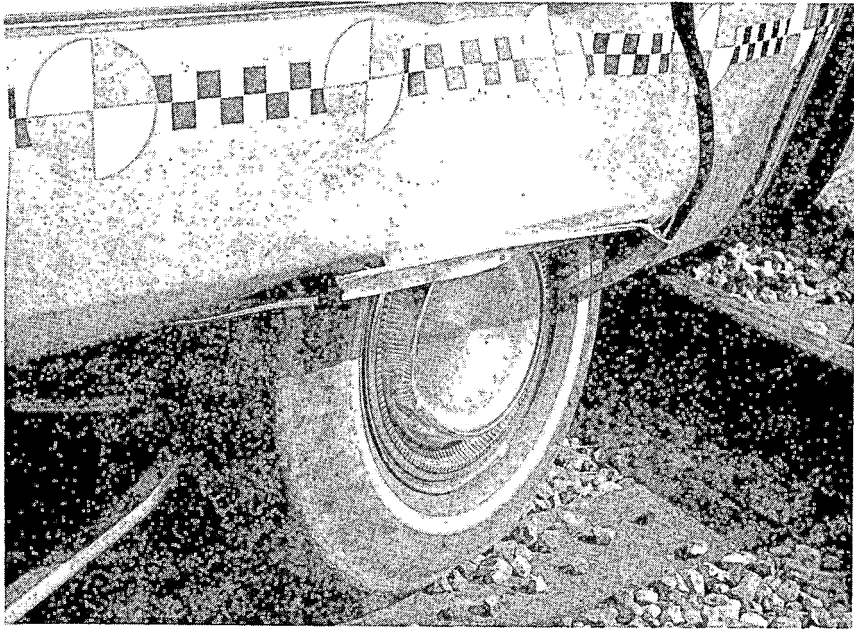
Imprint of rear wheel was observed on locomotive front plate

Figure 18. Deformation on Right Side of Automobile Due to Rear Axle Striking Locomotive Front Plate (Test TGB-1).

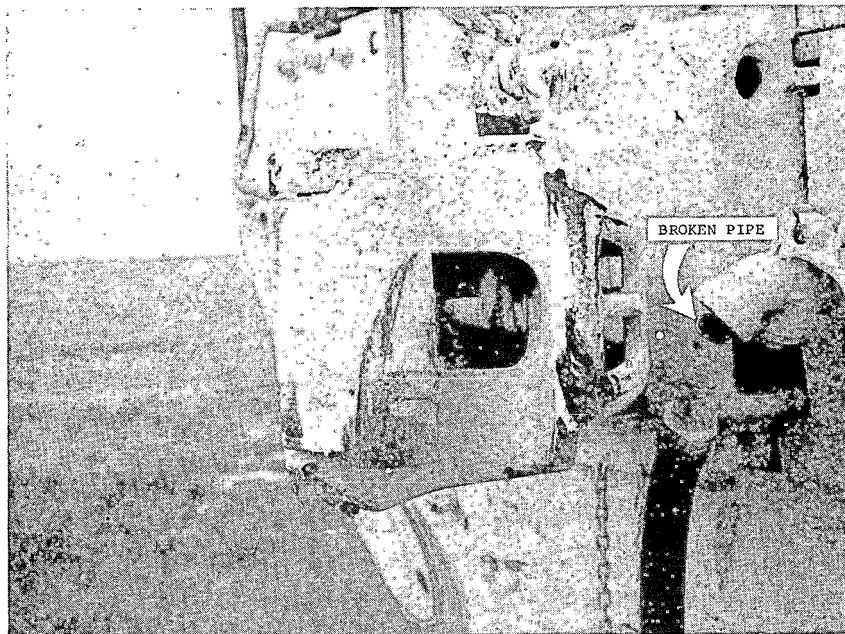
The automobile remained in contact with the front of the locomotive from impact until the locomotive came to rest. During impact a brake line on the locomotive broke causing the locomotive to go into emergency brake. The high brake pressure, resulting from having the locomotive in emergency, could have caused wheel slide if it had not been successfully bled off remotely via the remote controller.

Angle cock was broken on locomotive

Figure 21. Broken Pipe on Locomotive After Locomotive-to-Automobile Impact (Test TGB-1).

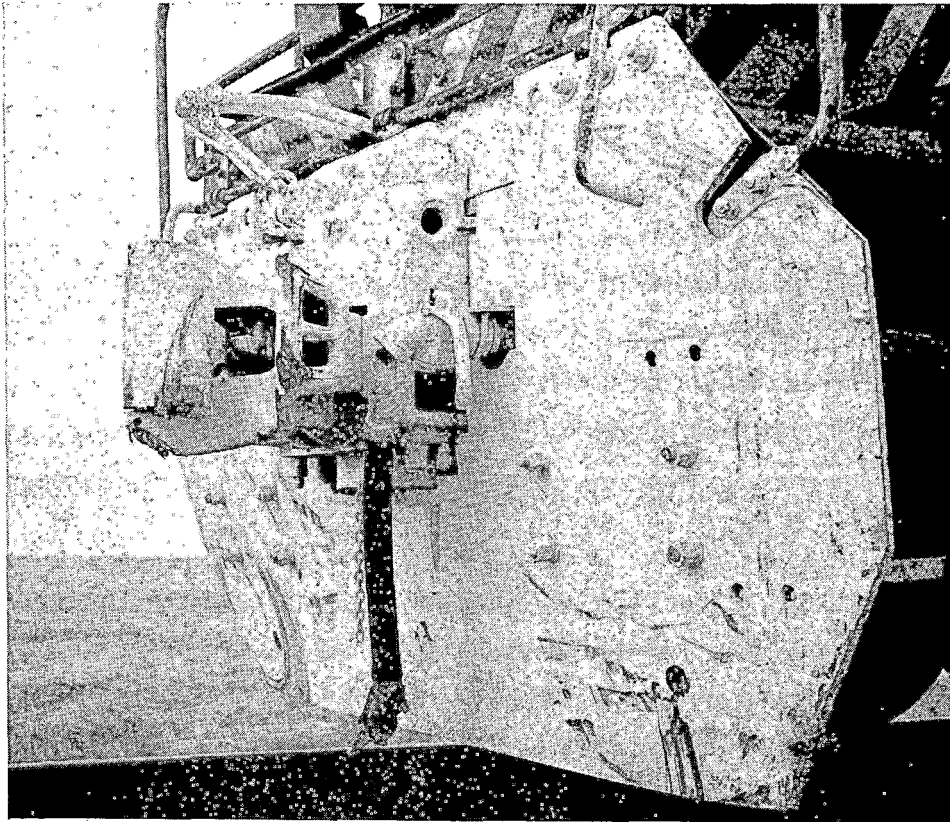
Figure 22. Post-test Condition of Locomotive Front  
(Test TGB-1).

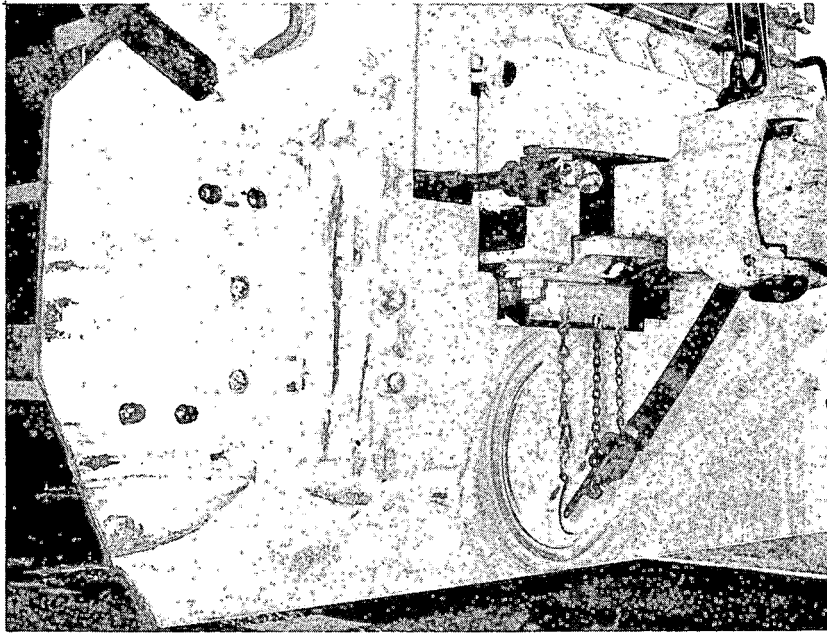
The imprint of the automobile on the locomotive front plate is shown in Figure 30. The automobile caused minor damage to the side of the locomotive when the left rear fender rotated into its side, as shown in Figures 31 and 32.

Figure 30. Post-test View of Locomotive Front Plate Showing Automobile Imprint (Test TGB-2).

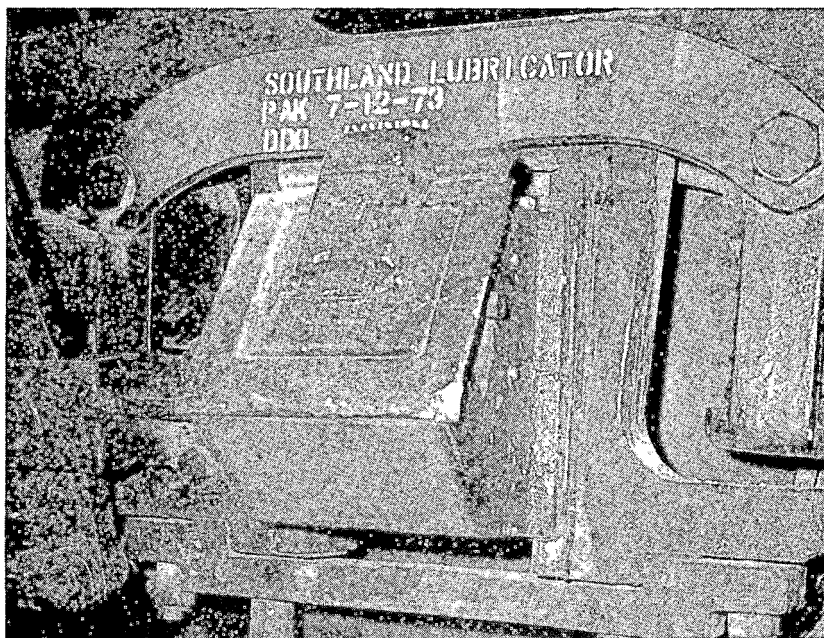
Since the impact force was ahead of the center of mass of the automobile, the automobile rotated into the locomotive. The rear portion of the automobile actually briefly moved in an up-track direction. The left rear fender impacted the side of the locomotive leaving paint on the brake cylinder and causing minor damage to the bearing box cover.

Figure 31. Post-test View of Axle Box Showing Minor Damage (Test TGB-2).

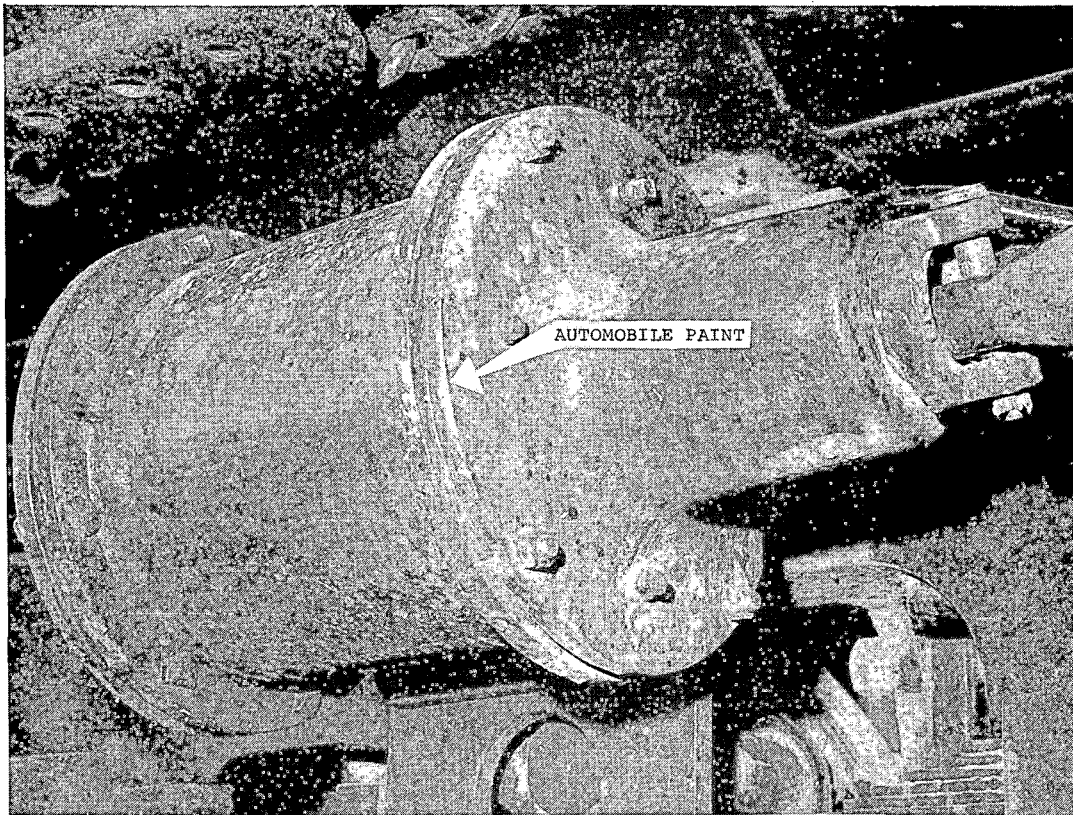
Figure 32. Post-test View of Locomotive Brake Cylinder With Automobile Paint Visible Around Front Collar.

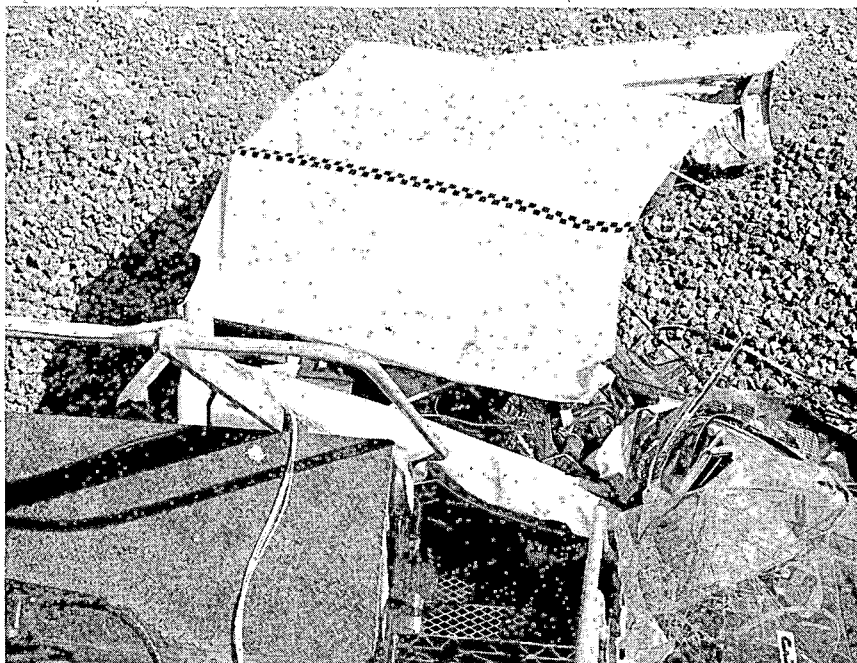
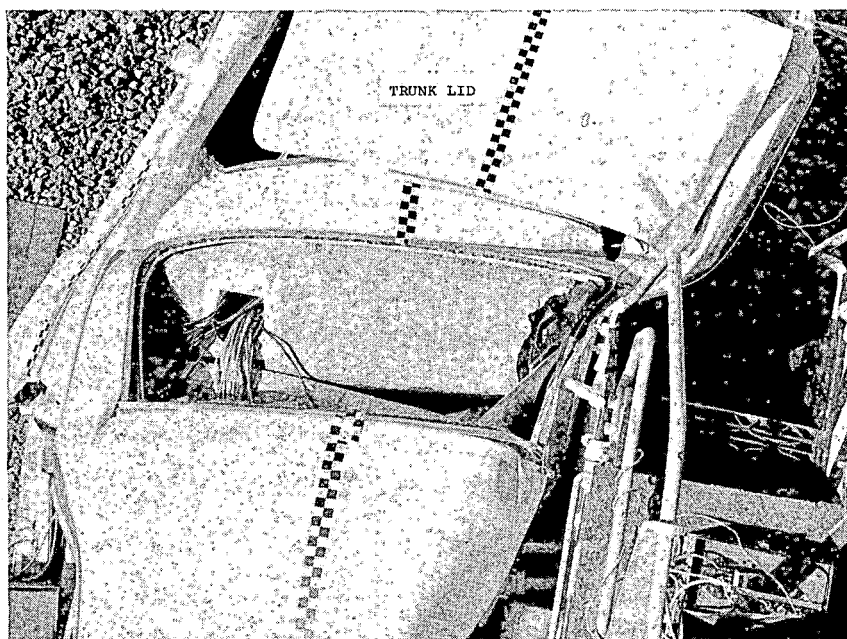
37, and 38 are post-test overhead views of the center, front, and rear sections of the automobile showing how the automobile is wrapped around the locomotive front plate and coupler.

Figure 37. Post-test View of Front Section of Automobile (Test TGB-3).

Figure 38. Post-test View of Rear Section of Automobile (Test TGB-3).

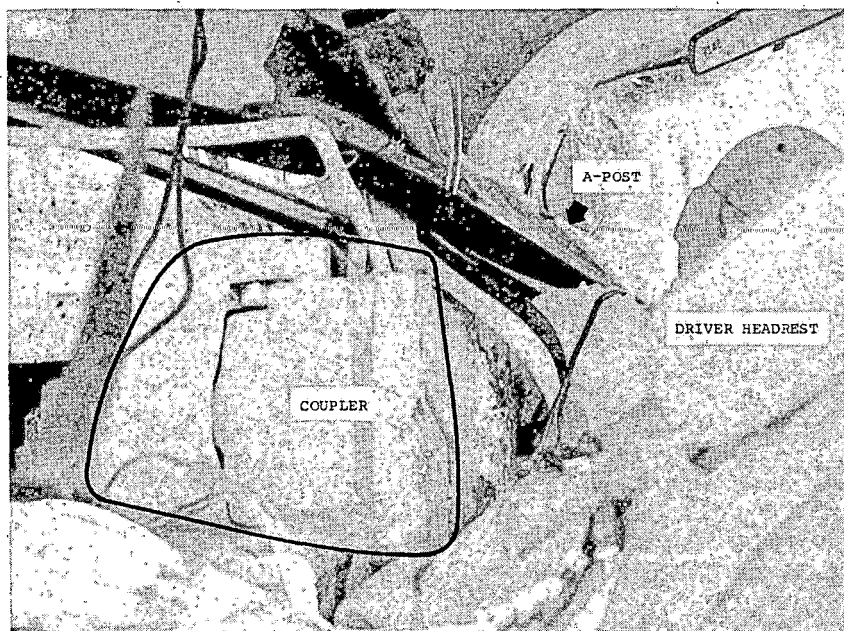
Figure 39 is a view of the coupler through the right rear door, showing the intrusion into the occupant space of the automobile. Figure 40 is a post-test view of the dummy in the driver area. The dummy retained its structural integrity with no apparent permanent damage, even though the loads experienced during the impact would have been fatal for a human, as will be discussed later. After the front section of the automobile was pulled back, the locomotive was simply backed away from the automobile leaving an imprint as shown in Figure 41.

Figure 39. Intrusion of Coupler Into Occupant Compartment (Test TGB-3).

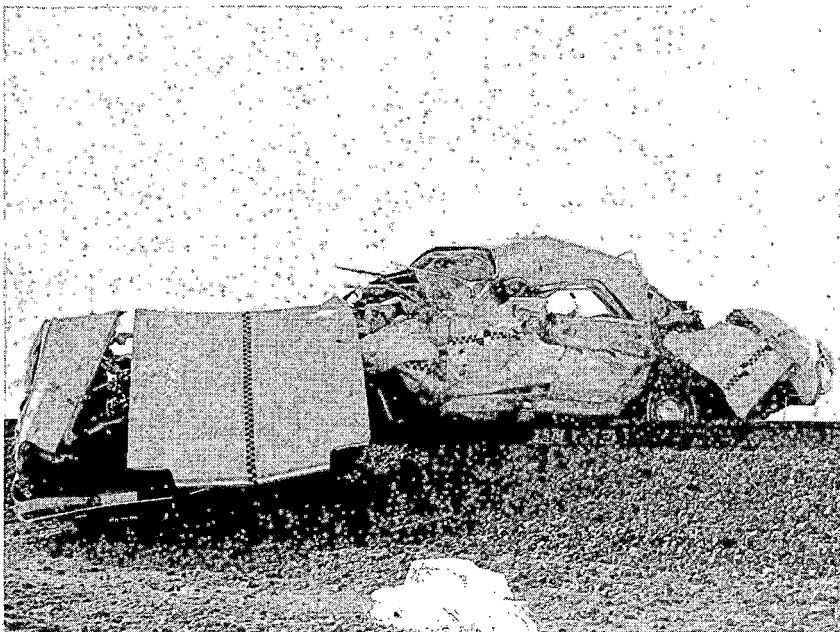
Figure 41. Post-test View of Automobile Showing Imprint of Locomotive Front (Test TGB-3).

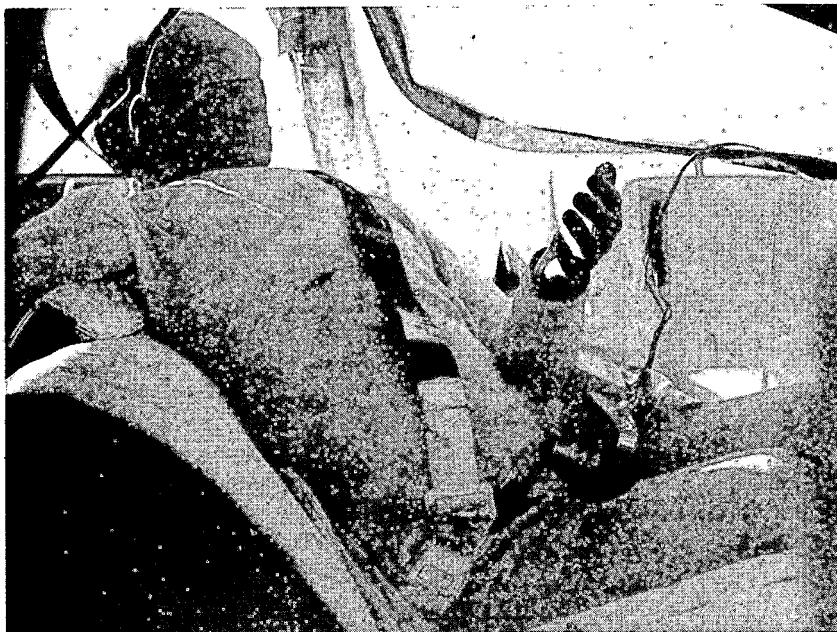
Figure 57 is a post-test view of the dummy after Test TGB-4. The dummy head touched the window header above the rear door window.

Figure 57. Post-test View of the Dummy (Test TGB-4).

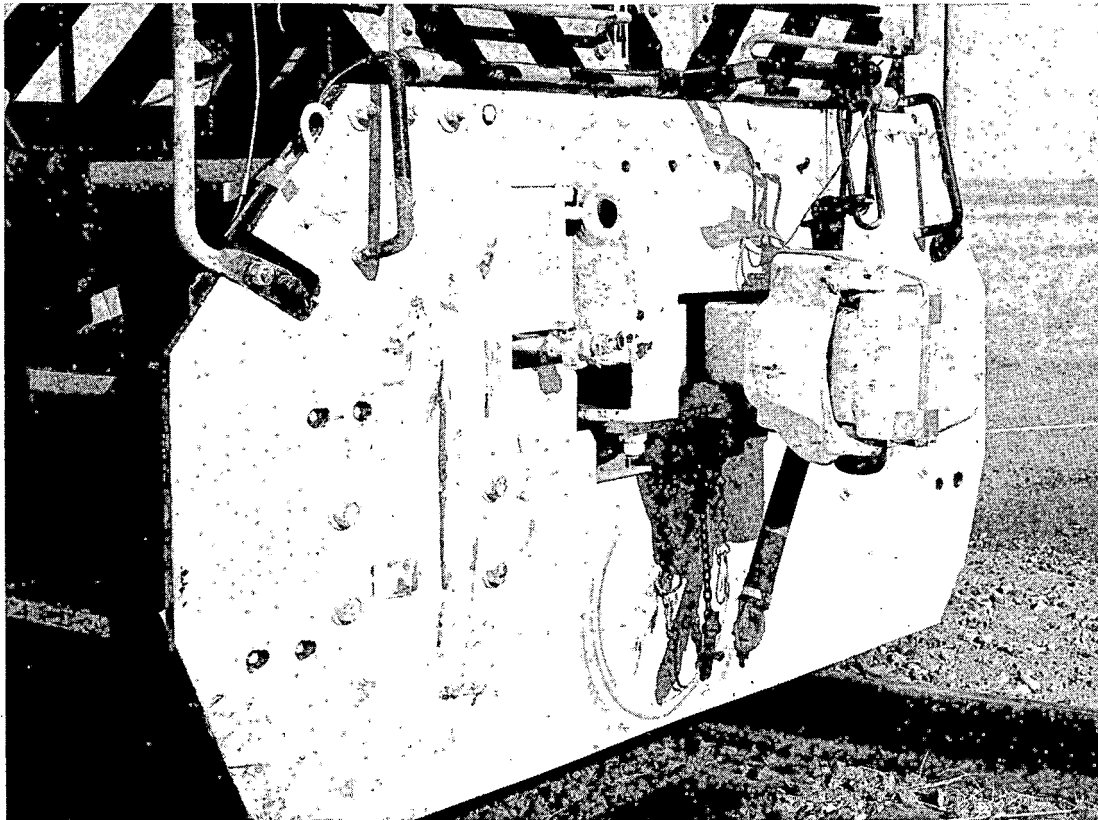
The front of the locomotive was undamaged except for broken brake pipes, as can be seen in Figure 58, which also shows the imprint of the left front wheel on the front face.

Figure 58. Post-test View of Locomotive Front Plate (Test TGB-4).

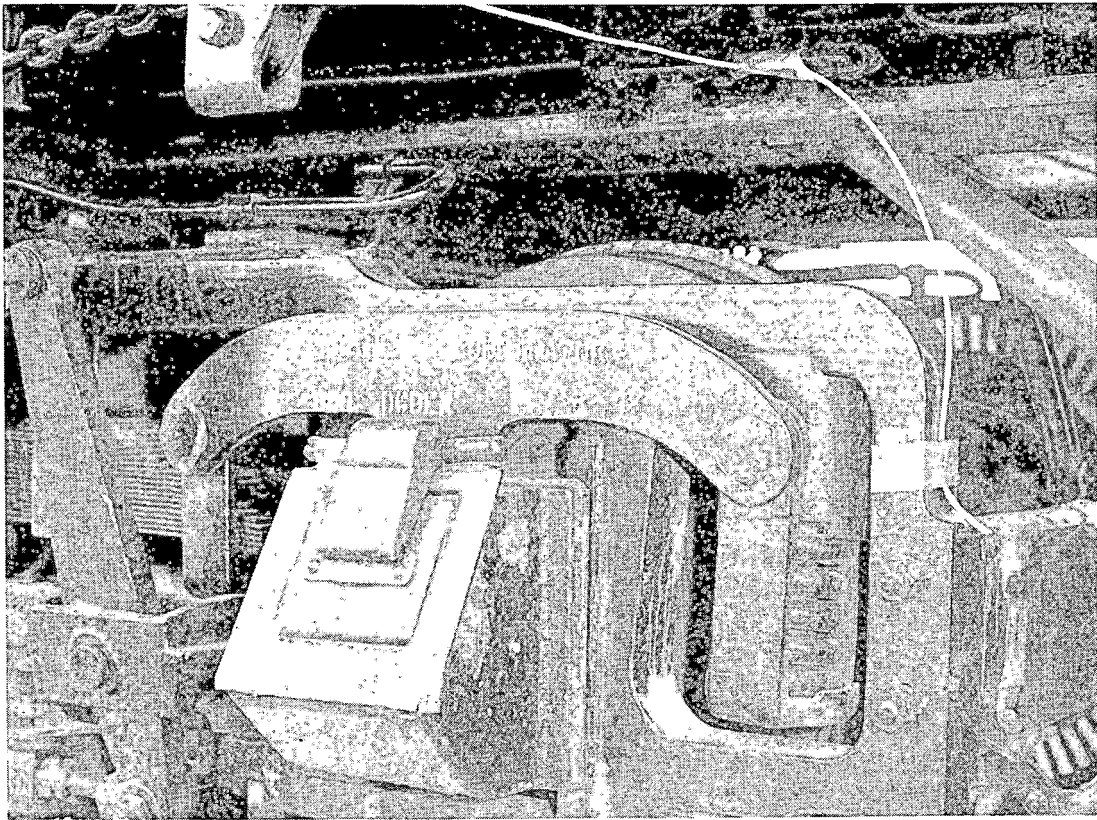
Figure 59. Post-test View of Damage to Locomotive (Test TGB-4).
