REPORT NO. FRA/TTC-80/02

CONCRETE AND WOOD TIE TRACK PERFORMANCE THROUGH 150 MILLION GROSS TONS

TRANSPORTATION TEST CENTER
PUEBLO, COLORADO 81001

INTERIM REPORT

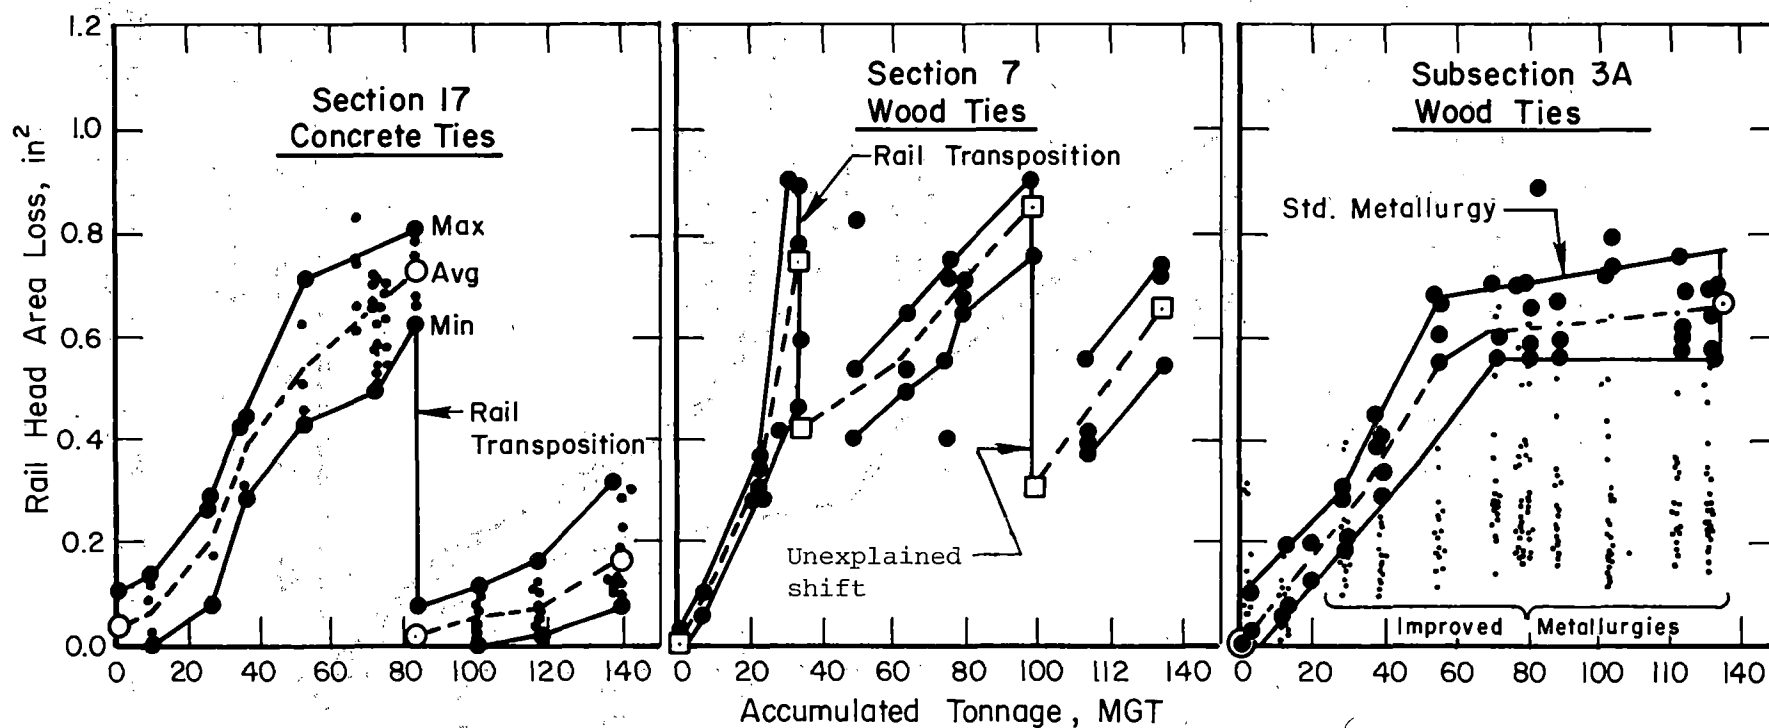
FIGURE 4-8. COMPARISON OF RAIL WEAR ON HIGH RAIL OF 5° CURVES IN SEVERAL SECTIONS OF CONCRETE AND WOOD TIE TRACK.

Figure 4-8 summarizes the results of measurements taken with a rail head profilometer in the 5⁰ curves of concrete tie Section 17 and wood tie Sections 07 and 03A. Curves show the maximum, minimum, and average values found at a given MGT in each test section. Between 0 and 135 MGT, each subsection of Section 03 contained rails with five different metallurgies, each in a 78-ft segment. In figure 4-8, the standard metallurgy segment is plotted separately from improved metallurgies--these included chrome molybdenum, fully heat-treated, high silicon, and head hardened rails.

Sharp breaks in the area loss plots occur for each test section. Two are caused by rail transposition, but one break at 100 MGT in Section 07 cannot be explained by maintenance activity. There is a sharp knee in the envelope for standard metallurgy in subsection 03A. This was probably caused by the addition of effective rail lubrication between 40 and 50 MGT. Lubrication substantially reduced the wear rate.

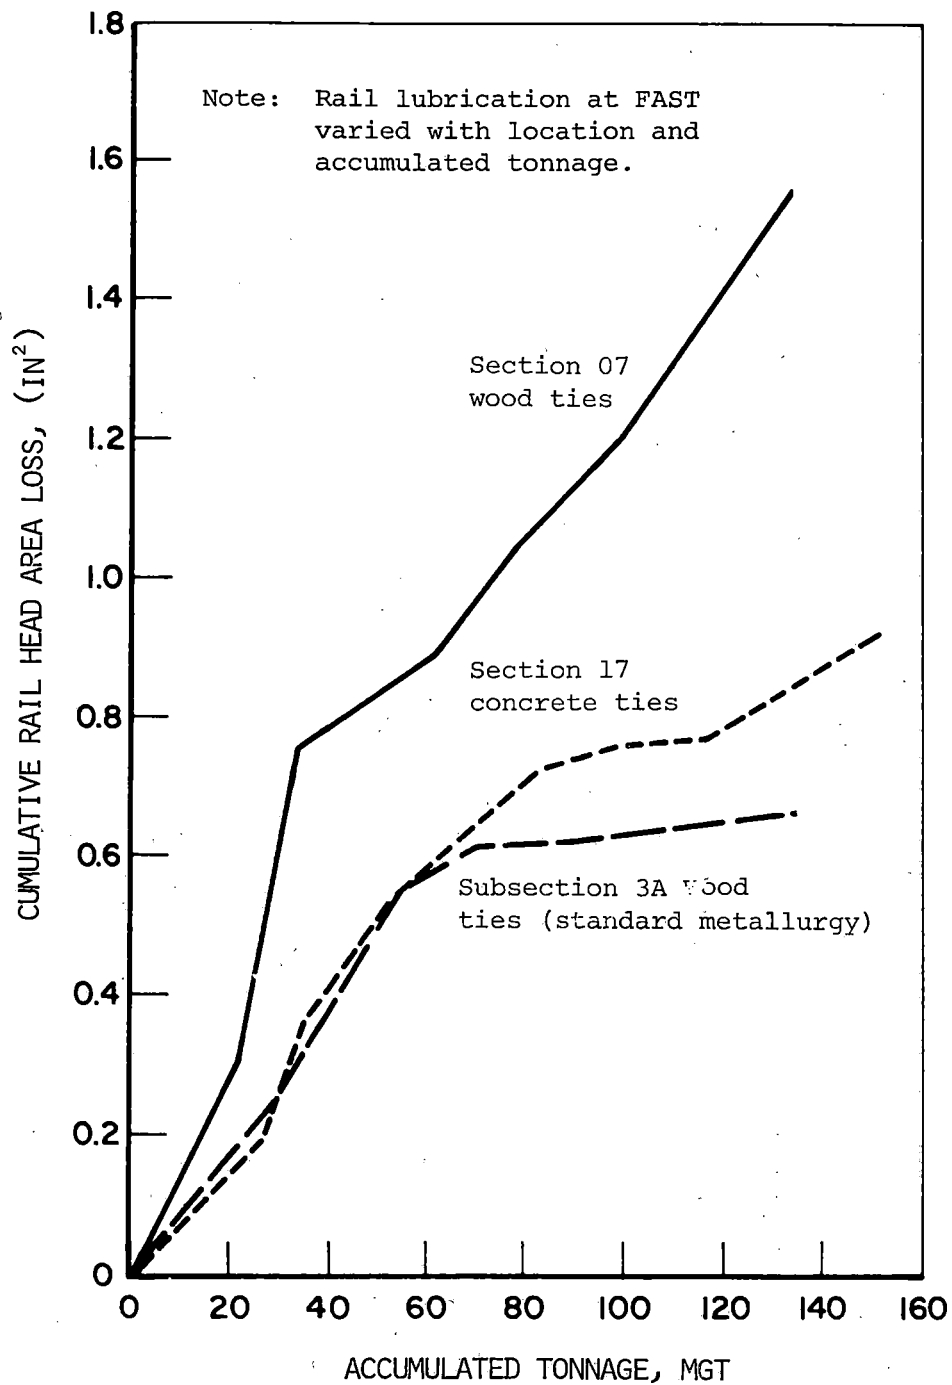
FIGURE 4-9. CUMULATIVE AVERAGE RAIL WEAR ON THE HIGH RAIL IN 5° CURVES OF CONCRETE AND WOOD TIE TRACK.

Cumulative average rail head area loss is plotted vs. MGT in figure 4-9. The curves were constructed by eliminating maintenance-related discontinuities in figure 4-8. Through 135 MGT, the rail in the wood tie Section 07 experienced approximately 80% greater wear than the rail in the concrete tie Section 17. Wear of standard rail in the wood tie subsection 03A was equivalent to that in Section 17 up to 50-60 MGT, when rail lubrication produced a significant reduction in wear rate.

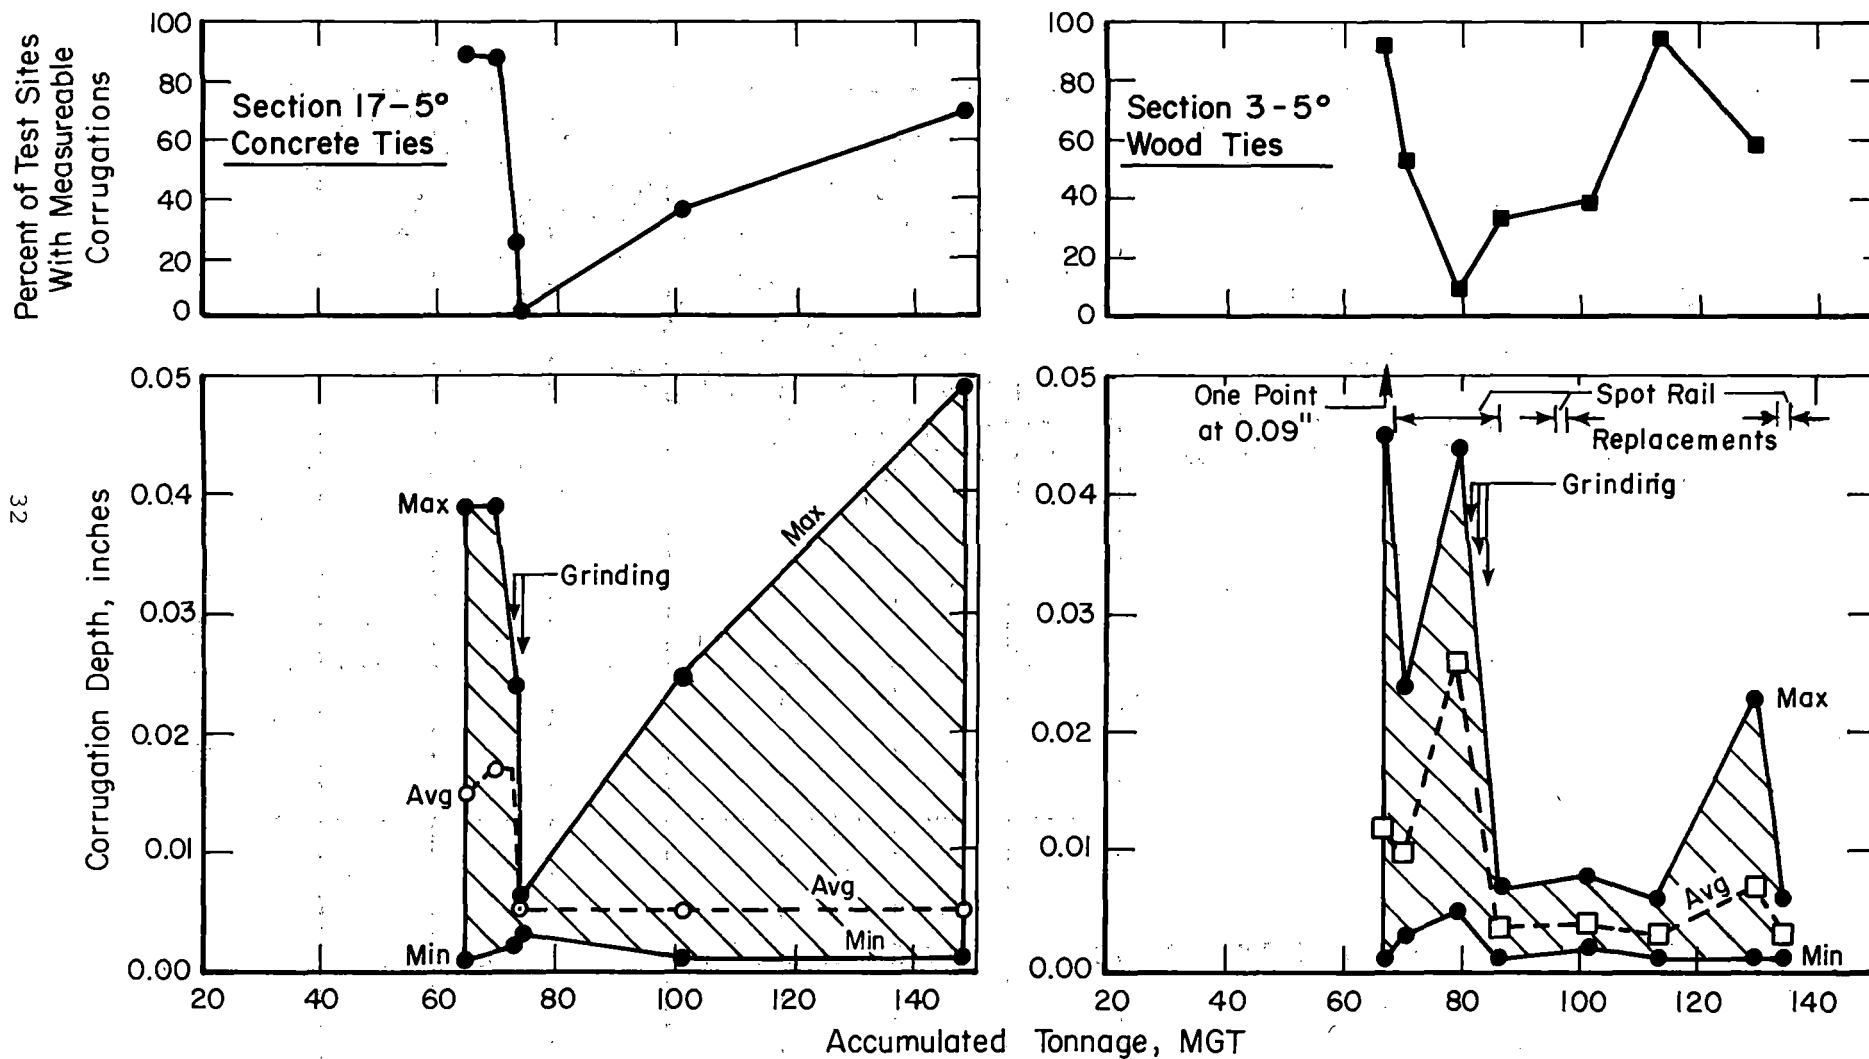
FIGURE 4-11. GROWTH OF RAIL CORRUGATIONS IN 5° CURVES OF CONCRETE AND WOOD TIE TRACK..

Figure 4-11 summarizes rail corrugation measurements taken in the 5⁰ curves of the concrete tie Section 17 and the wood tie Section 03.

The top plot for each section in figure 4-11 contains the percentage of total measurement sites where measurable corrugations were found each time measurements were made. The data show that grinding effectively removed corrugations although they quickly redeveloped.

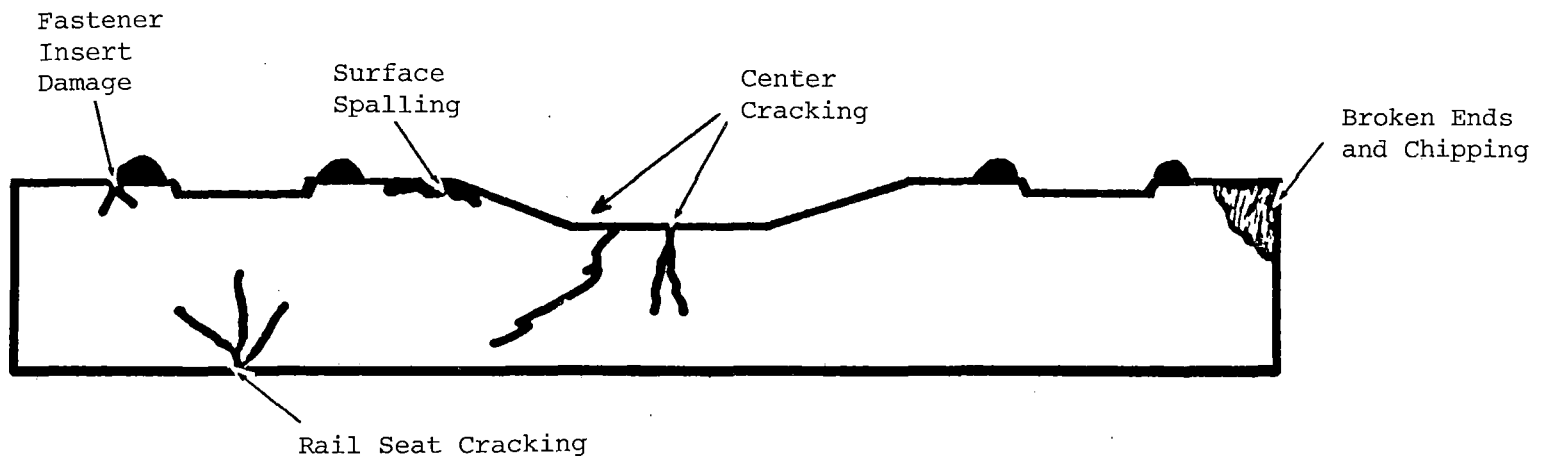
FIGURE 5-1. TIE DEGRADATION AND FAILURE MODES.

Figure 5-1 illustrates the types of tie flaws which were included in regular inspections of limited numbers of ties in 12 concrete tie subsections. Several problems which were encountered in the inspections include:

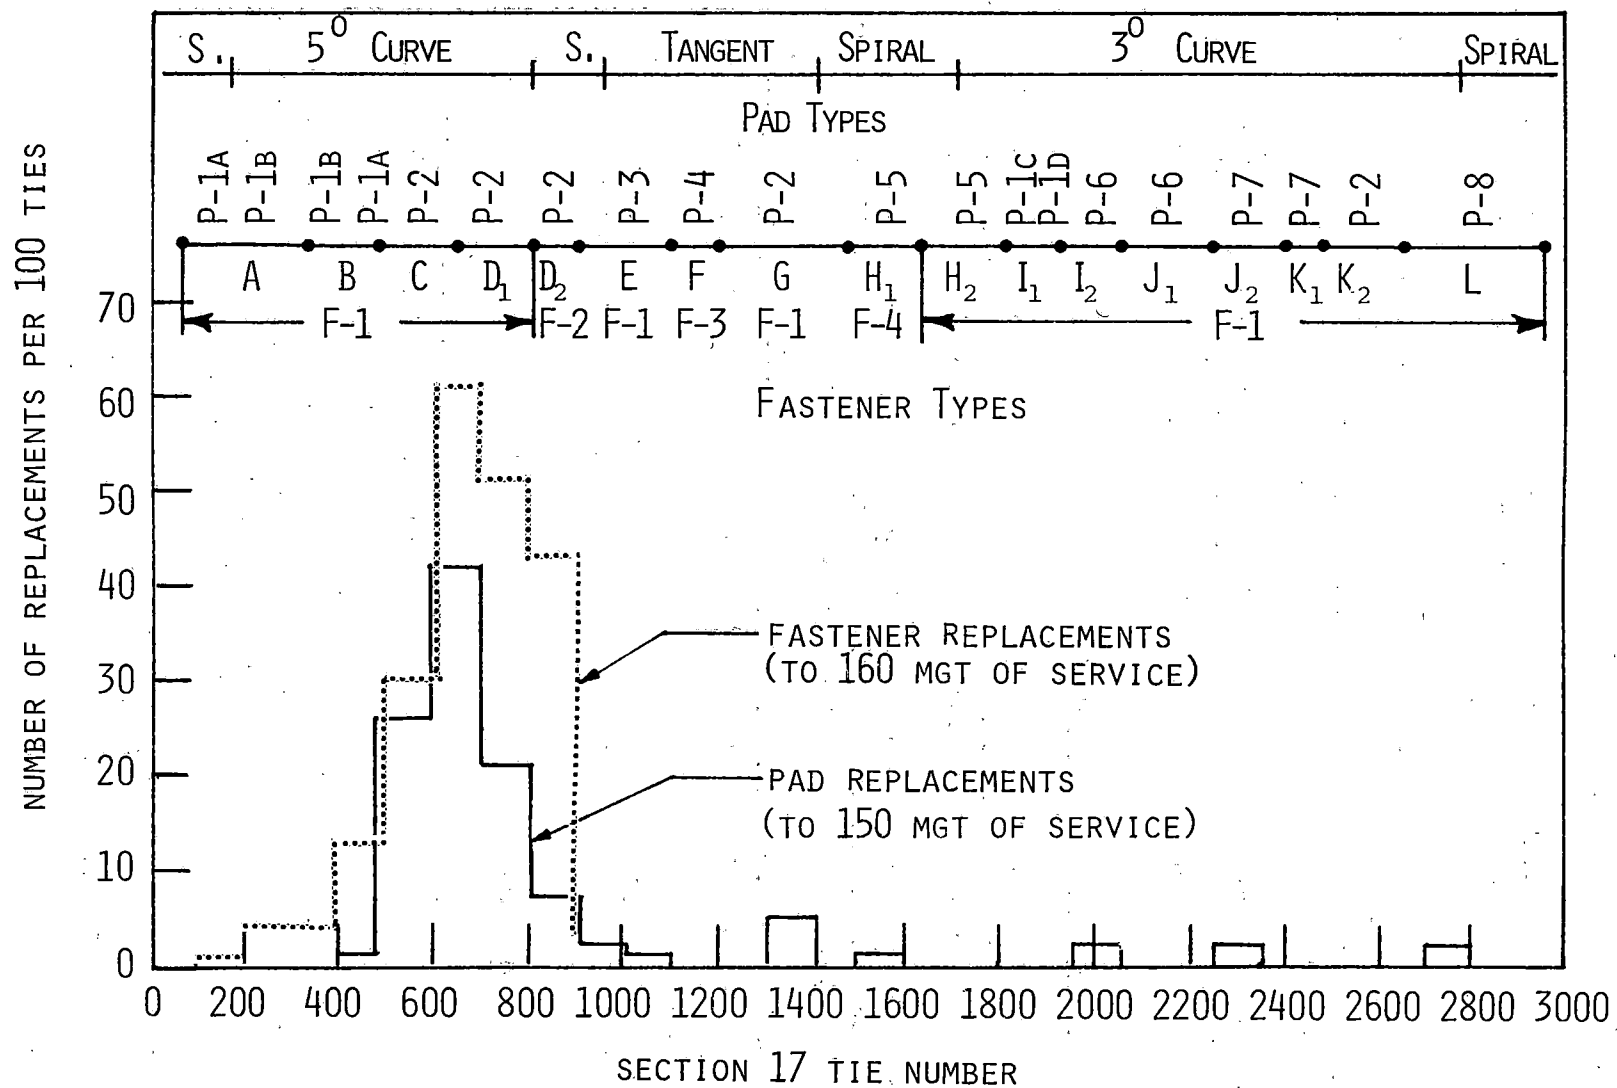
FIGURE 5-4. SUMMARY OF RAIL PAD AND FASTENER CLIP FAILURES IN SECTION 17.

Extensive fatigue fractures of type F-1 elastic rail clips began to develop in one region of the 5° curve of Section 17 at about 100 MGT. These fasteners were all new, installed after the track buckled at 61 MGT. The fractures were concentrated over the region of the 5° curve where the type P-2 pads, one of the softest tie pads, were installed. Other fasteners, which were installed at 61 MGT in the 5° curve with different pads, had much lower failures rates.

The 11 types of tie pads were arranged into three groups according to hardness. The P-2 pad, which is connected with high rates of fastener fracture and fall-out, is one of the softest pads.

The softness of the P-2 pad probably contributed to the concentration of rail fastener clip failures in the 5° curve.

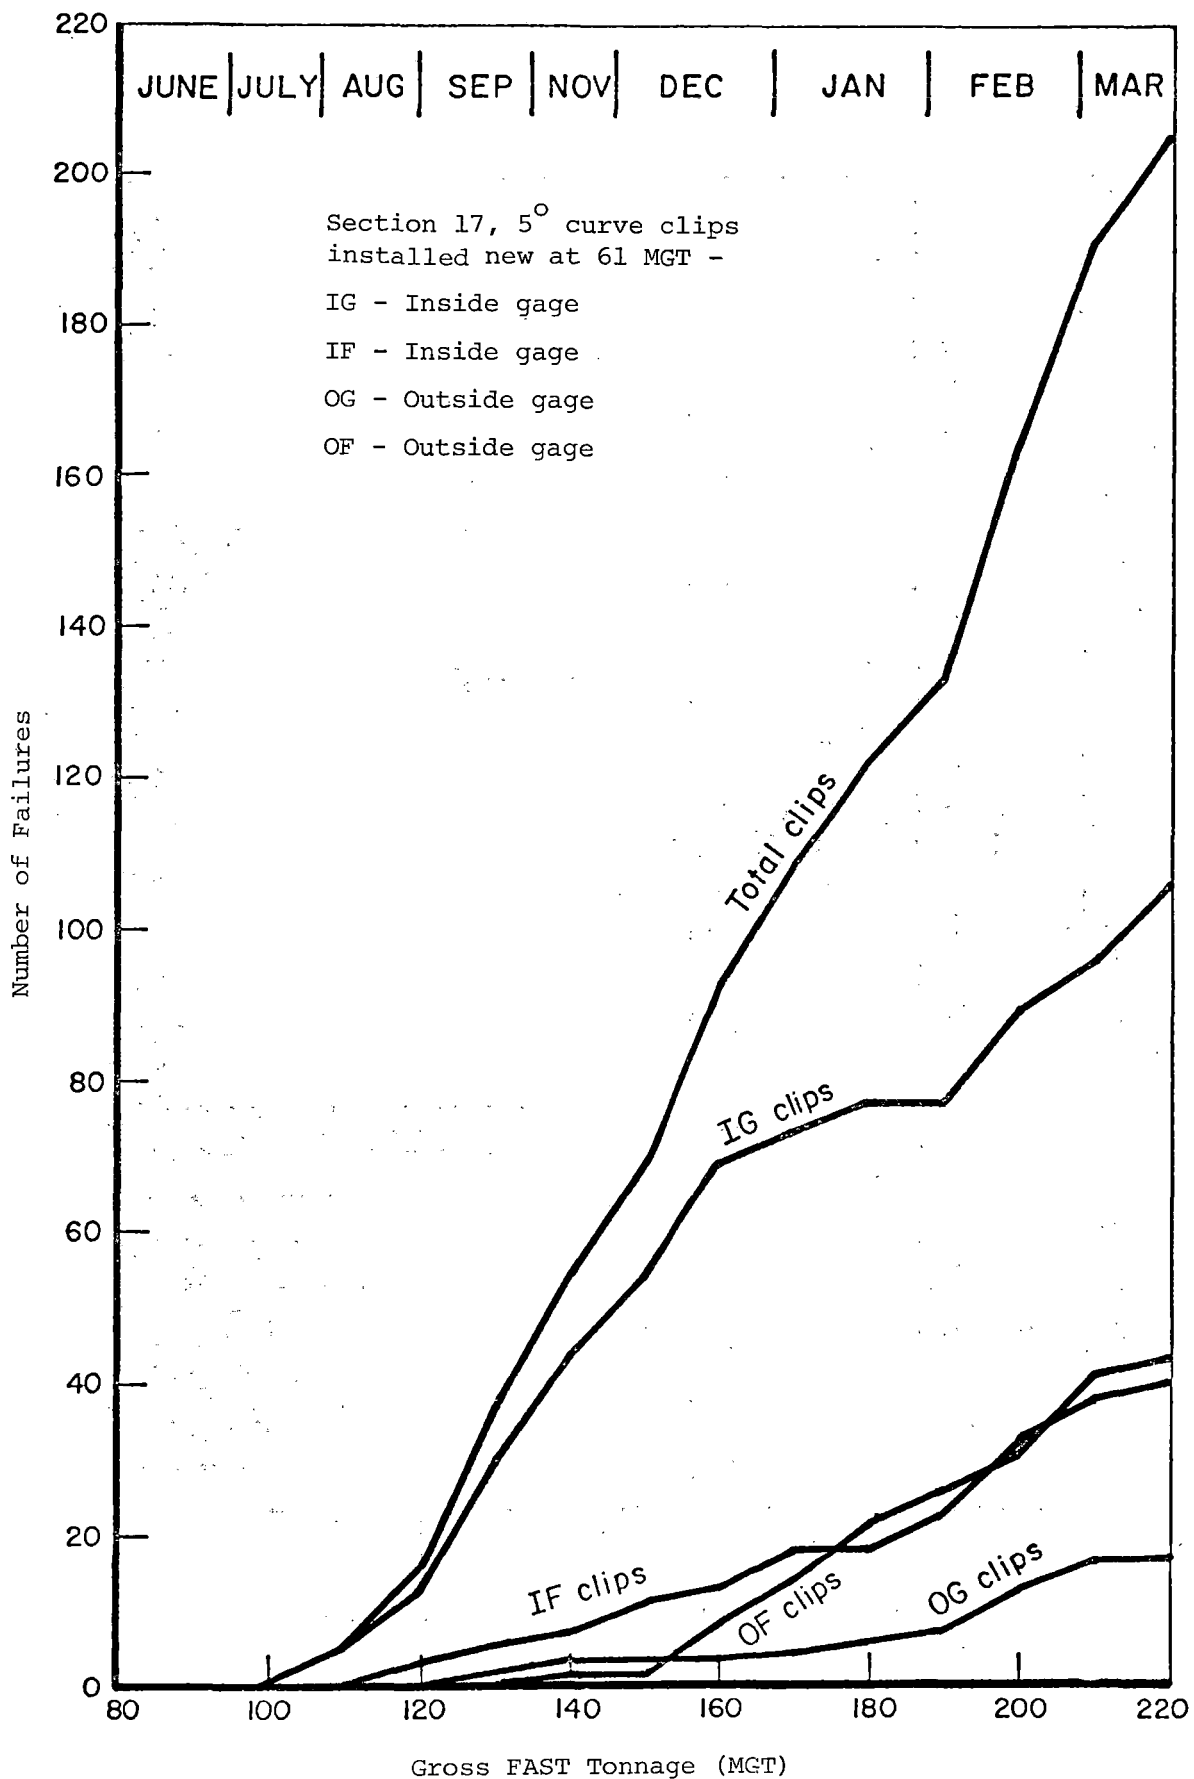
FIGURE 5-5. ELASTIC CLIP FAILURES AT EACH CLIP LOCATION VS. MGT.

Extensive fatigue failures of type F-1 elastic clips began to develop in one region of the 5° curve of Section 17 at about 100 MGT. These clips were

all from a batch installed at 61 MGT after the lateral track buckle. No clip failures had been reported prior to 100 MGT.

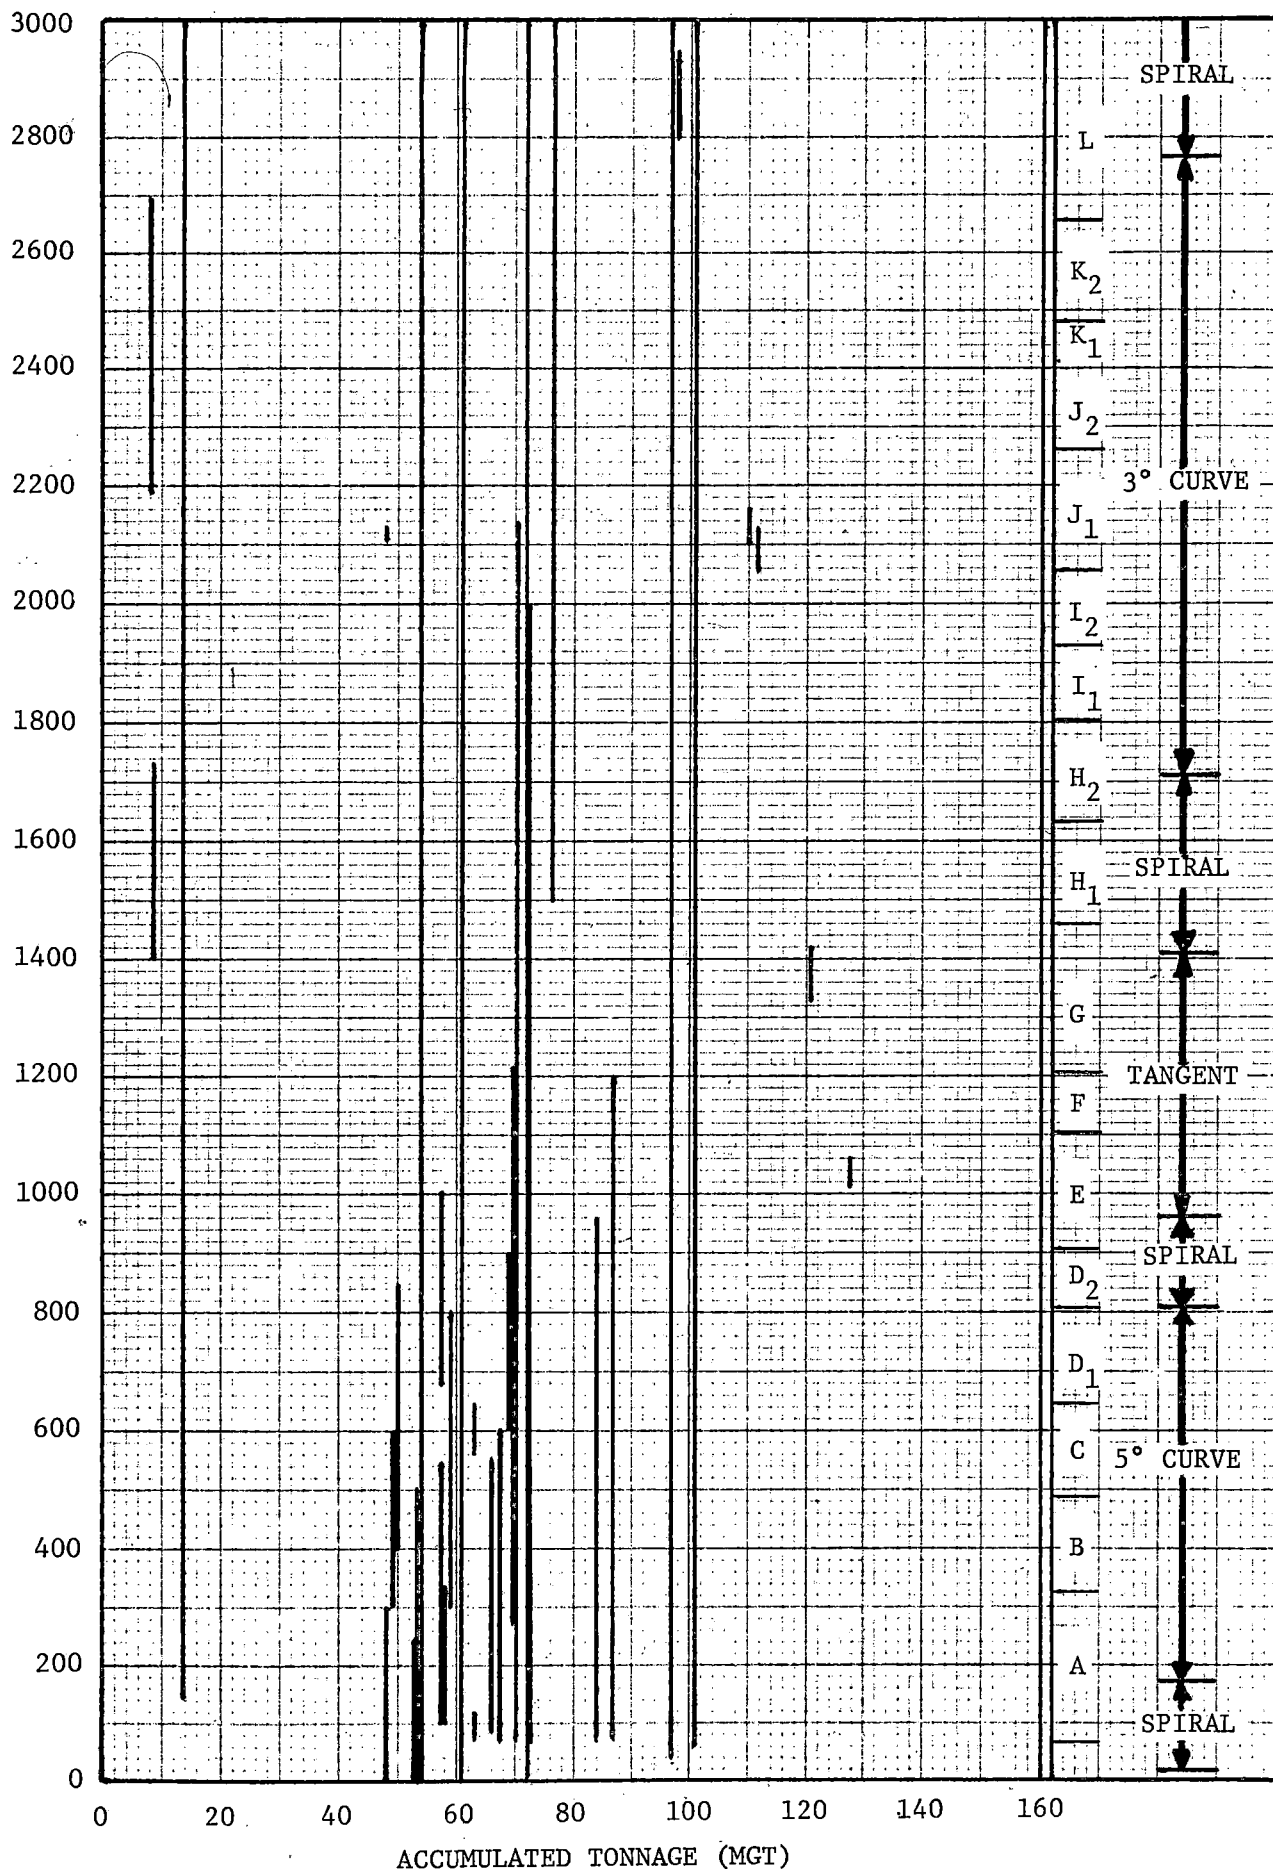
FIGURE 5-14. SUMMARY OF MAINTENANCE AFFECTING BALLAST COMPACTION IN SECTION 17 (TAMPING, SURFACE/LINE/TAMP, BALLAST ADDITION AND RESHAPING).

maintenance had a major impact on the lateral stiffness of the track.⁵⁻⁴ The frequency of maintenance beginning at 48 MGT coincided with a rapid increase in tie movement seen earlier in figure 5-10. This tie movement culminated in the lateral instability incident at 61 MGT.
