**FAST/HAL TURNOUT AND
FROG PERFORMANCE**

**REPORT NO. R-798
FRA/ORD-91/25**

***Facility for Accelerated Service Testing
Heavy Axle Load Program***

November 1991

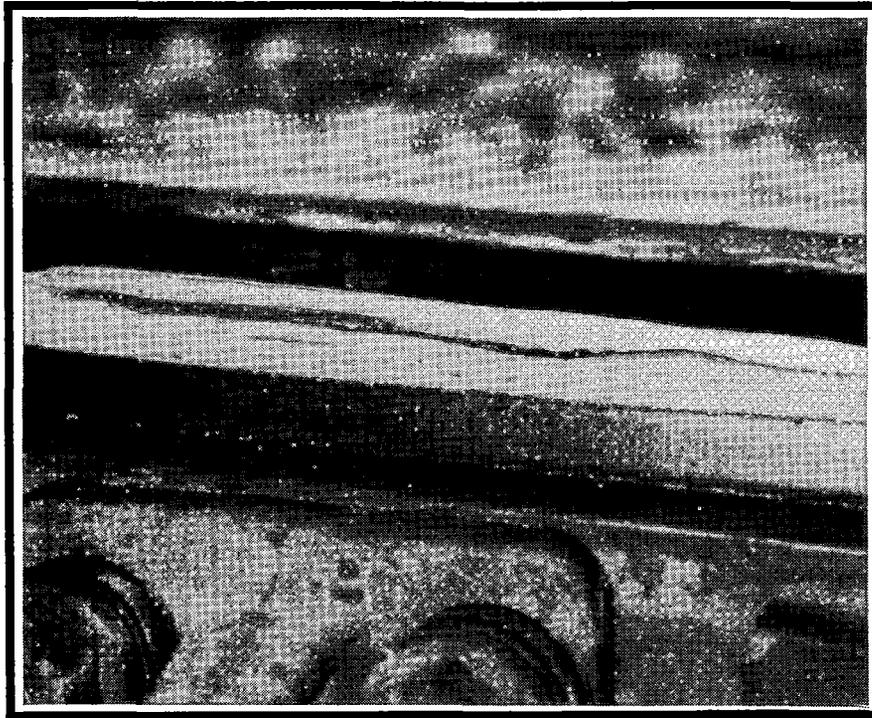
All switch point failures occurred on switch points manufactured of 300 Bhn rail and were all related to fatigue cracks of 4 inches to 10 inches at or near the point of switch. All three failures were related to observable metal flow along the gage side of the stock rail which caused a poor fit of the point to the stock rail. In all cases, the cracks were removed by grinding and the points restored by buildup welding of the point in track. Figure 5 shows a typical point failure.

**Figure 5. Typical Switch Point Failure
Diverging Side of Trailing Point Turnout**

2. Three AREA design switch points manufactured of 300 Brinell hardness (Bhn) rail exhibited fatigue cracks near the point of switch. The cracks were associated with metal flow along the gage side of the stock rail which affected the fit of the point to the stock rail.

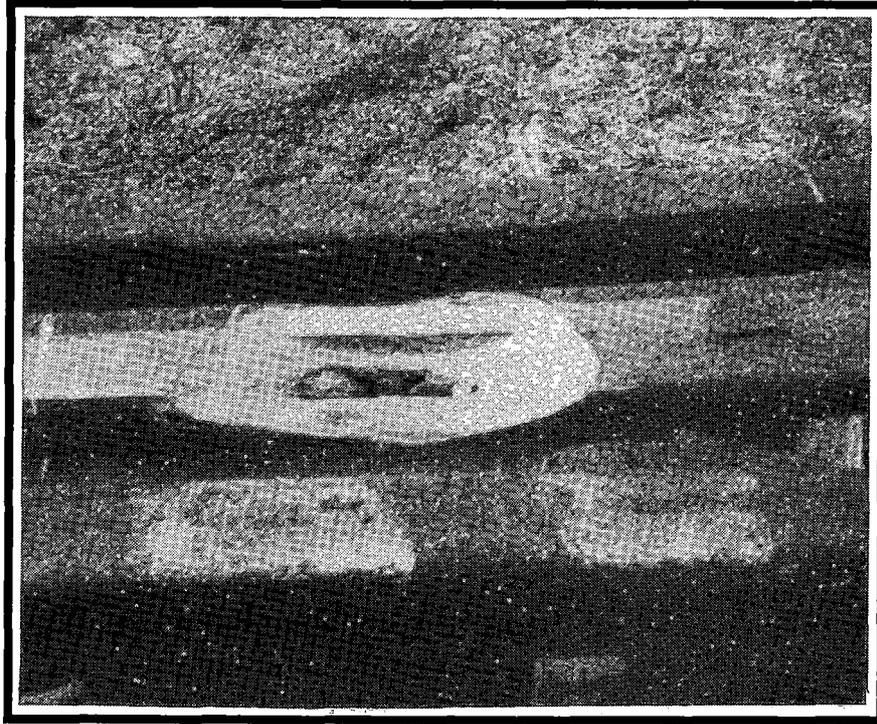
Frog casting failures resulted from cracks of 4 inches to 6 inches long in the manganese insert. All casting defects were first observed as a flattening or crushing of the insert surface. Figure 6 shows the void left after removal of the crack in the standard No. 20 frog facing point turnout.

Figure 6. Void in Frog Casting After Removal of Casting Defect

3. The thin walled frog casting installed at the facing point No. 20 turnout failed after 70 MGT of service and the heavy wall design at the trailing point No. 10 turnout failed after 98 MGT. A third casting failure was recorded at the

trailing point No. 20 after 160 MGT of 33-ton axle load traffic and 75 MGT of 39-ton axle load traffic. All three failures resulted from cracks that developed in the casting body.

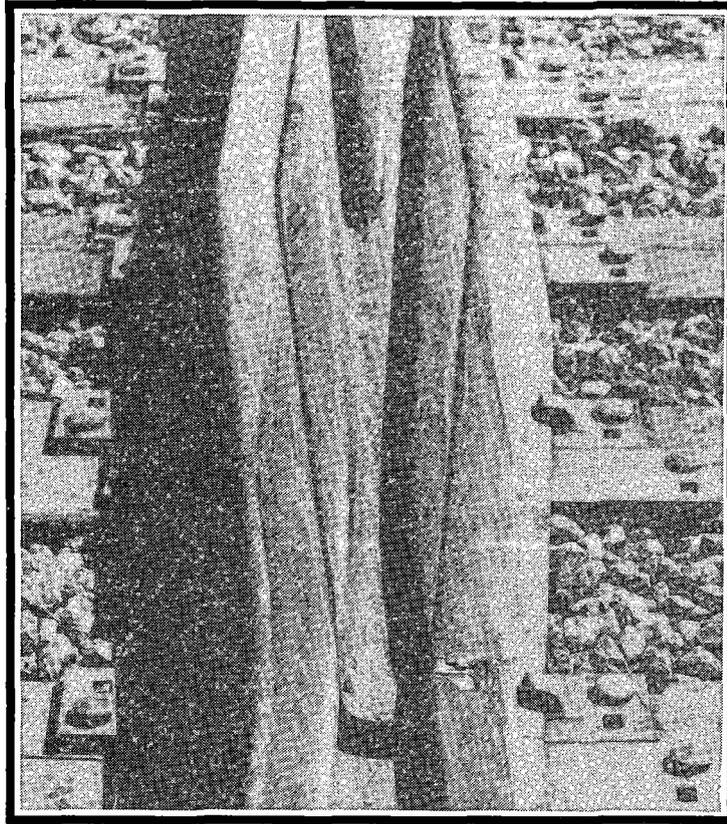
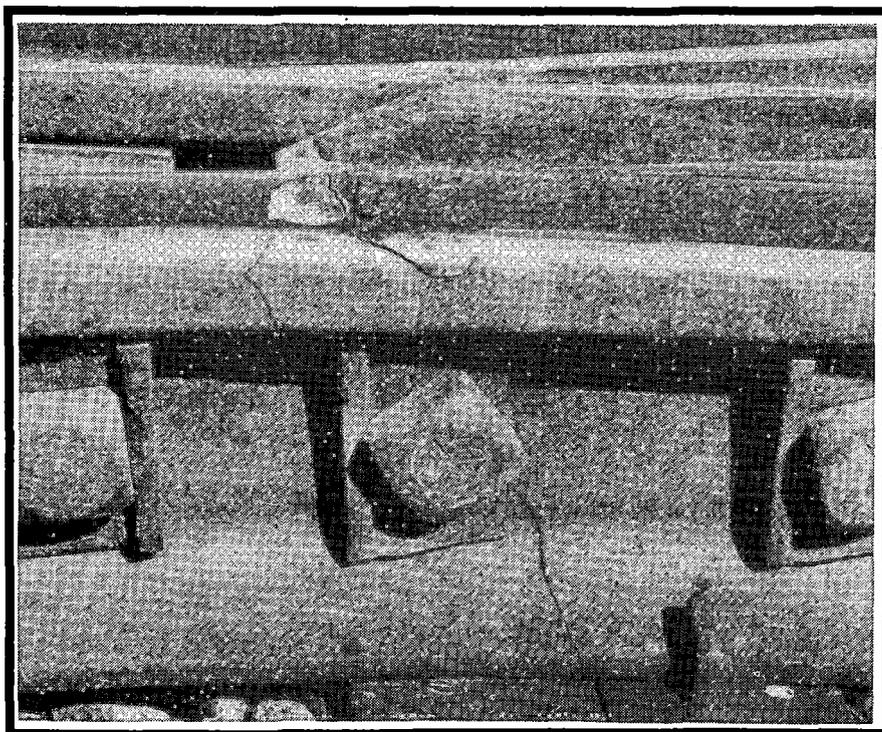
Perhaps the most significant failures in terms of axle load comparison were the wing rails on the No. 10 frogs. As shown in Table 2, three failures were recorded, two of which occurred at the facing point frog after relatively short service life and the other occurring at the trailing point frog after a moderate service life of 95 MGT. All three failures were identical: a transverse fracture of the rail at the bolt hole located just ahead of the casting throat. What makes these failures significant in terms of axle load comparison is that similar fractures were not noted during the 1,000 MGT generated during the 33-ton axle load phase.

Figures 7 and 8 show the second wing rail failure (facing point No. 10 after 14 MGT on the wing rail), taken with the frog in track before initiation of repairs.

Figure 7. Location of Wing Rail Fracture on the Frog

Figure 8. Side View of the Fracture Showing the Position of the Bolt Hole

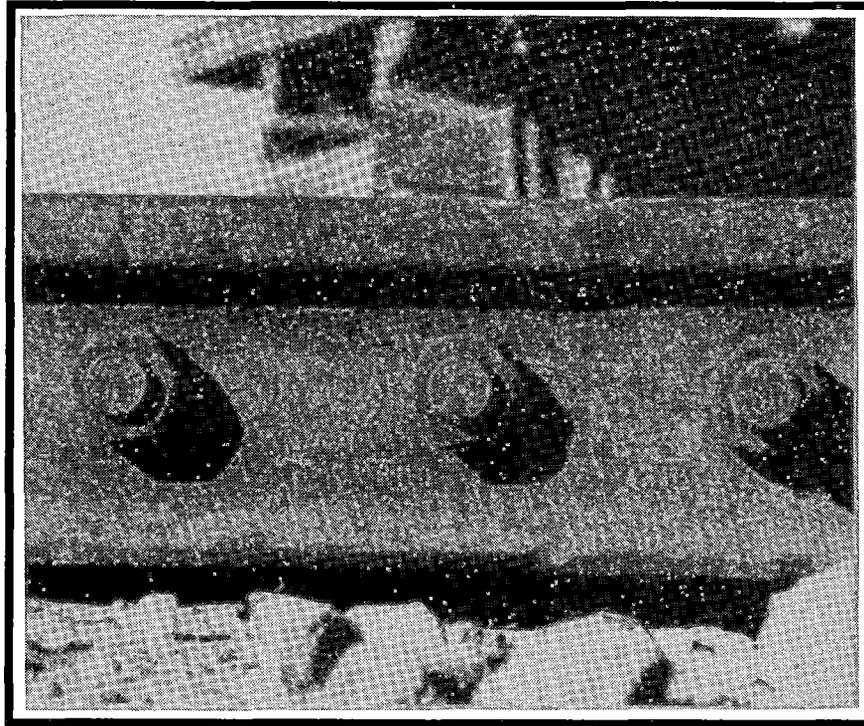
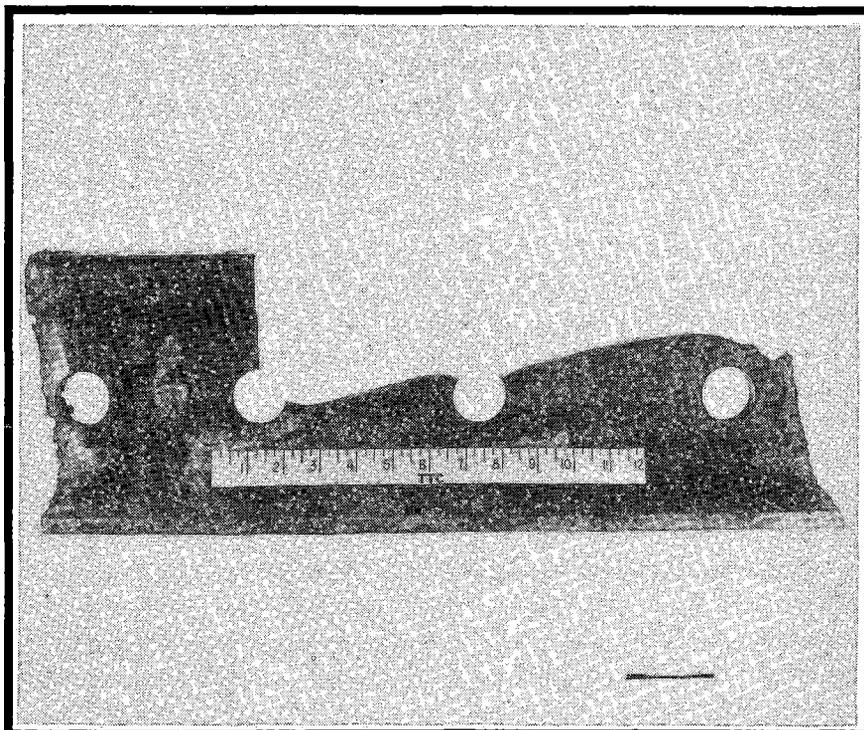
Although all three defects were similar, the third failure at the trailing point frog was the most serious. Figures 9 and 10 show the longitudinal progression of the crack in the rail web for a distance of about 16 inches before final rupture along the vertical axis.

Figure 9. Longitudinal Crack Through the Rail Web and Vertical Rupture

Figure 10. View of Cracked Web in the Laboratory

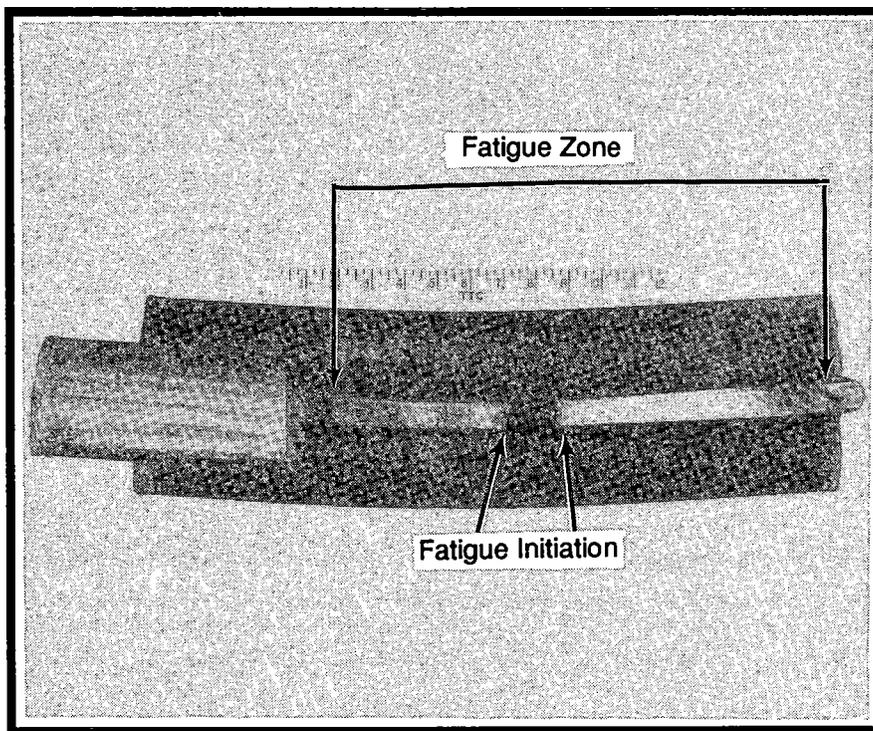
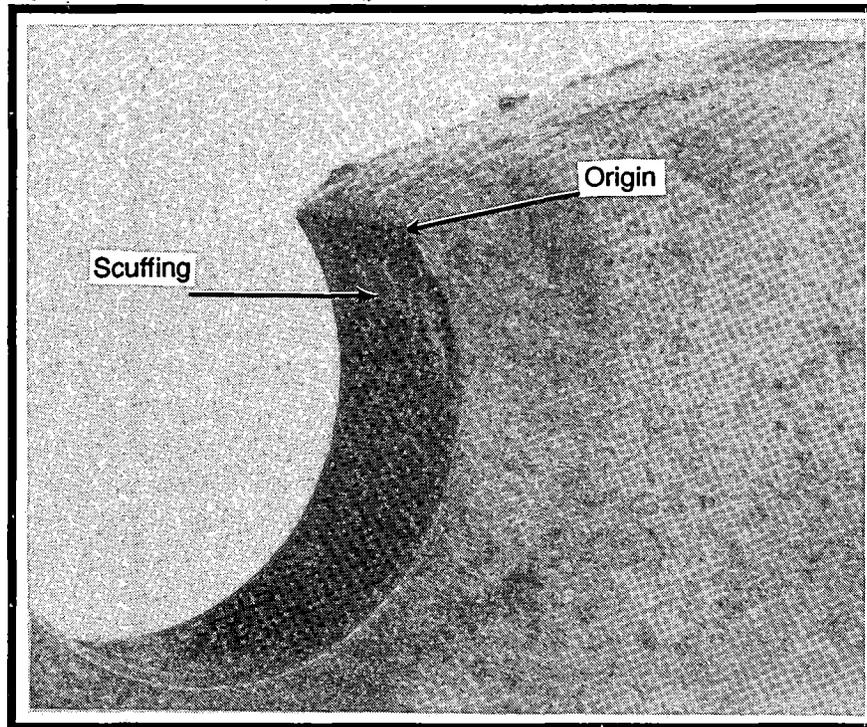
All three failures were analyzed at the TTC's Metallurgy Laboratory to determine the origin and cause of the cracks. In each case, the analysis showed the crack originated at the bolt hole on the side of the bend nearest the frog's toe and at the gage side of the rail where the surface is in tension from the bending (Figures 11 and 12). With the use of a stereo microscope and magnifying glasses, it was determined that fatigue cracks originated at the sharp edges at the periphery of the bolt holes.² It was also noted, during the examination, that the bolt holes responsible for the failures were only partially chamfered, resulting in sharp edges -- ideal stress risers for cracks to initiate. Evidence of scuffing on the inner surface of the bolt hole indicated the third failure (the specimen with the longitudinal crack) was also aggravated by a loose bolt.

Figure 11. Top View of Wing Rail Failure Showing Fatigue Initiation and Length of Fatigue Zone

Figure 12. Close-up of Bolt Hole Showing Origin of Fracture

1. Three wing rails installed on No. 10 frogs failed as a result of fatigue cracks originating at the bolt hole near the throat of the frog, where the rail is bent to fit around the frog casting. Analysis of the cracks indicated that in each case the origin was at the edge of the hole on the field side of the rail where the rail surface is in tension from the bend. The edges of the holes were found to be sharp, presumably due to inadequate chamfering during the manufacturing process, which created stress risers. No similar fractures were noted during the 33-ton axle load program on frogs at the same locations.

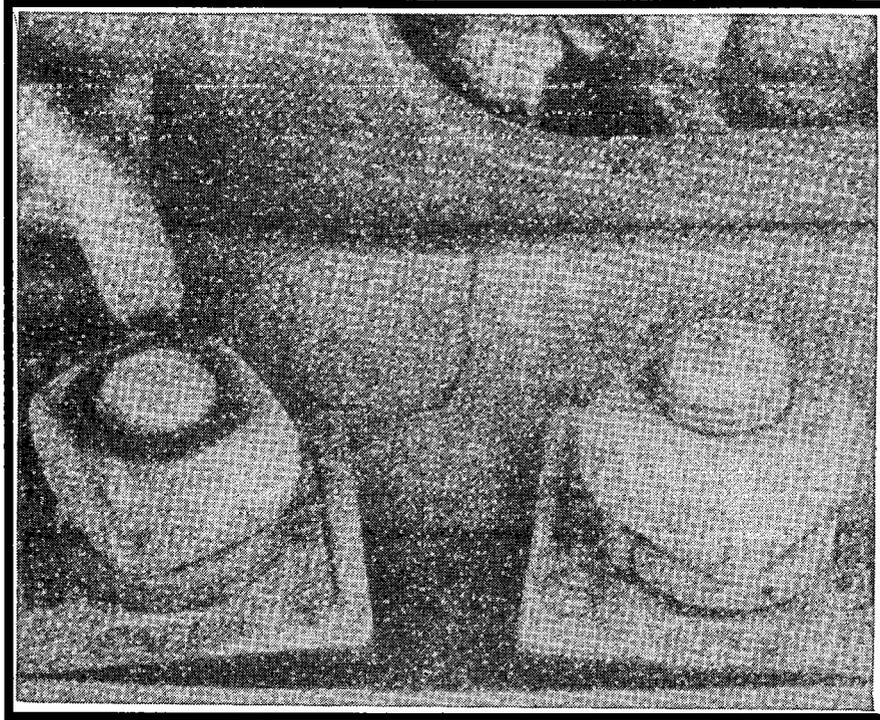
A wing rail on the Nortrak frog broke at 13 MGT, just after the insert was ground. The wing rail, which was fully heat treated, failed at the first bolt hole in the insert as shown in Figure 6. The failure was apparently due to the manufacturer's bending process and subsequent service conditions. The manufacturer uses a four point contact, which the rails are bent around. These contacts touch the rail in the web (two locations), on the head, and on the toe. The contact on the toe applied force during the bending process and caused the metal to bulge down below the normal base dimensions of the rail.

Figure 6. Fracture of Nortrak Wing Rail

Post failure analysis showed that this bulged area subsequently rubbed against the frog plate directly beneath. This obviously created high impact loads on the bulge which, when combined with the abraded surface, created the failure conditions. A transverse defect propagated upward 5 millimeters (mm) from the bulge surface into the toe, at which point the wing rail fast fractured. Figure 7 shows the fracture surface with the fatigued zone where the transverse defect began and the chevrons that occurred during the fast fracture. The wing rail was replaced and the frog was reinstalled at 36 MGT of the test.

There are numerous Nortrak frogs of this design in revenue service in North America. To date, wing rail failures of this type have been either uncommon or non-existent.³ Current design limitations of the wing rail are possibly being exceeded under 39-ton axle loads. The wing rail bending process may need to be modified in order to meet the requirements of heavy axle load operation.

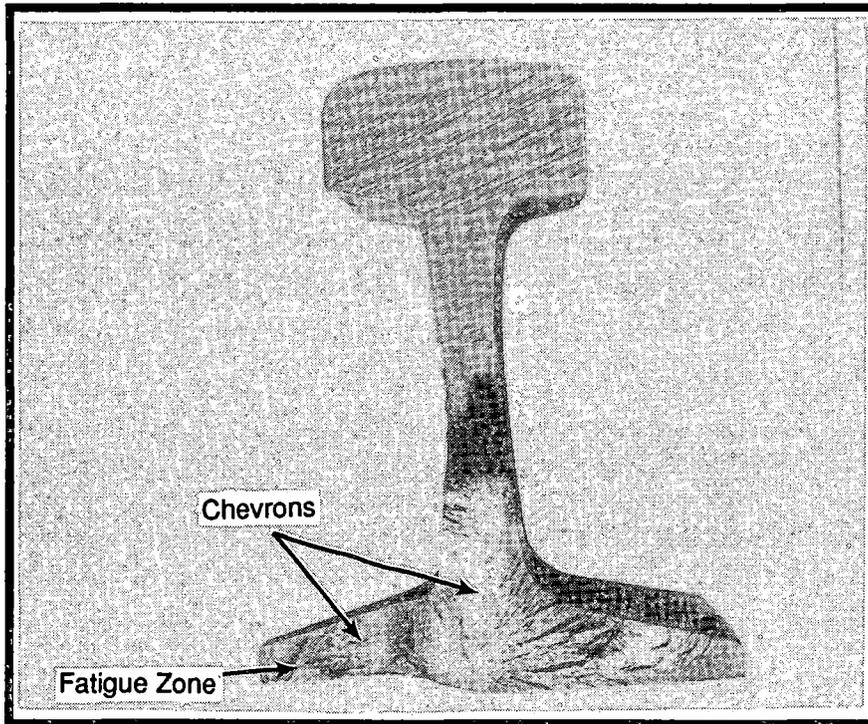
Figure 7. Fracture Surface of Nortrak Wing Rail

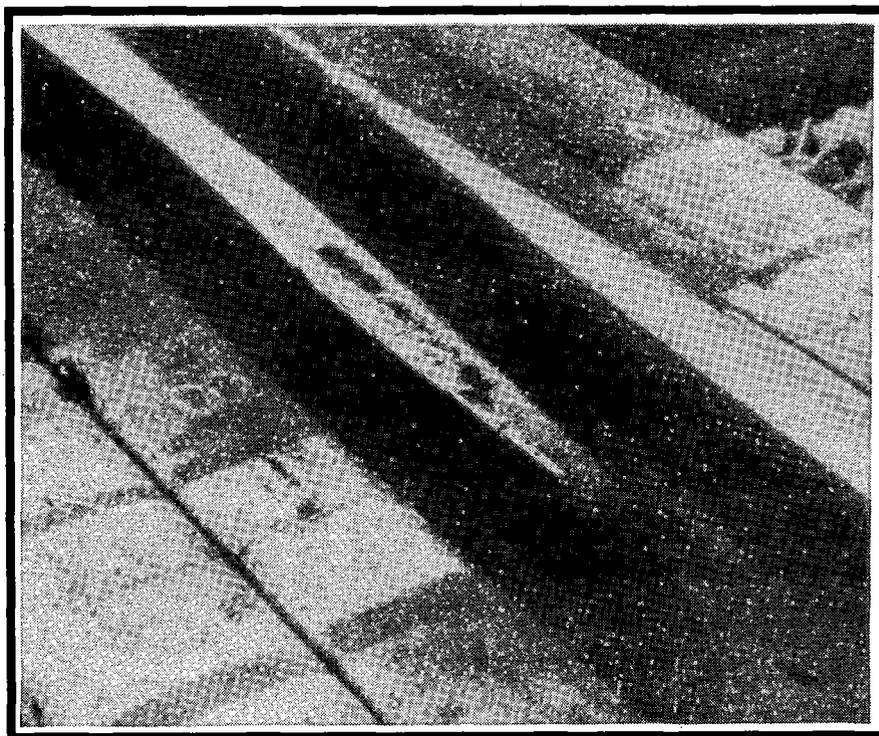
The Bethlehem frog has not required maintenance, other than grinding. At 40 MGT, it did begin to develop spalling on the first 8 inches of the point, which may eventually require building up. This spalling, shown in Figure 8, was a result of the wheel profile and frog profile contact characteristics. The FAST consist wheels exhibit a worn tread profile. This probably created slippage on the point of the frog as the wheel transferred to the point, i.e., the wheel was dragging on the point which created the spalling. The guard rail bolts adjacent to the point of the frog required replacement several times during the test.

Figure 8. Spalling of Bethlehem Frog Point

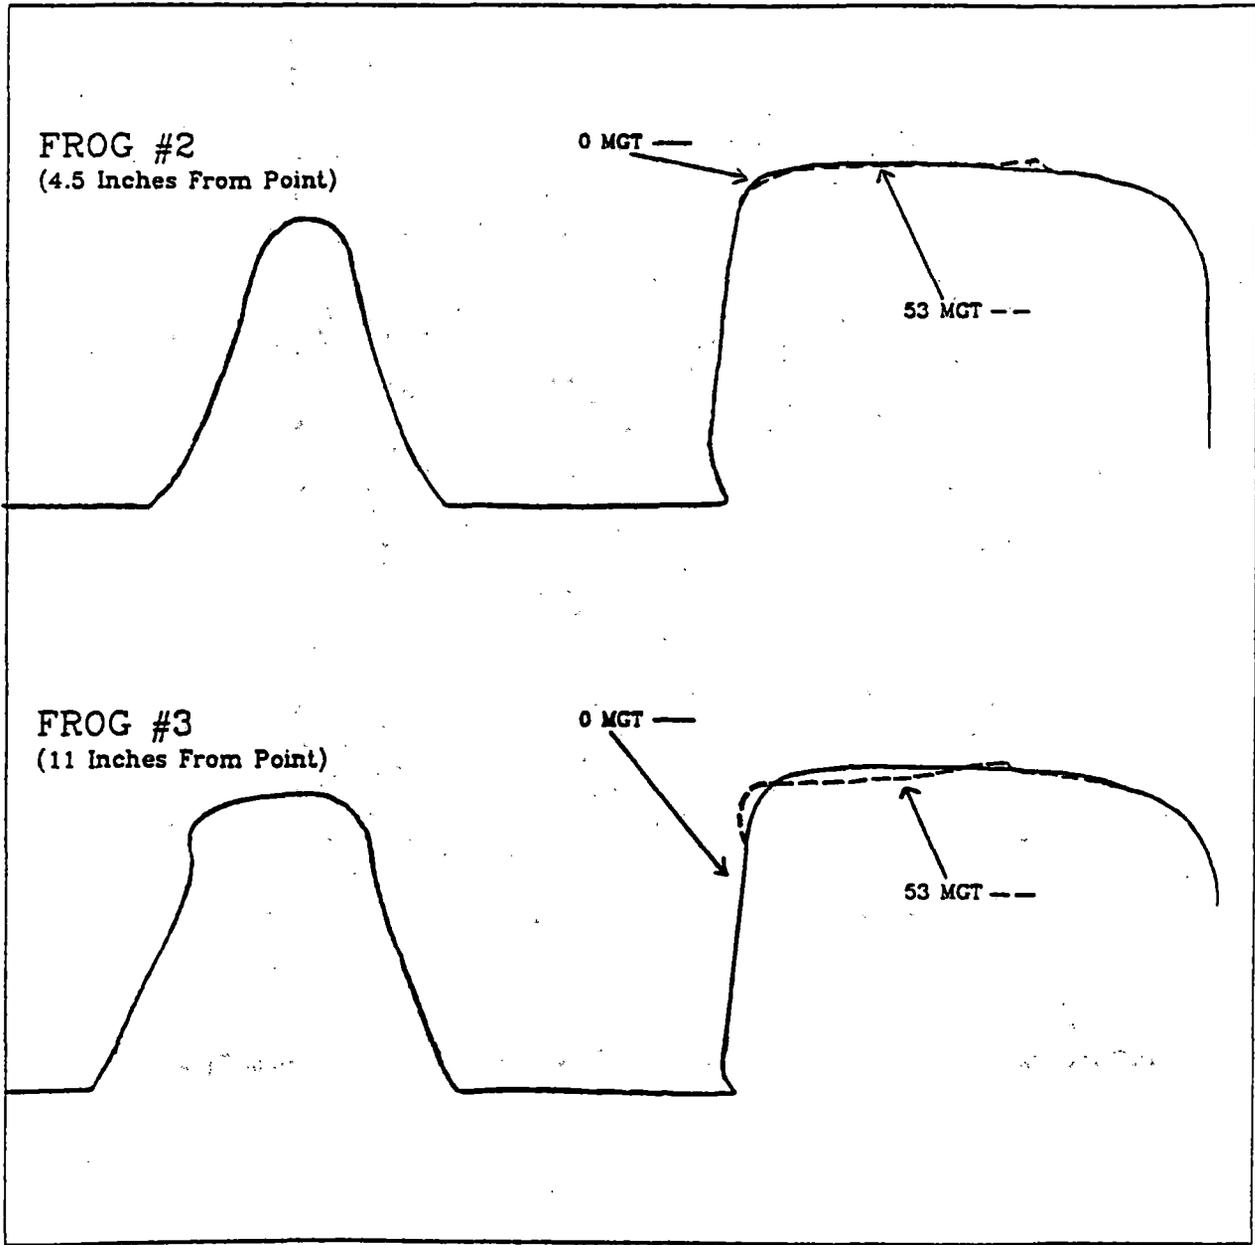
Profile overlays for the Voest-Alpine frog points showed no metal flow on the alloy and only very little on the manganese steel frog. But as the test progressed, it was observed that the wing rails on both (especially the Manganese steel casting) were beginning to crush and form transverse cracks on the surface. The wing rail crushing of the manganese casting frog can be seen in Figure 10. Figure 11 displays the overlays of the worst areas of the head crushing on the two Voest-Alpine frogs, 4.5 inches behind the 1/2 inch POF for the alloy frog, and 11 inches behind the 1/2 inch POF for the manganese frog. The worst area for the alloy frog was at the very beginning of the point. This suggests that the point itself was able to withstand the vertical wheel loads. However, on the manganese frog, the worst area of wing rail crushing being further back from the point (11 inches behind the 1/2 inch POF) suggests that the point itself must be crushing. Figure 10 shows that this is the case, with metal flow on the gage corner of the point. Also, since the head is crushing, the wing rail must support more of the load which in turn would cause it to crush more.

Figure 11. Wing Rail Crushing of European Frogs

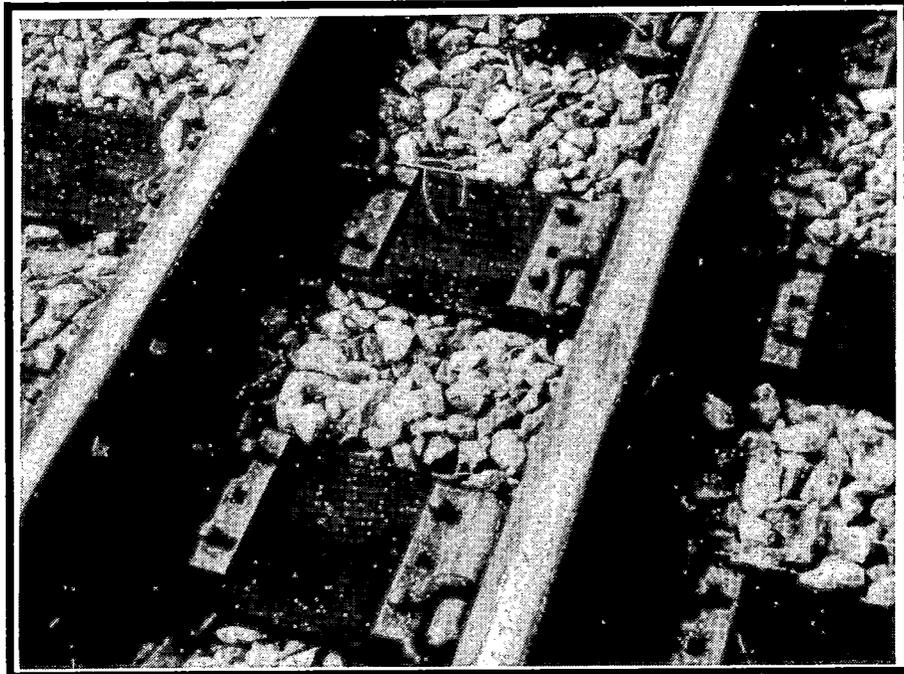
Figure 11. Typical Welded Rail Joint Batter

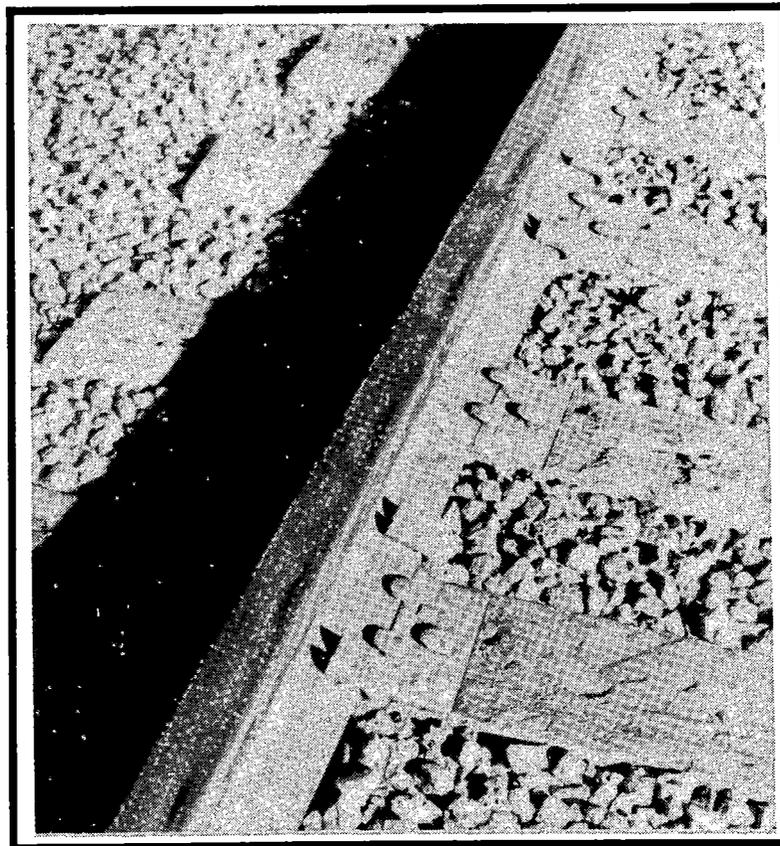
Figure 12. Typical Corrugations

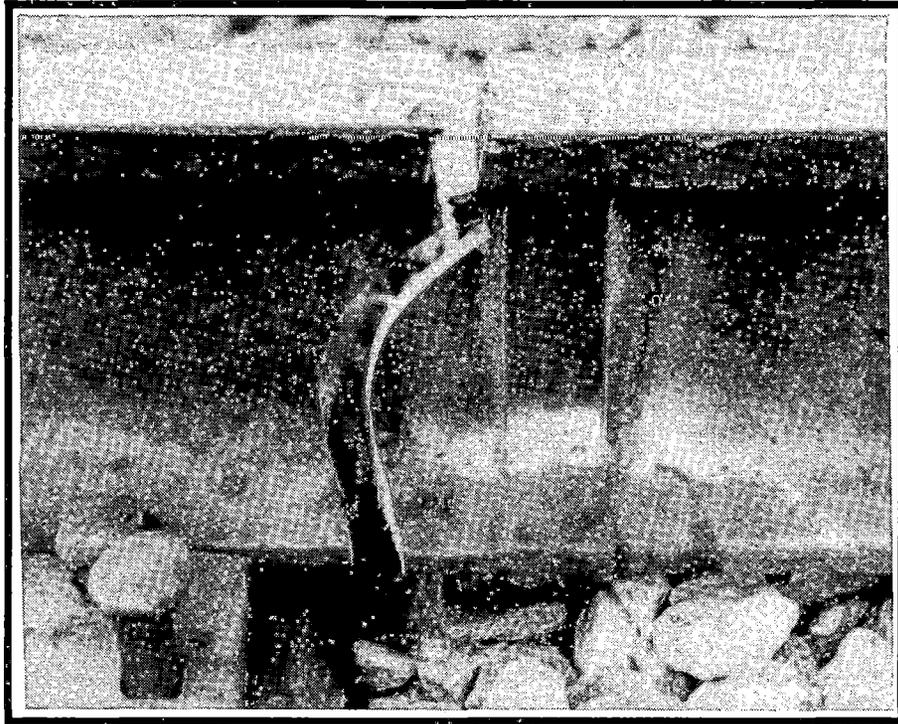
Field weld failures (Figure 13) played an important part in the efficiency of operation during the HAL Test. Frequent failures, which were not observed during the 33-ton phase, resulted in a significant impact to train operations. The need for improved quality control during the welding process as well as improved welding techniques and materials to withstand the heavier axle loads was noted. The standard mix content of most field welds often lead to excessive batter, especially when used on 300 Brinell hardness (Bhn) and heat treated rails of standard chemistry.

Figure 13. Typical Broken Field Weld

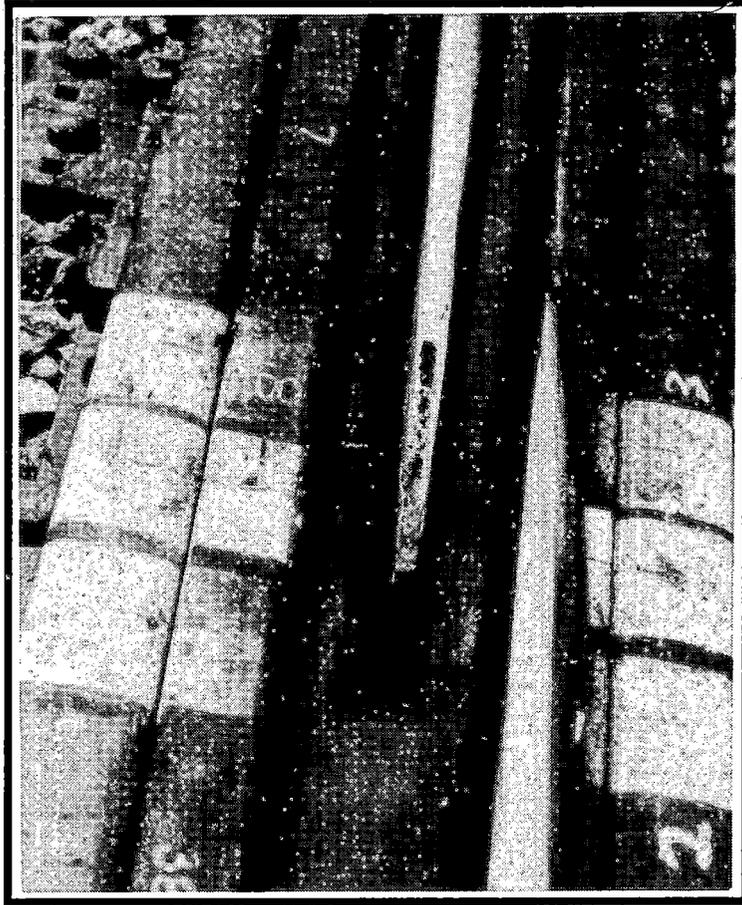
Under the HAL train operation, turnouts were second to field weld failures in the area of increased track maintenance. As with conventional field weld material, standard rail and frog components exhibited the shortest life and highest amount of maintenance and repair (Figure 14). Overall, turnouts required a significant increase in spot maintenance, grinding, and buildup requirements.

Figure 14. Typical Worn Frog Components
