***Federal Railroad Administration
Office of Railroad Safety
Accident and Analysis Branch***

***Accident Investigation Report
HQ-2015-1052***

***Amtrak (ATK)
Philadelphia, PA
May 12, 2015***

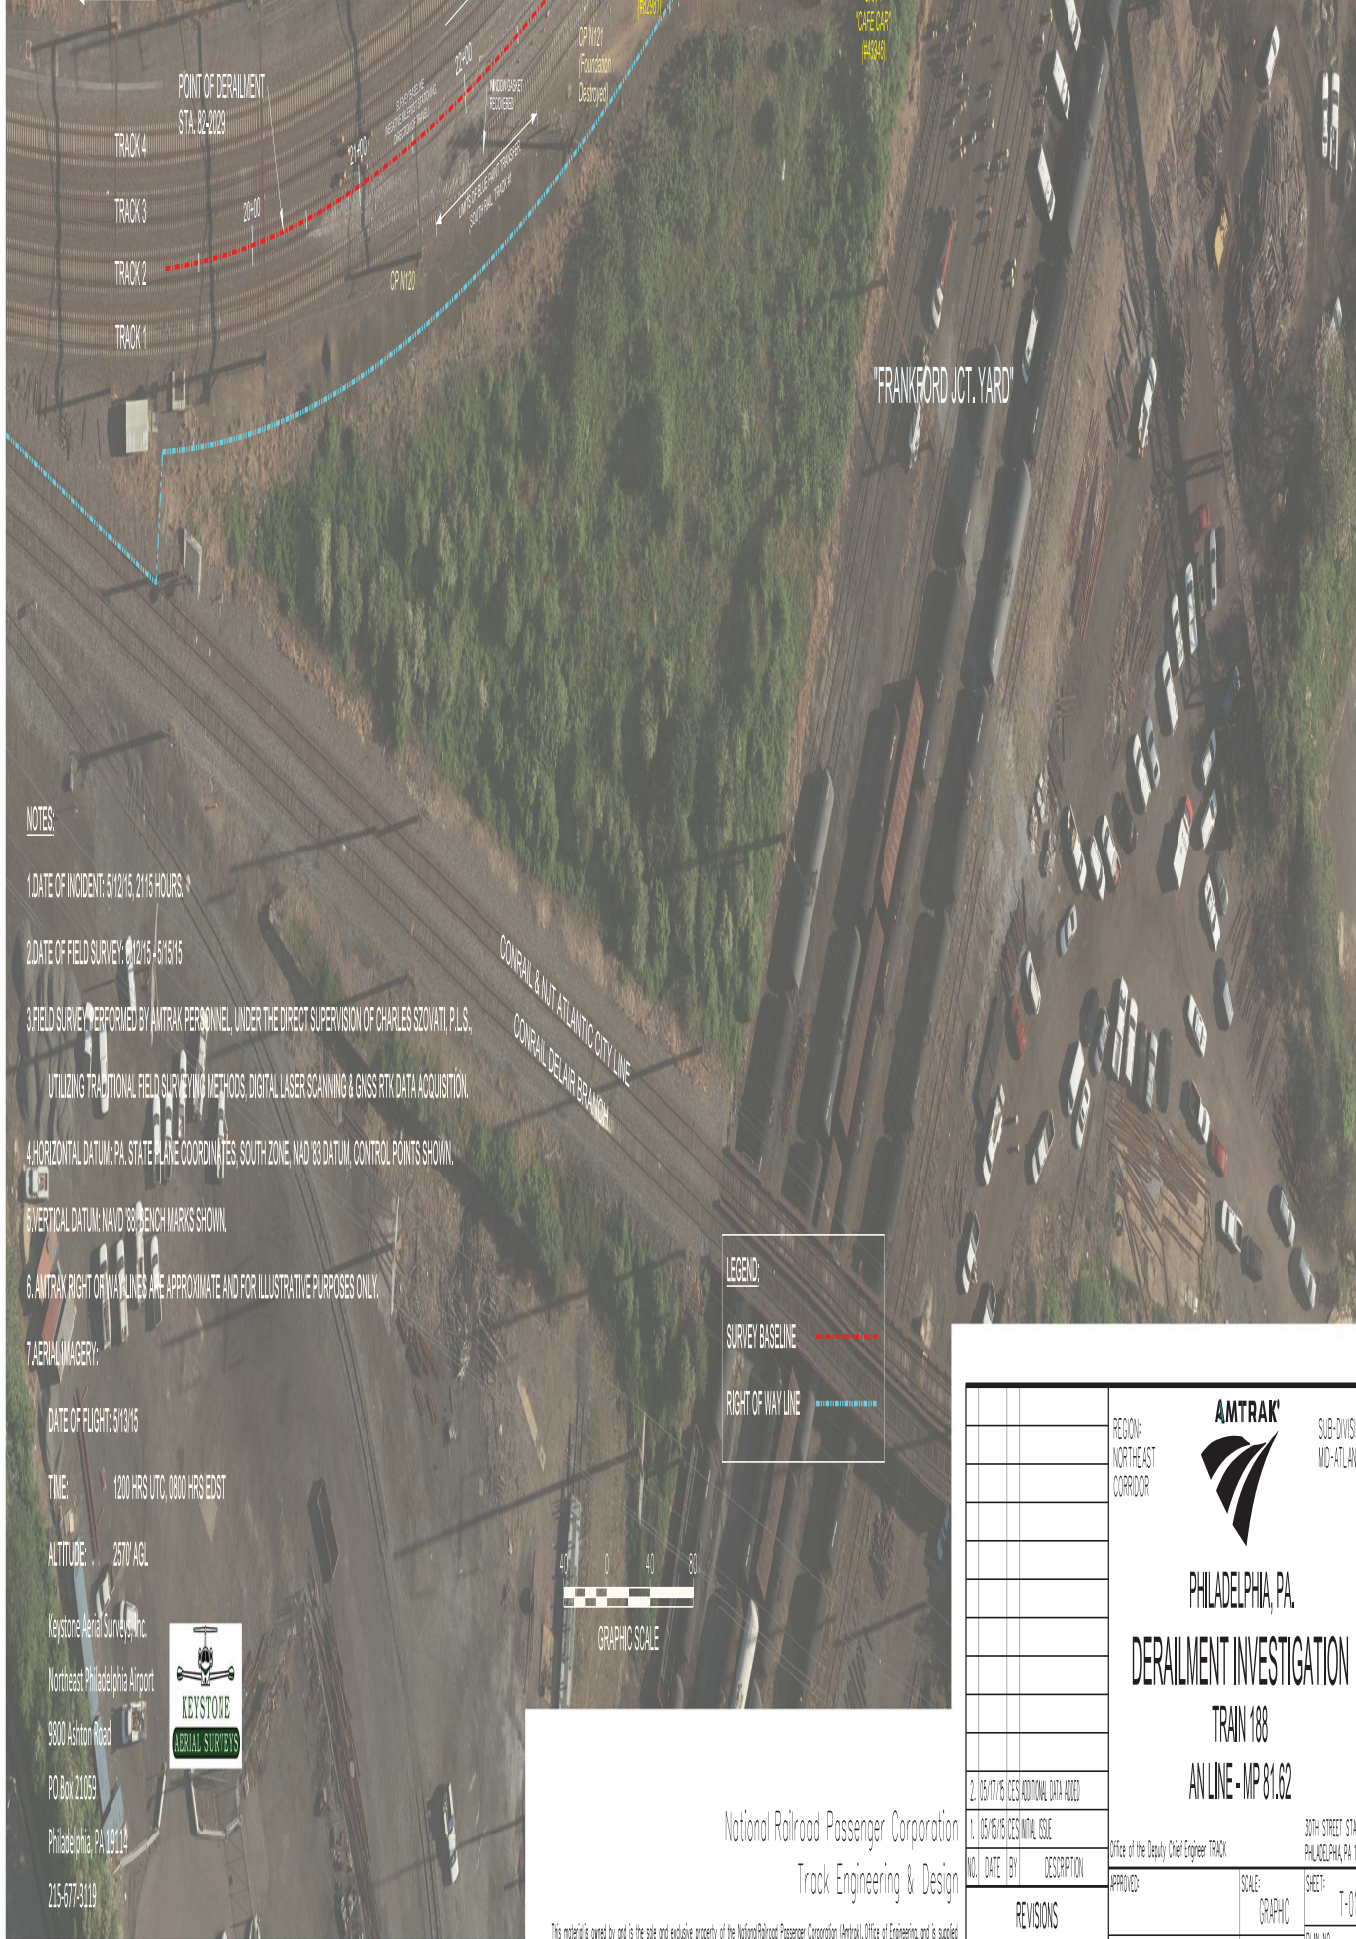
SUB-DIVISION: MD-ATLANTIC	
				PHILADELPHIA, PA.			
				DERAILMENT INVESTIGATION			
				TRAIN 188			
				AN LINE - MP 81.62			
2. 05/17/15 (CES) ADDITIONAL DATA ADDED				Office of the Deputy Chief Engineer, TRACK		30TH STREET STATION, PHILADELPHIA, PA 19104	
1. 05/15/15 (CES) INITIAL ISSUE				APPROVED:		SCALE: GRAPHIC	
NO. DATE BY DESCRIPTION				APPROVED:		SHEET: T-01	
REVISIONS				APPROVED:		DATE: MAY 15, 2015	
DESIGNED: C.E.S. CHECKED: C.W.H.						PLAN NO. 10239
