***Accident Investigation Report
HQ-2015-1007***

***Canadian Pacific Railway Company (CP)
Sherrill, IA
February 4, 2015***

FRA FACTUAL RAILROAD ACCIDENT REPORT

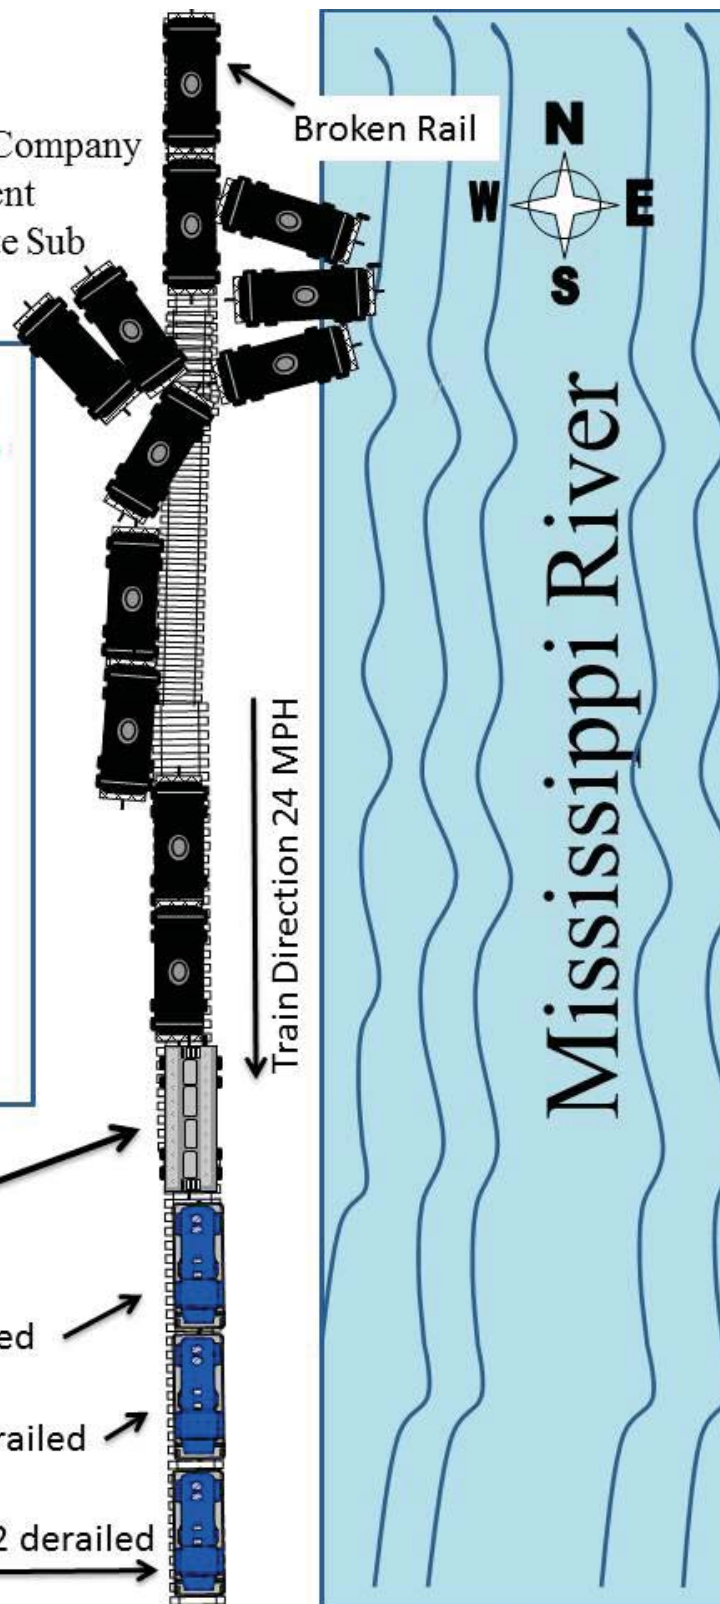
sketch

All Tanks releasing are DOT 111
Cars in Red released Hazmat
VMSX311153-a 1232 car -on side
CTCX730792 – ON SIDE
DBUX303187 – ON SIDE
NATX302997 – ON FIRE
NATX302743 – ON FIRE
CITX224195 – ON FIRE
NATX302867
CITX224244
CTCX730766 – ON SIDE
DBUX303073
CTCX730782
CITX730034
NATX302986
NATX364455

CMHX246528
HOPPER BUFFER CAR
FILLED WITH SAND

3rd Unit – DME 6069 derailed

2nd Unit KCS – 3905 not derailed

Lead Locomotive – NS 9052 derailed
