***Federal Railroad Administration
Office of Railroad Safety
Accident and Analysis Branch***

***Accident Investigation Report
HQ-2015-1094***

***BNSF Railway Company (BNSF)
Alma, WI
November 7, 2015***

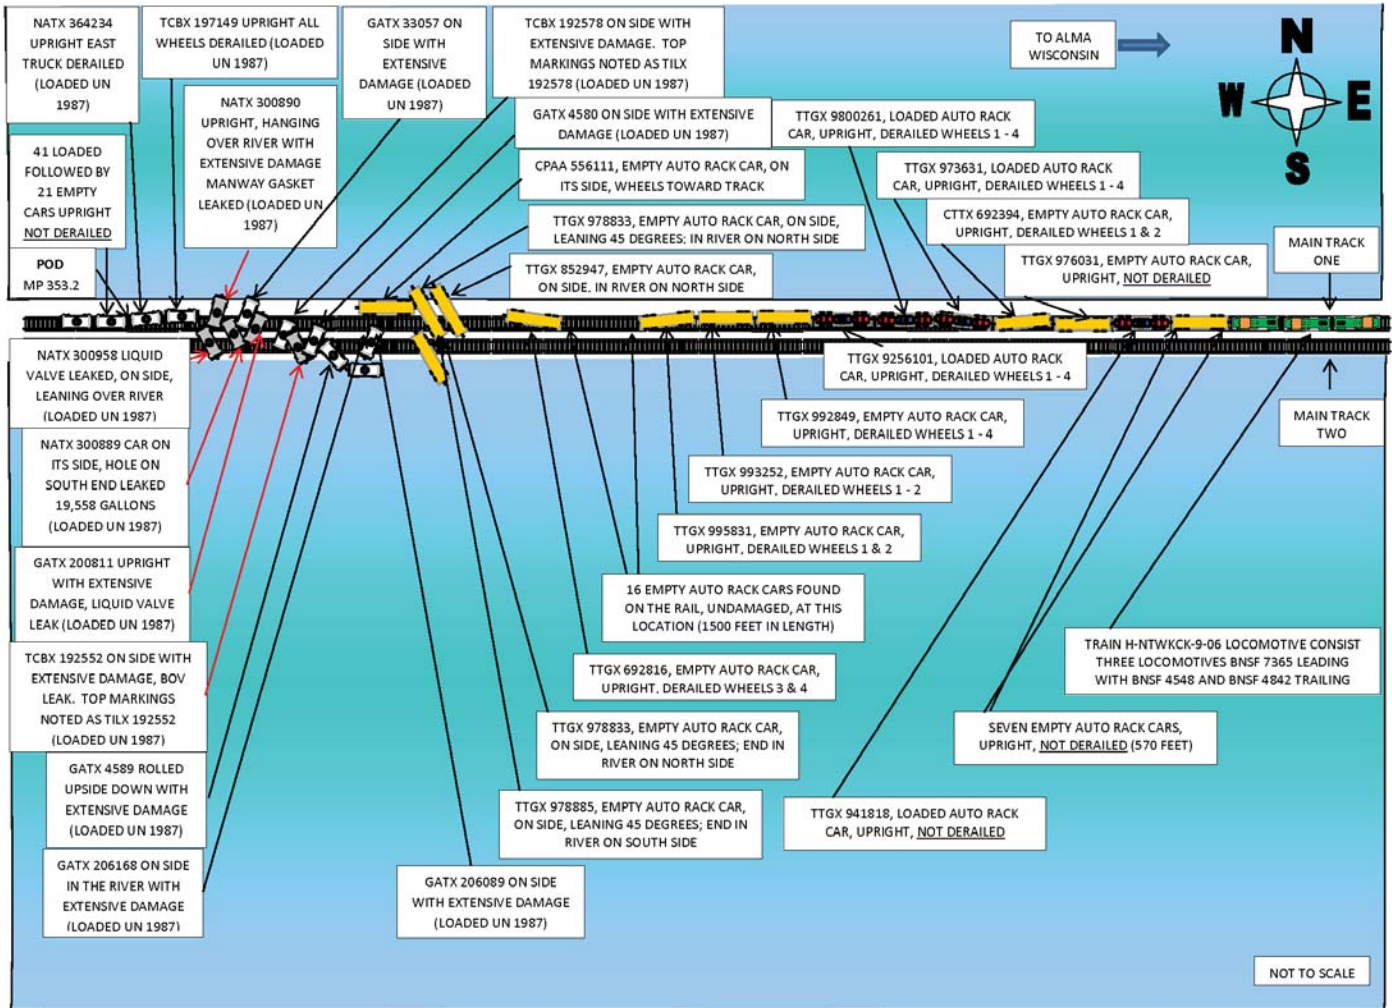
Alma Derailment Scene

The derailed cars were found in two sections of the train. As the rail cars were noted on the train consist, lines 10 through 16 were derailed, coupled together and upright. Lines 17 through 32 were not derailed. Cars 33 through 50 were derailed. Line 33 had two wheels on the ground and was upright. Line 34 was derailed on its side with the north-end of the car in the river. Lines 35 and 36 were derailed across both main tracks leaning at a 45-degree angle. Line 37 was derailed on its side between Main Track 1 and the Mississippi River, which flows immediately west of the tracks. The 13 loaded Alcohol, not otherwise specified (N.O.S.) cars were Cars 38 through 50 from the head-end of the train. Lines 38 through 48 were derailed sideways across both main tracks, with five of these cars leaking product. Lines 49 and 50 were derailed but still upright and coupled to the rear of the train. Line 10, Rail Car CTTX 692394, an empty auto transport car, appeared to have been lifted up off the rail or rolled the rail over at Milepost (MP) 353.2 due to buff force. This action began the derailment.
