***Federal Railroad Administration
Office of Railroad Safety
Accident and Analysis Branch***

***Accident Investigation Report
HQ-2015-1100***

***Amtrak (ATK)
New Iberia, LA
December 22, 2015***

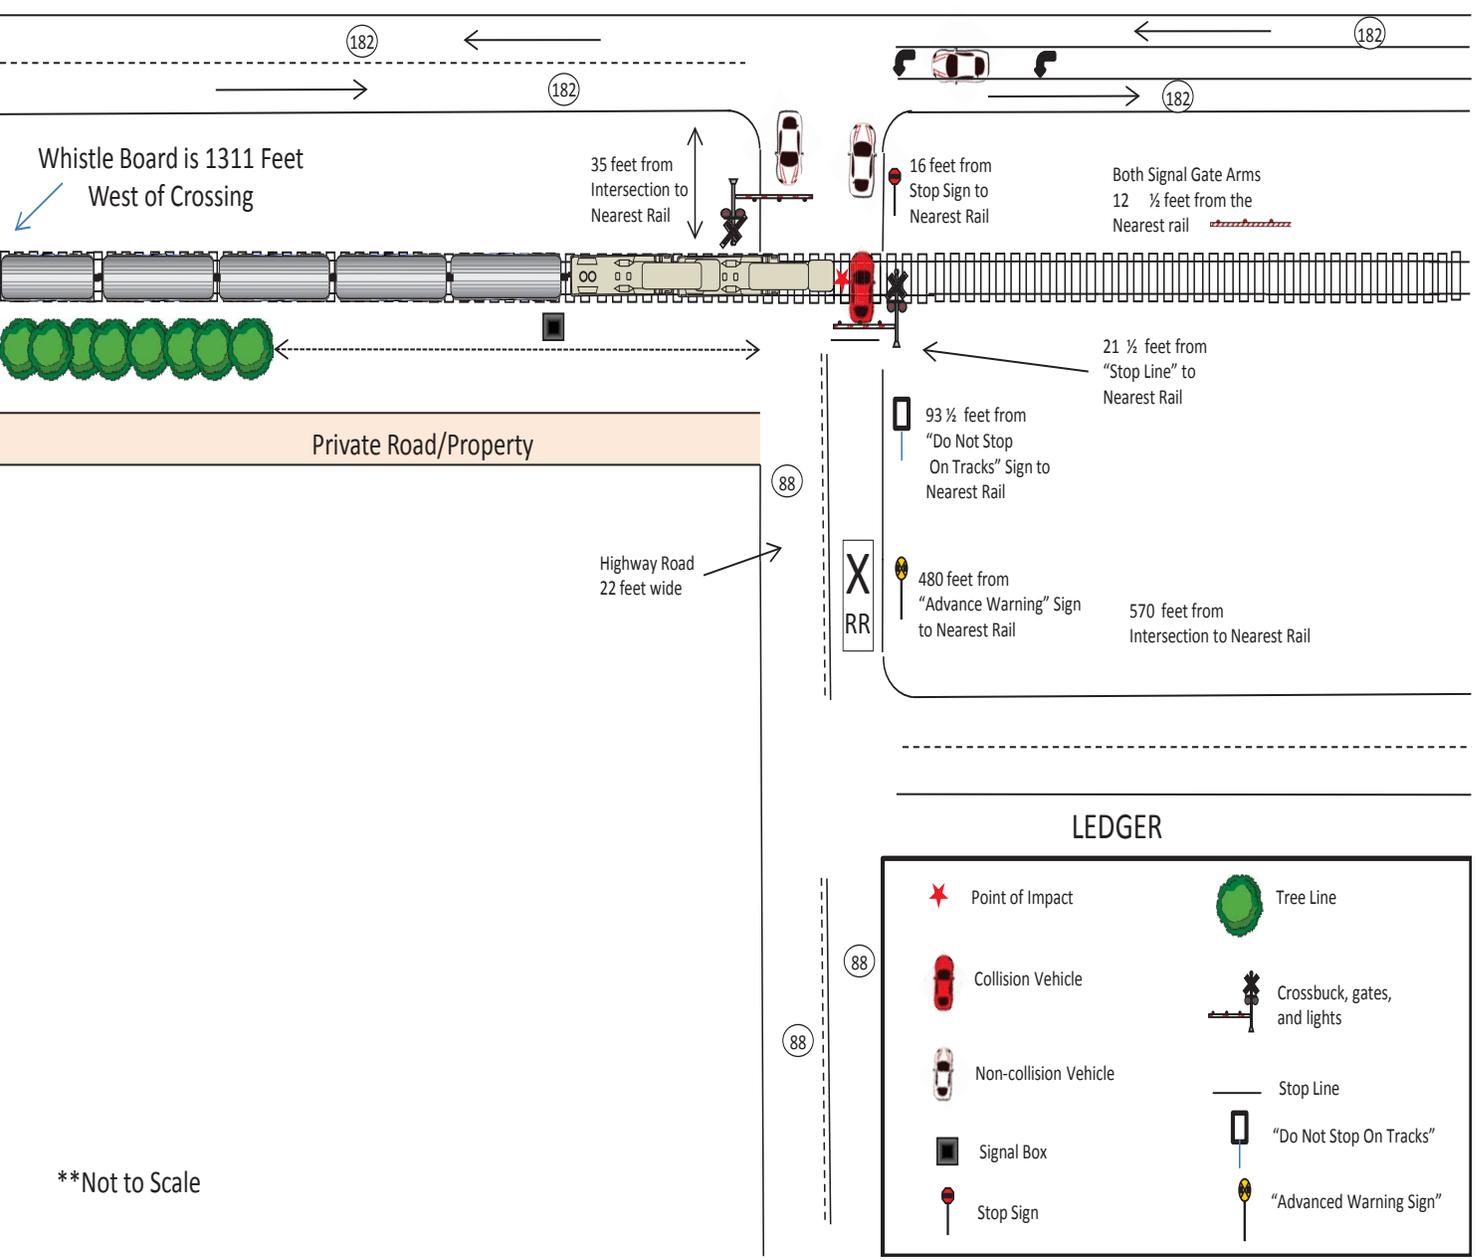
Sketch, Iberia Parish, Louisiana (AMTRAK) Quintuple Fatality (DOT 767687R)

The automobile driver was facing north on the tracks at the time of the collision. The automobile driver (V1) stopped on the crossing, backed up slightly, and then pulled forward on the crossing and remained stationary prior to the impact.

According to a witness (W1) on Louisiana State Highway 182 waiting to turn left onto Louisiana Highway 88 and the train crew, there was a vehicle (V2) north of the crossing on Louisiana State Highway 88 in front of the incident vehicle waiting at the "Stop" sign. W1 also stated that the incident vehicle driver was sounding her horn attempting to make V2 move so V1 could clear the tracks. V2 did not move.

The train impacted the front portion of the four-door automobile while the automobile was between the gates at the crossing. The automobile traveled in a southwest direction, rotating and overturning an unknown amount of times before coming to rest 176 feet from the area of impact. The front of the automobile came to rest against a tree and was resting on its tires. After impact, the train continued southeast on the tracks and the engine came to rest 1601 feet from the area of impact. Personnel from the Louisiana State Police Troop I, Iberia Parish Sheriff's Office, Coteau Fire District, Acadian Ambulance, and the Iberia Parish Coroner responded to the scene. Acadian Ambulance transported three occupants to the hospital. The Iberia Parish Coroner's Office pronounced three occupants dead on the scene. All six occupants were ejected from the automobile. Three occupants sustained fatal injuries on the scene. Two occupants succumbed to their injuries within days in the hospital. Only one occupant survived the collision. The damage amount to the rail equipment was \$6,093. The damage amount to the automobile was \$15,000.
