***Federal Railroad Administration  
Office of Railroad Safety  
Accident and Analysis Branch***

***Accident Investigation Report  
HQ-2014-1049***

***CSX Transportation (CSX)  
Vandalia, IL  
October 30, 2014***

Vandalia, IL October 30,  
2014  
CSX Eastbound Freight –  
Struck Southbound SUV

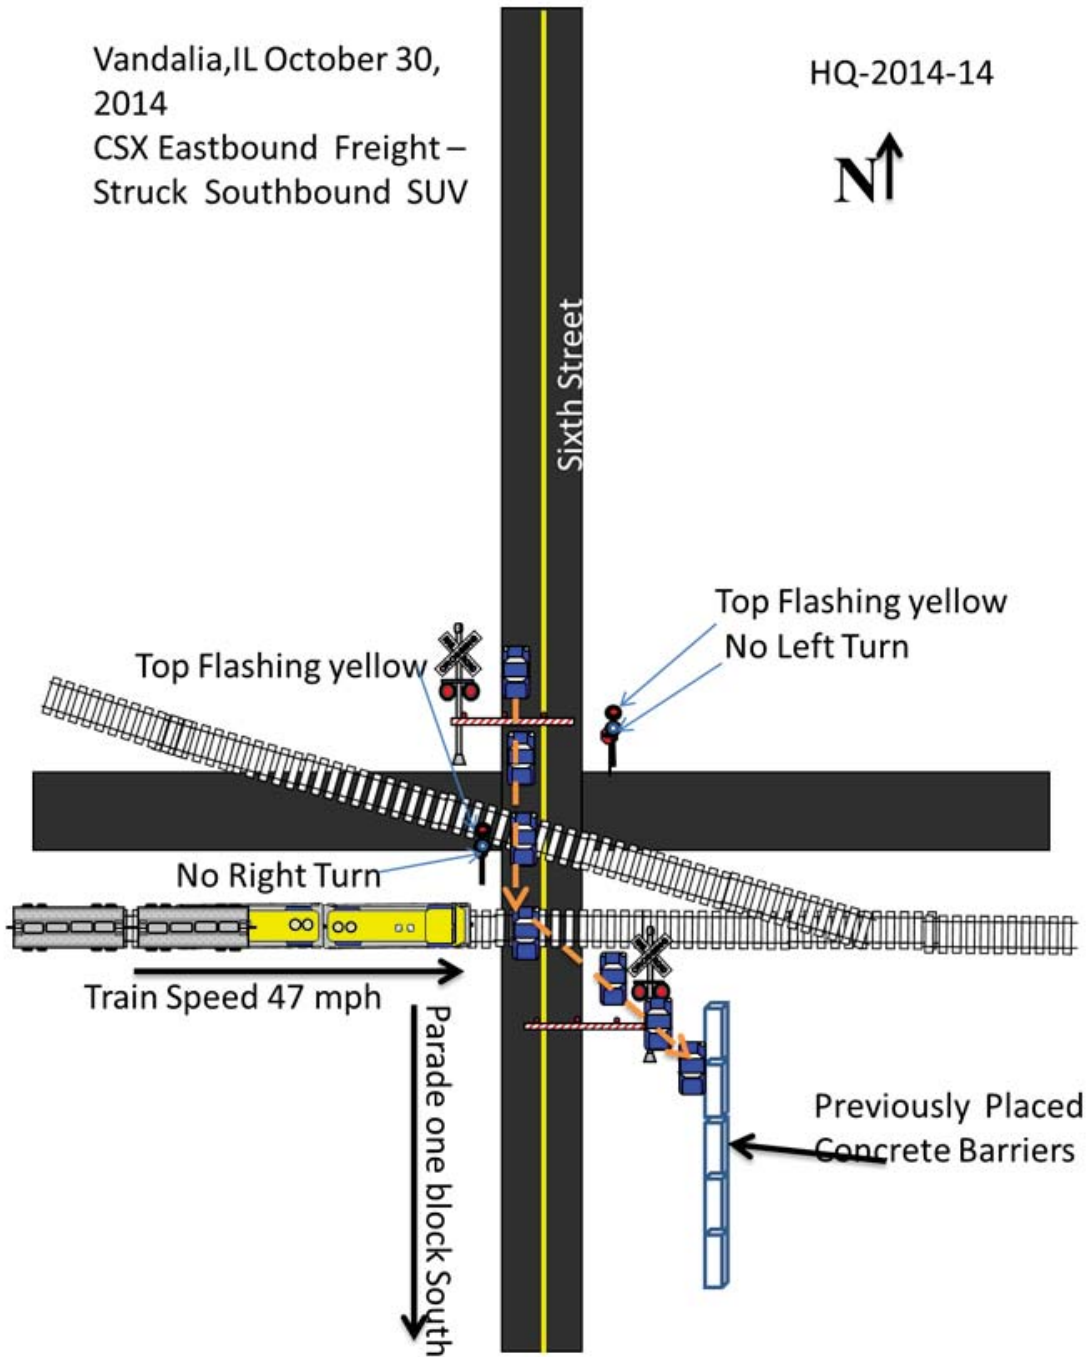
Sketch of Scene

The lead locomotive struck the right side toward the rear of the motor vehicle. The vehicle then spun clockwise as it separated from the train. The front passenger portion of the vehicle then struck the signal post/crossing gate at the southeast corner of the crossing. The vehicle continued to spin clockwise until it came to rest facing southwest with the driver's side rear tire pinned against a concrete barrier. During the impact with the crossing gate/signal pole, the male seated in the driver's side third row seat was ejected through the rear window and landed approximately 60 feet south of the tracks and against the concrete barrier. The crossing gate/signal post broke and came to rest on top of the vehicle.
