***Federal Railroad Administration  
Office of Railroad Safety  
Accident and Analysis Branch***

***Accident Investigation Report  
HQ-2015-1008***

***Union Pacific Railroad Company (UP)  
McGrew, NE  
February 11, 2015***

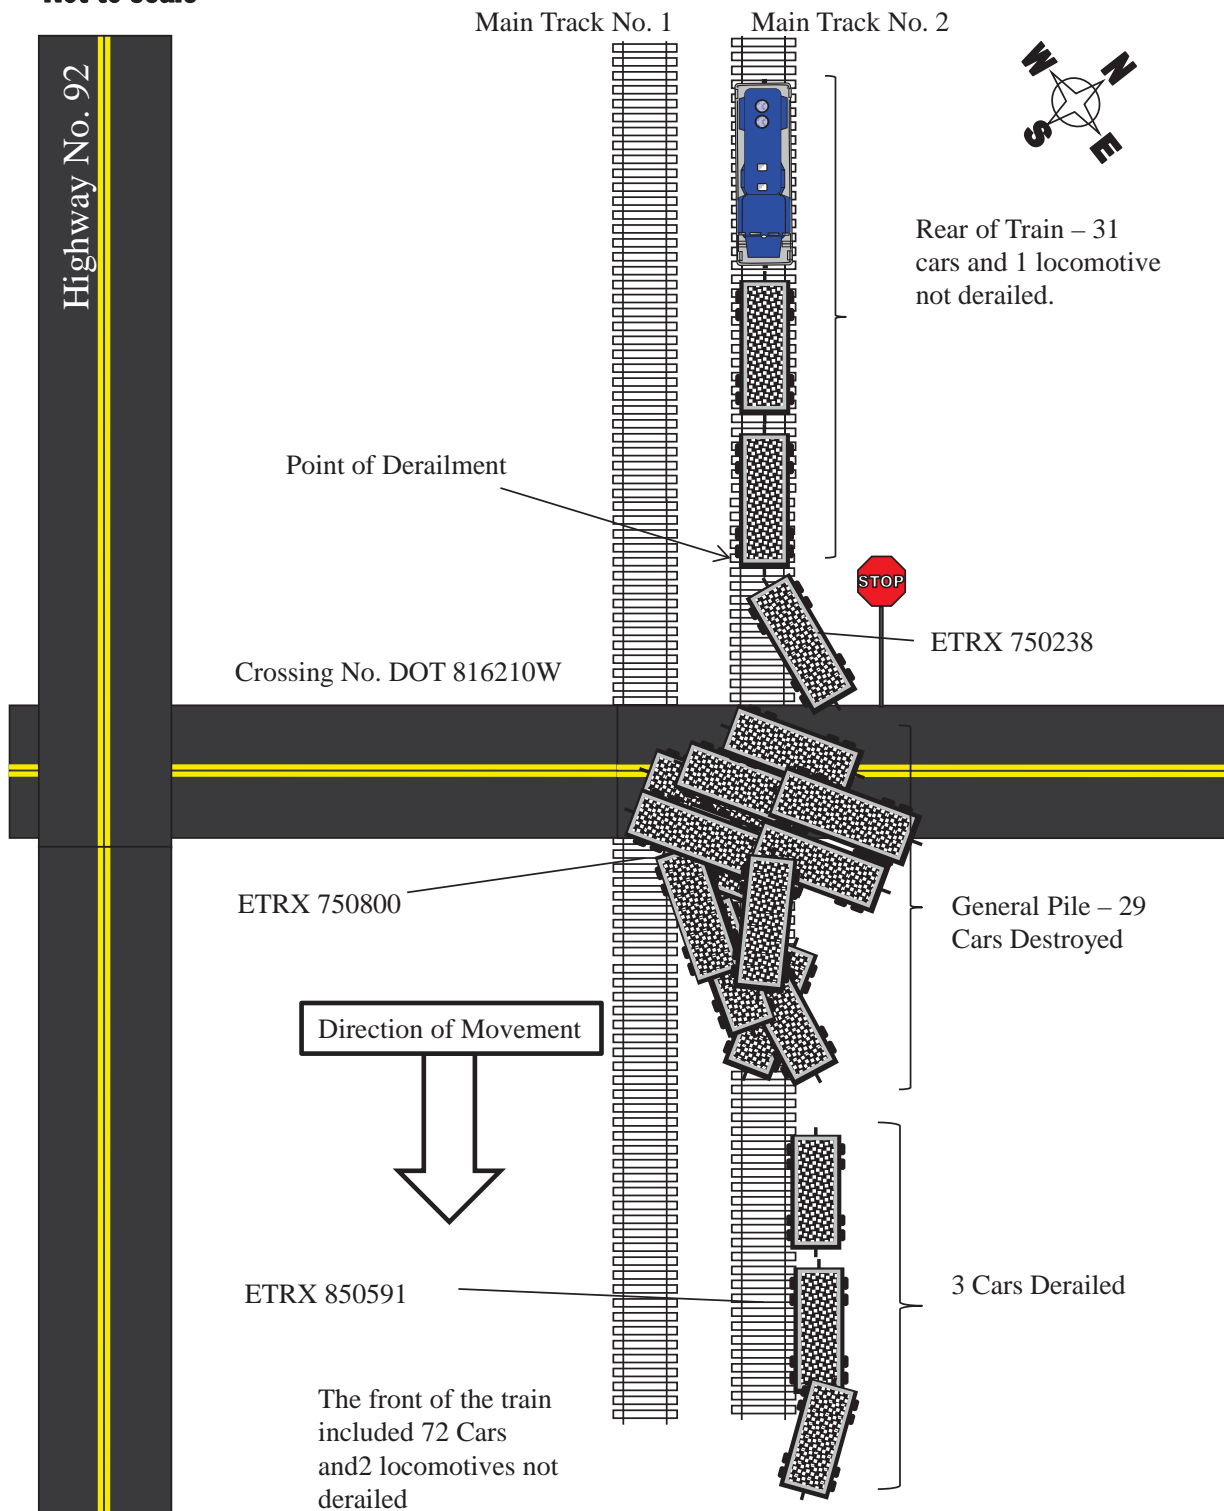
HQ-2015-1008 Sketch

After the accident, a walking inspection discovered marks on top of the north rail and then on the ties consistent with wheel flange markings. The markings were in the direction of travel some 100 feet prior to the crossing and this was deemed the point of derailment (POD).
