***Federal Railroad Administration
Office of Railroad Safety
Accident and Analysis Branch***

***Accident Investigation Report
HQ-2015-1095***

***Canadian Pacific Railway Company (CP)
Watertown, WI
November 8, 2015***

FRA FACTUAL RAILROAD ACCIDENT REPORT

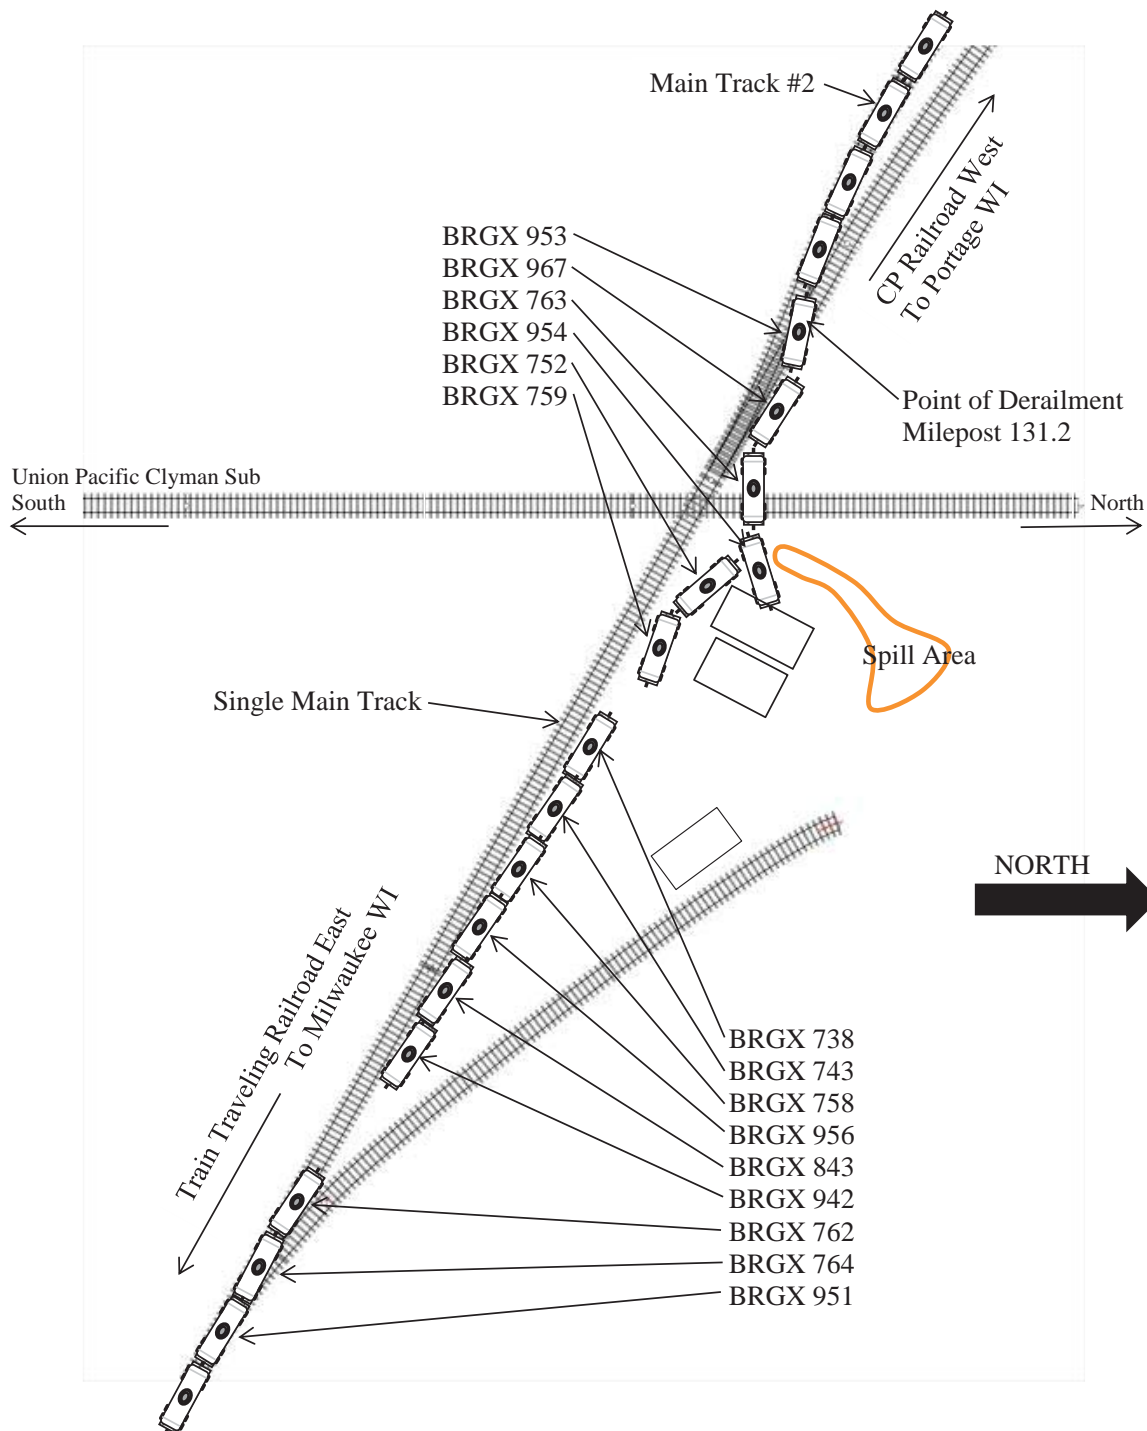
Derailment Sketch

HQ-2015-1095: CP Derailment at Watertown, WI
Watertown Subdivision November 8, 2015
