***Federal Railroad Administration
Office of Railroad Safety
Accident and Analysis Branch***

***Accident Investigation Report
HQ-2015-1089***

***Amtrak (National Railroad Passenger Corporation) (ATK)
Northfield, VT
October 5, 2015***

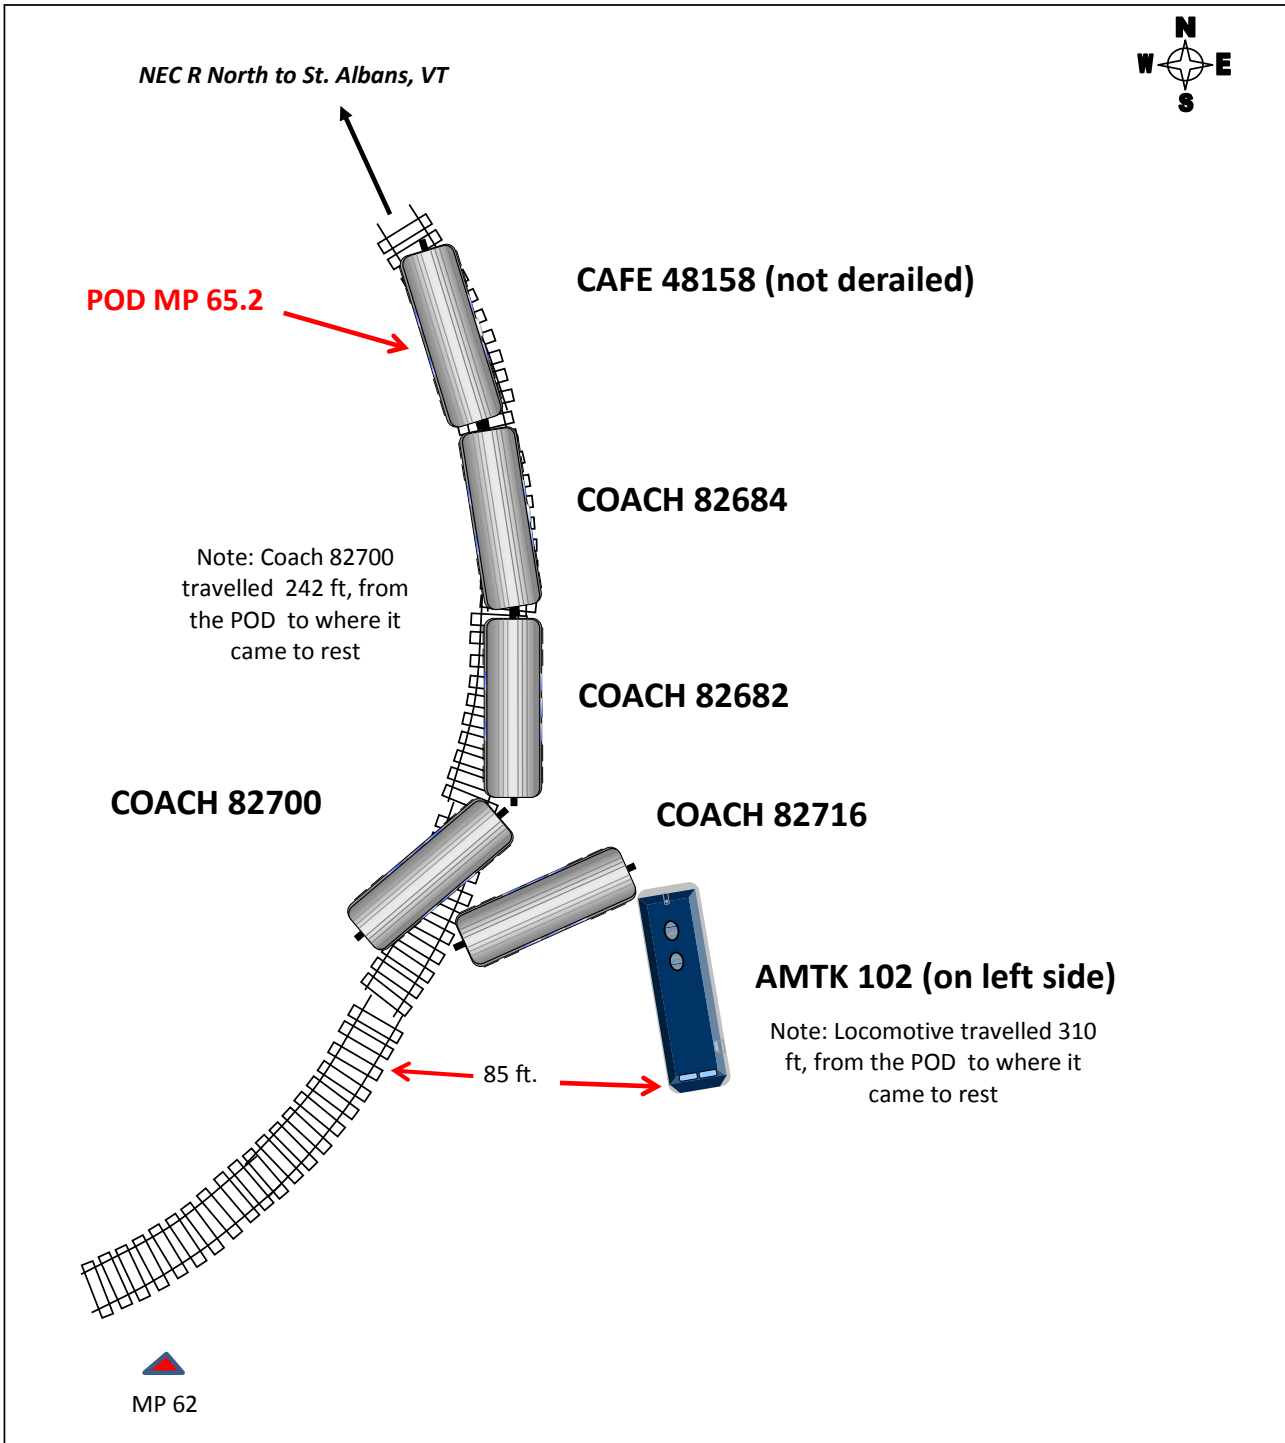
Derailment sketch

Sketch of Derailment of Amtrak Train 55
MP 65.2 NECR Roxbury Subdivision Northfield, VT
October 5, 2015
