U.S. Department
of Transportation
**Federal Railroad
Administration**

RR 17-10 | September 2017

Bridge Approach Remedies Implemented at Western Mega Site

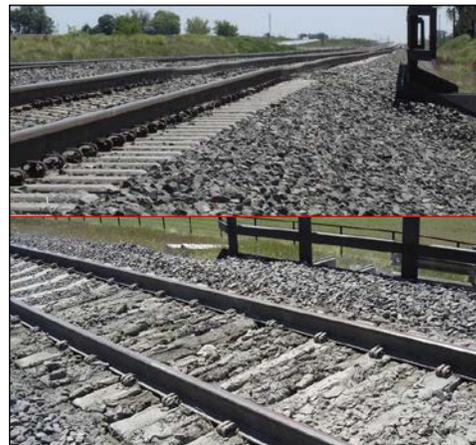
Before remediation, these two locations required localized maintenance work on a quarterly basis (approximately 63 Million Gross Tons [MGT]) due to excessive track geometry degradation, mud pumping, and track component failure—see Figure 1. After remediation, no localized maintenance (except regularly programmed surfacing operations for the entire line) was required for more than 1,000 MGT, which indicated that the problems were effectively addressed.

It was discovered that both bridge locations had problems with high track stiffness and low track damping at the track on the bridges, which adversely affected dynamic vehicle-track interaction when differential track settlement started to occur at the bridge approaches.

Figure 1 - Rough Track Geometry and Mud Pumping Associated with Bridge Approaches

The track at bridge approaches inherently deforms and settles more under HAL train operations than the track on the bridge, since the track structure is changing from the open track to the bridge. In general, for the track on the bridge, there is less ballast, no subballast, and obviously no subgrade foundation, as compared to the adjacent open track. As a result, differential track settlement (see Figure 1) occurs along the track, leading to higher dynamic vehicle-track interaction.

The two bridges were given different remediation strategies: concrete ties fitted with rubber pads on the bottom surface were used for one location, and ballast mats between the ballast layer and bridge deck were used for the other. Both strategies were designed to reduce track stiffness and increase track damping for the track on the bridge. For both bridges, the ballast section was increased to a minimum depth of 12 inches below the bottom of the ties. In addition, drainage improvement was made to ensure that water would not accumulate on the bridges or in the approaches.

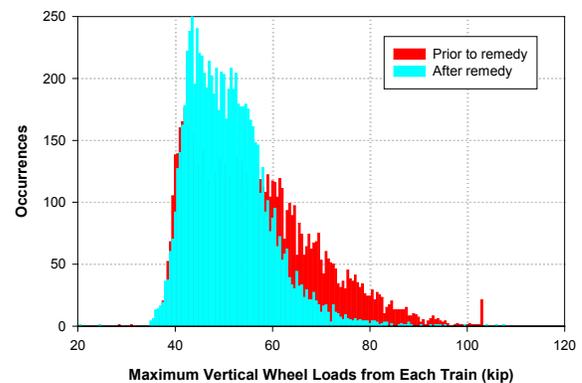
In some cases, differential track settlement, in conjunction with high track stiffness and low track damping, can produce a vicious cycle that leads to higher dynamic wheel-rail forces, larger differential track settlement, degradation of ballast particles, and mud pumping when the track drainage condition is poor. Figure 1 shows an example of mud pumping. At one of the western mega site bridge locations, the maximum dynamic wheel loads generated was three times as high as the static wheel loads (Figure 2).

Figure 2 - Maximum Dynamic Wheel Loads at a Bridge Location Measured Before and After Remediation

At the first bridge location, dynamic responses were measured before and after remediation and as a result of improved track geometry, track stiffness, and damping characteristics, Figure 2 shows a considerable reduction of maximum dynamic impact forces, especially in the range of 60,000 to 105,000 pounds.

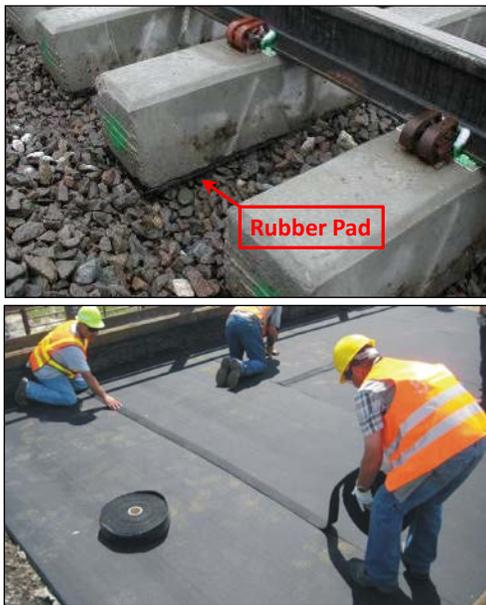
Figure 3 - Concrete Ties Fitted with Rubber Pads (Top) and Ballast Mat Installation (Bottom)

It was determined that an effective remediation method would need to reduce track stiffness and increase track damping for the track on the bridge to be at levels consistent with that of open track. In addition, improved track drainage is an essential part of remediation. Note that there was no poor subgrade in the bridge approaches causing problems for the locations investigated at the western mega site. As such, soil improvement and stabilization were not included as part of the remediation.

In September 2007, a short single-span ballast deck concrete bridge was reconfigured with concrete ties fitted with rubber pads on the bottom surface (Figure 3 top) and in June 2009, a 3-span ballast deck steel bridge was reconfigured with a ballast mat installed between the ballast layer and the bridge deck (Figure 3 bottom). As part of the remediation, degraded ballast was replaced with at least 12 inches of new ballast between the bottom of the ties and the surface of the bridge deck. At both bridge locations, measures were taken to ensure proper drainage for the track on the bridge as well as in the approaches.

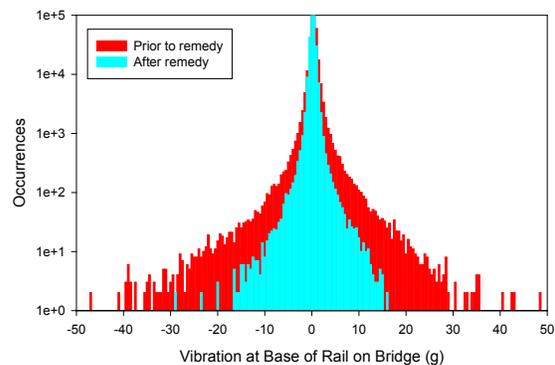
Consistent with what is shown in Figure 2, installation of the remedy led to a considerable reduction in high amplitude vibration expressed in terms of acceleration, e.g., from 50 g to 20 g for the vertical acceleration measured on the rails, as illustrated in Figure 4, indicating improved track component performance.

Figure 4 - Reduction of Vibration from Remedy

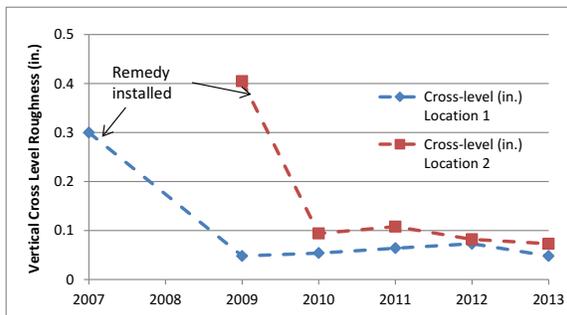
In Figure 5, track cross levels measured from track geometry inspection vehicles were processed as roughness from the years (2007 and 2009) when the installation of rubber pad and ballast mat remedies were completed. Both bridge locations show that track surface geometry conditions have improved during the time the two remedies were implemented.

Figure 5 - Track Geometry Roughness Improvement for Two Locations with Remediation
