***Federal Railroad Administration
Office of Railroad Safety
Accident and Analysis Branch***

***Accident Investigation Report
HQ-2016-1132***

***Amtrak ((National Railroad Passenger Corporation) ATK)
Flora, MS
May 18, 2016***

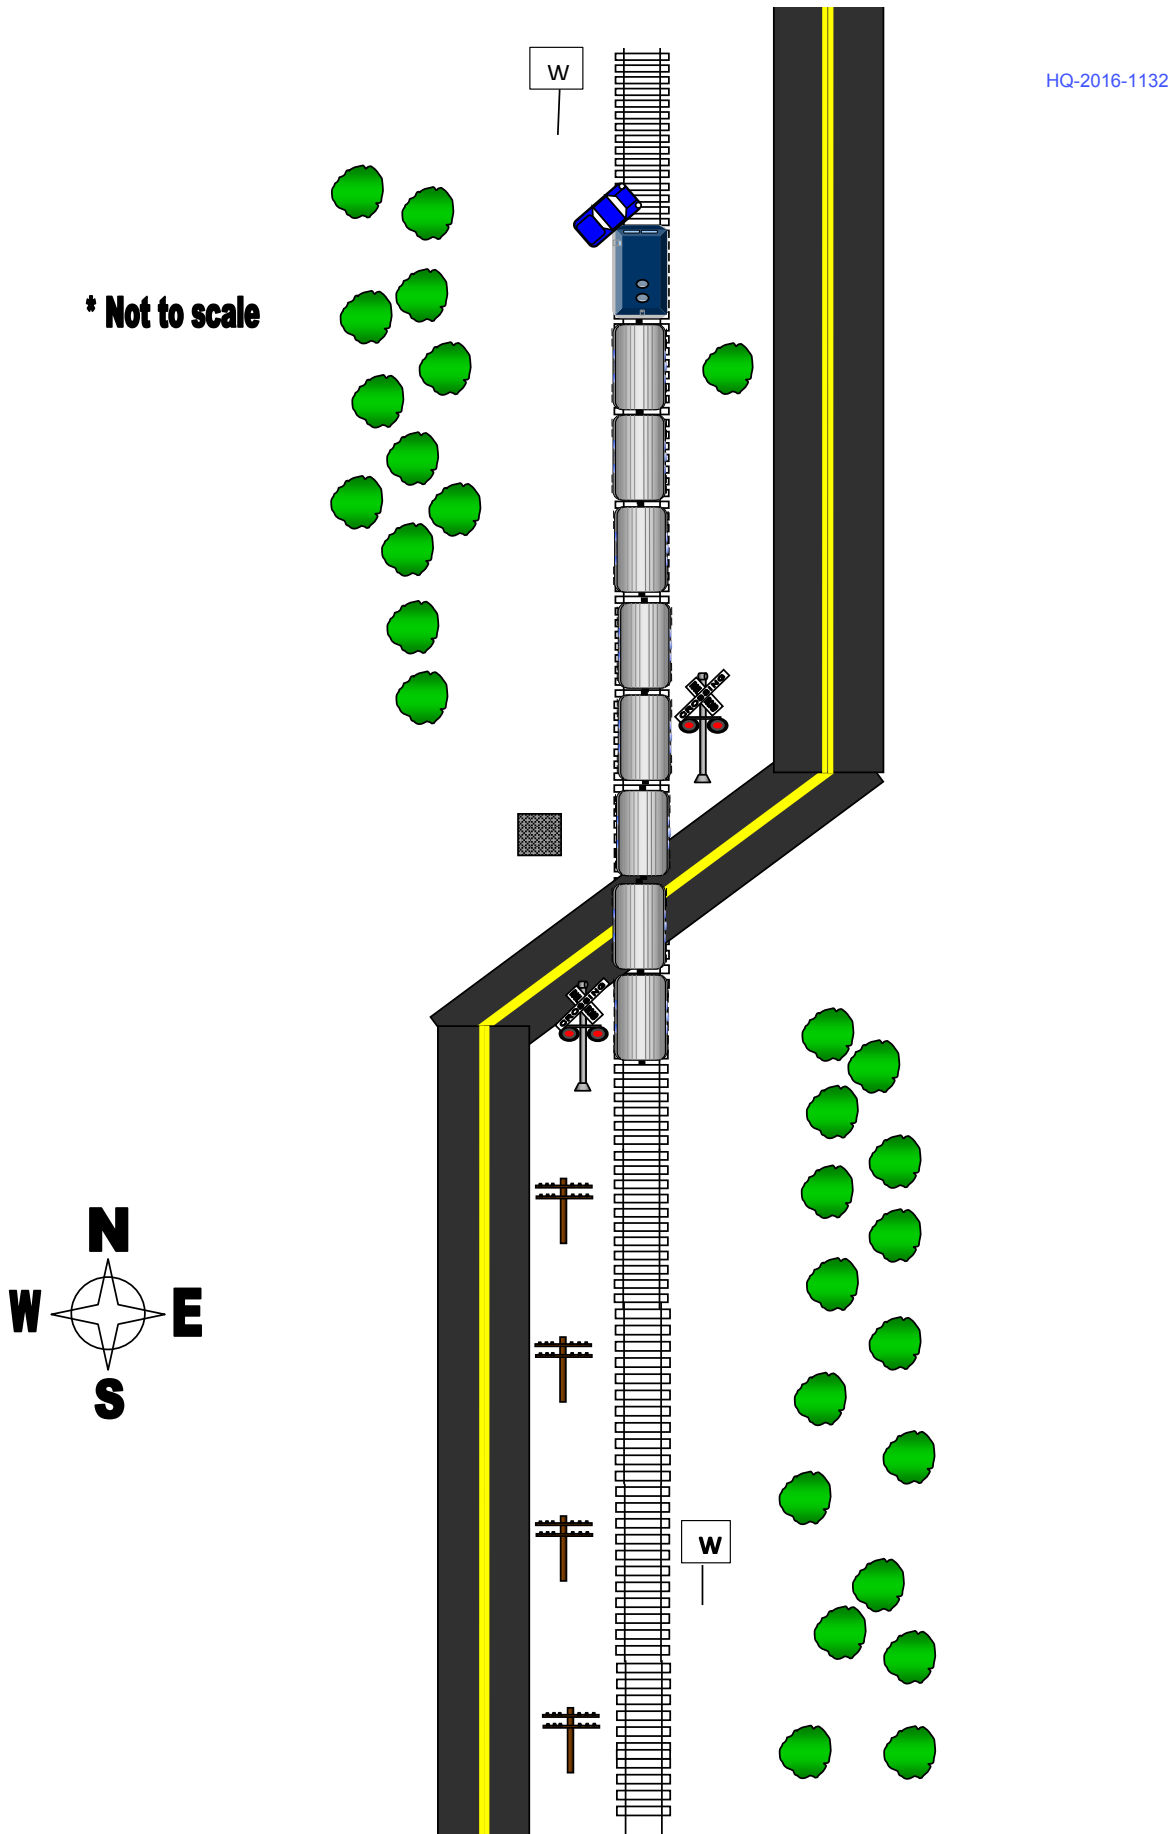
SKETCHES

Moving northward, Kearney Park Road parallels the west side of the main track for about $\frac{3}{4}$ -mile, crosses the main track at grade at approximately a 45-degree angle (northeast direction) at Milepost 200.6, and then parallels the east side of the main track for about 1-mile beyond. There is a slight grade at the crossing. The speed limit is 30 mph.

Kearney Park Road is a two-lane, paved city street with a posted speed limit of 30 mph. Travelling north on Kearney Park on the west side of the tracks, the road runs parallel to the tracks and intersects the crossing at approximately a 45-degree angle and then continues to run parallel to the tracks travelling north on the east side.

The site distance at the crossing when stopped at the painted stop bar on the west side looking north is approximately 1,500 feet (vegetation and trees are the reason the site distance is limited due to the degree of angle you are in when stopped at the stop bar) and looking south on the tracks is

approximately 4,000 feet or greater. The site distance at the crossing when stopped at the painted stop bar on the east side looking north is approximately 3,500 feet and looking south is approximately 4,000 feet or greater.
