***Federal Railroad Administration
Office of Railroad Safety
Accident and Analysis Branch***

***Accident Investigation Report
HQ-2016-1126***

***CSX Transportation (CSX)
Washington, DC
May 1, 2016***

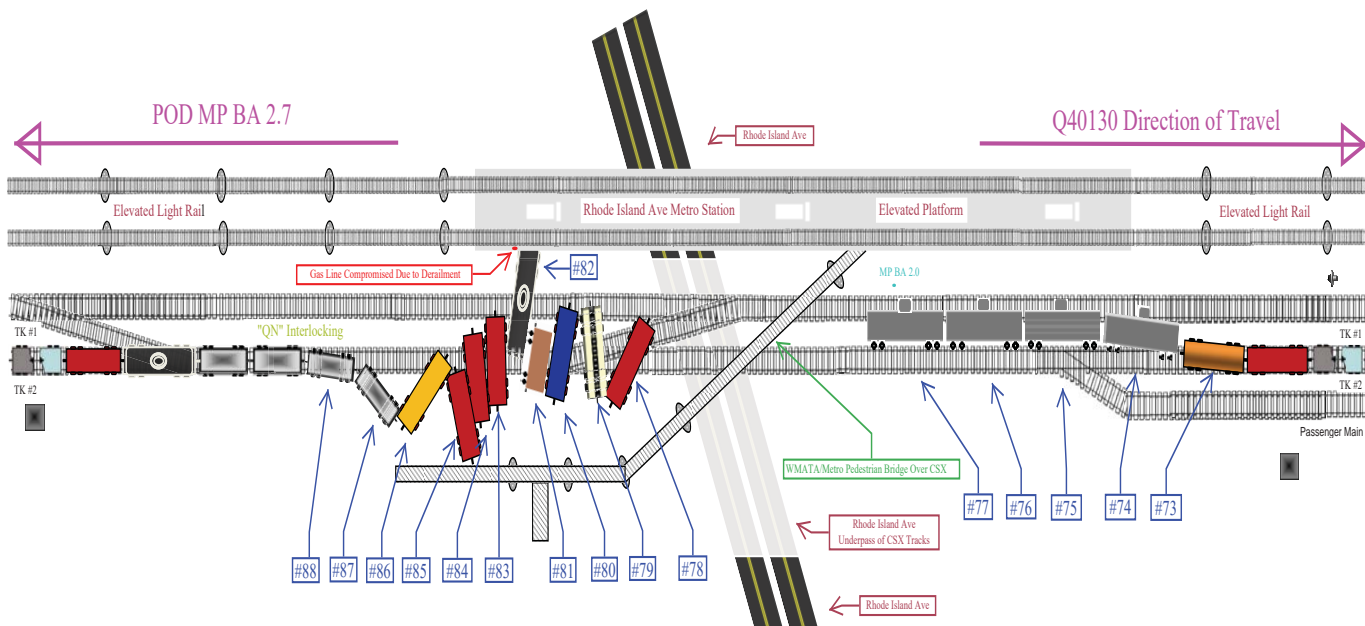
DERAILMENT SKETCH

- #73 NADX 815028 -Empty Covered Hopper
- #74 NATX 364047 -Loaded Tank Car -HAZMAT (Alcohol) Releasing 628 gallons of contents -Lying on side "Post Derailment"

- #75 UTLX 67096 -Loaded Tank Car -Calcium Chloride -Lying on Side "Post Derailment"
- #76 DPUX 17732 -Loaded Tank Car -Calcium Chloride -Lying on Side "Post Derailment"

- #77 UTLX 630894 -Loaded Tank Car -HAZMAT (Sodium Hydroxide) Releasing 729 gallons of contents -Lying on Side "Post Derailment"
- #78 CSXT 142619 -Empty Box Car

- #79 FURX 824097 -Empty Covered Hopper
- #80 CSXT 129969 -Empty Box Car
- #81 DREX 851 -Loaded Gondola Car -Scrap
- #82 NATX 401104 -Residue Tank Car -HAZMAT (Propane) -Intruded into WMATA/Metro "Right of Way"

- #83 NS 472306 -Empty Box Car
- #84 NS 472277 -Empty Box Car
- #85 BKTY 150737 -Empty Box Car -Left CSX "Right of Way" and made Incidental Contact with WMATA/Metro Pedestrian Bridge

- #86 BKTY 154883 -Empty Box Car
- #87 JTSX 900591 -Empty Hopper Car
- #88 JTSX 900521 -Empty Hopper Car
