***Federal Railroad Administration
Office of Railroad Safety
Accident and Analysis Branch***

***Accident Investigation Report
HQ-2016-1129***

***Amtrak ((National Railroad Passenger Corporation) ATK)
Madera, CA
May 16, 2016***

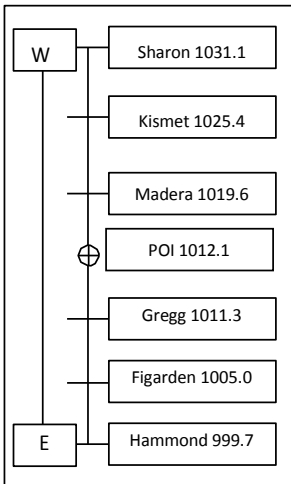
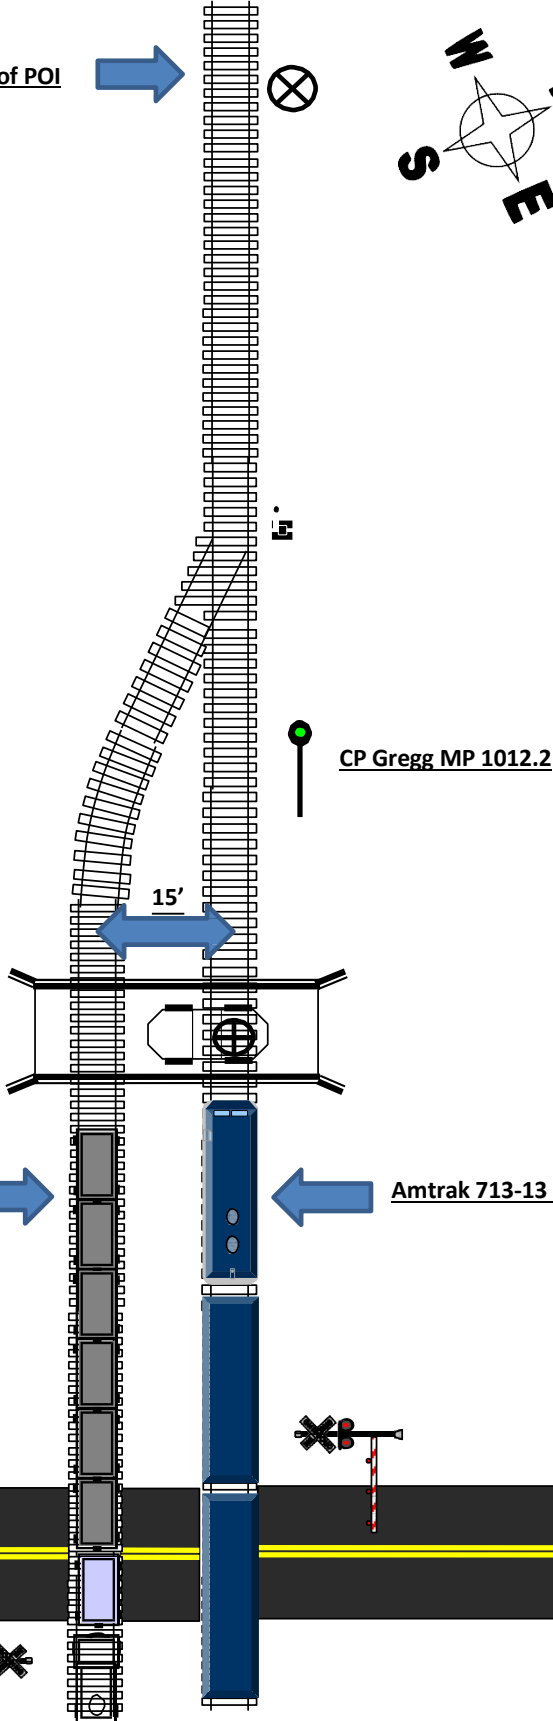
Madera Sketch

ATK713-13 came to rest 1,645' NW of POI

Private crossing DOT #028596W MP 1012.1

Standing BNSF ZNBYWSB7-131 EB

Amtrak 713-13 WB

9th Avenue DOT #028595P MP 1011.5
