***Federal Railroad Administration
Office of Railroad Safety
Accident and Analysis Branch***

***Accident Investigation Report
HQ-2015-1084***

***Union Pacific Railroad Company (UP)
Texarkana, TX
September 8, 2015***

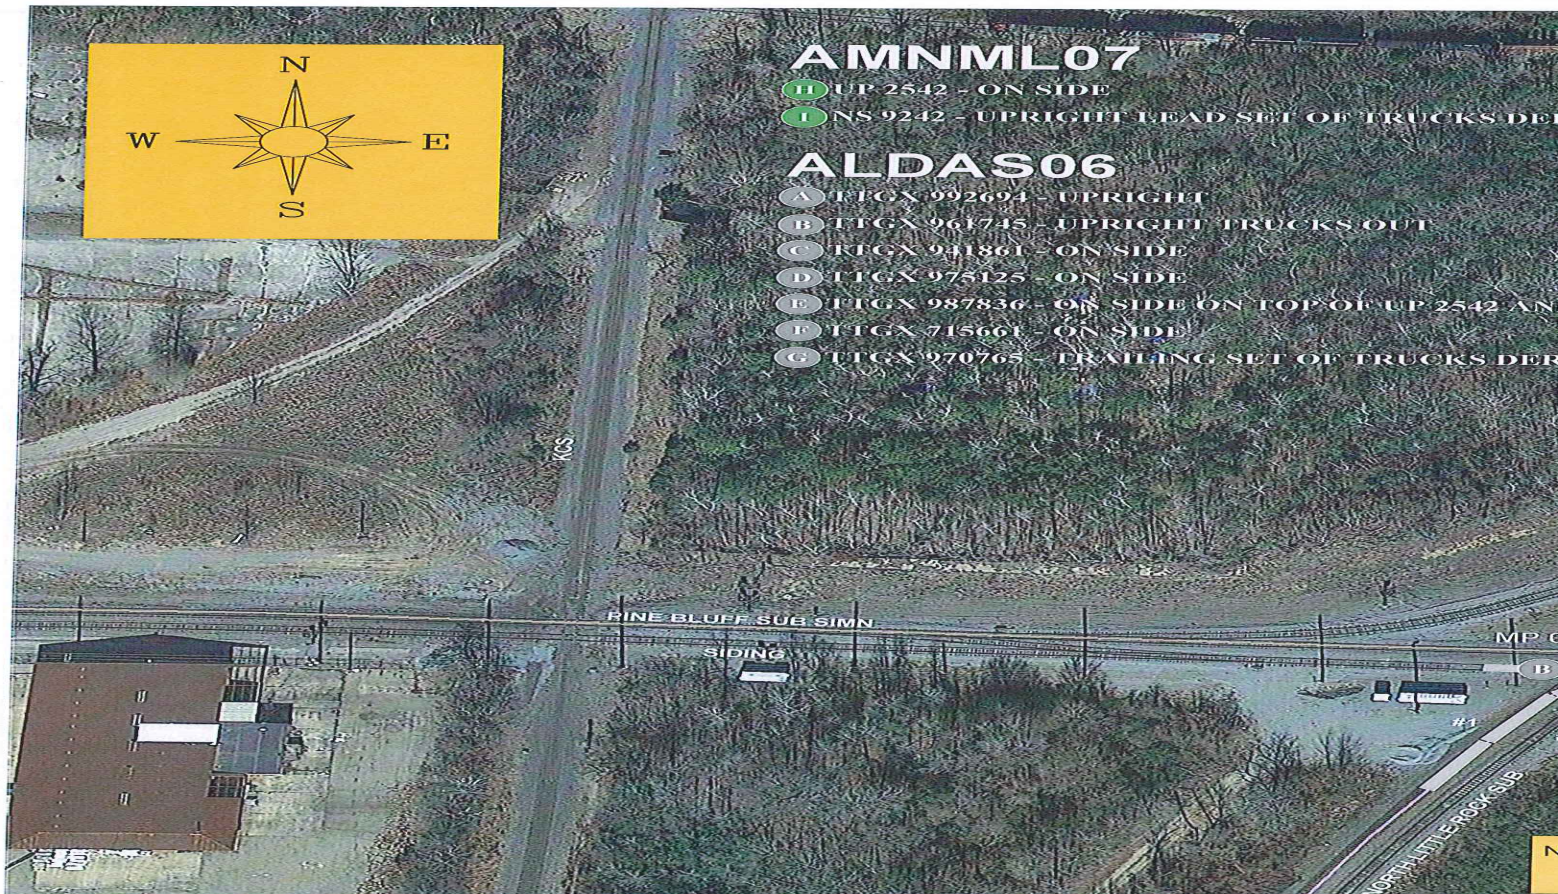
Sketch

At the time of the accident, both trains were located within the limits of the Texarkana Interlocking, located at MP 419.1 and governed by GCOR, timetable instructions, general orders, and signal indications of an interlocking. At MP 419.1, a single main track and a siding track of the Pine Bluff Subdivision crosses the two main tracks of the Little Rock Subdivision MP 0.5 at grade. The railroad timetable direction of the striking train was west and the railroad timetable direction of the struck train was north. Timetable directions are used throughout this report.

The locomotive of the striking train made impact with the thirteenth car of the struck train and derailed seven cars (cars 13-19 from the second locomotive in the consist) with one car, TTGX 987836, coming to rest on top of the striking train's lead locomotive. The struck train's speed at impact was 26 mph based on data from the event recorder of the lead locomotive. The struck train experienced an emergency braking application after the brake line connections were severed. The crew members of the struck train were not injured. Witnessing the collision, Texarkana's Yard Office located near the interlocking contacted the Conductor of the struck train immediately by radio and offered assistance. During this radio conversation with the Conductor, the Engineer of the struck train contacted UP's Dispatcher by cellular telephone to report the accident. Following their conversations, the crew members of the struck train secured their train by setting hand brakes on the locomotive and assisted in the emergency efforts.
