Office of Railroad Safety Summary Report

Derailment of Metro-North Passenger Train 8808

Spuyten Duyvil, Bronx, New York

December 1, 2013

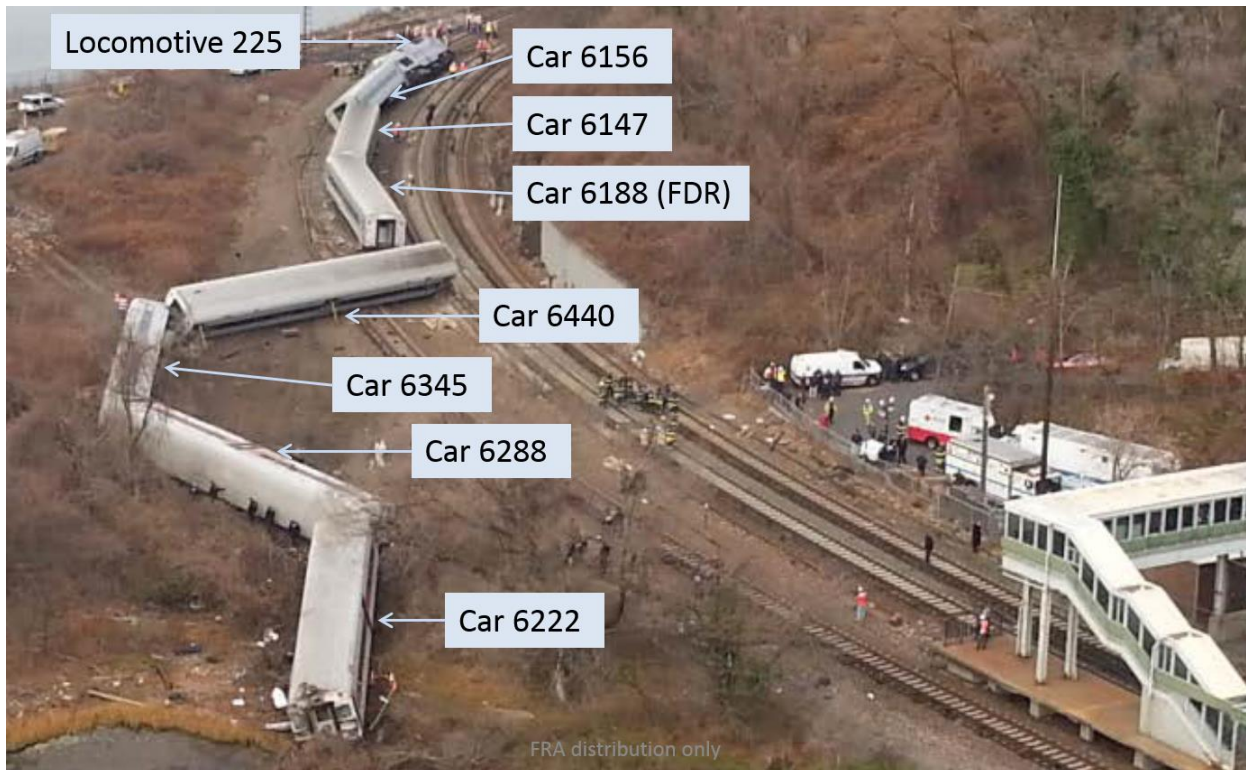
81 through seven derailed in the same manner. The first five cars rolled onto their right sides, then
82 the fourth car rolled over coming to rest leaning to the left. Cars one and five up-righted
83 themselves, while cars six and seven, as well as the locomotive, traveled through the debris field
84 at a 45-degree angle and were slowed by plowing into the ballast. The train traveled
85 approximately 880 feet from the point of derailment (POD) before coming to rest. When the
86 train came to rest, the first car, Cab Car 6222, was upright. The second and third car, 6228 and
87 6345 respectively, were on their right sides. The fourth car, 6440, rolled over completely and
88 was leaning at a 45-degree angle to the left. The fifth car, 6188, and the sixth car, 6147, were
89 upright with their wheels buried deep in the ballast. The seventh car, 6156, and Locomotive 225,
90 was leaning at a 45-degree angle on its right side. (Figure 1).

Figure 1: Aerial view of MNCW Passenger Train 8808 derailment

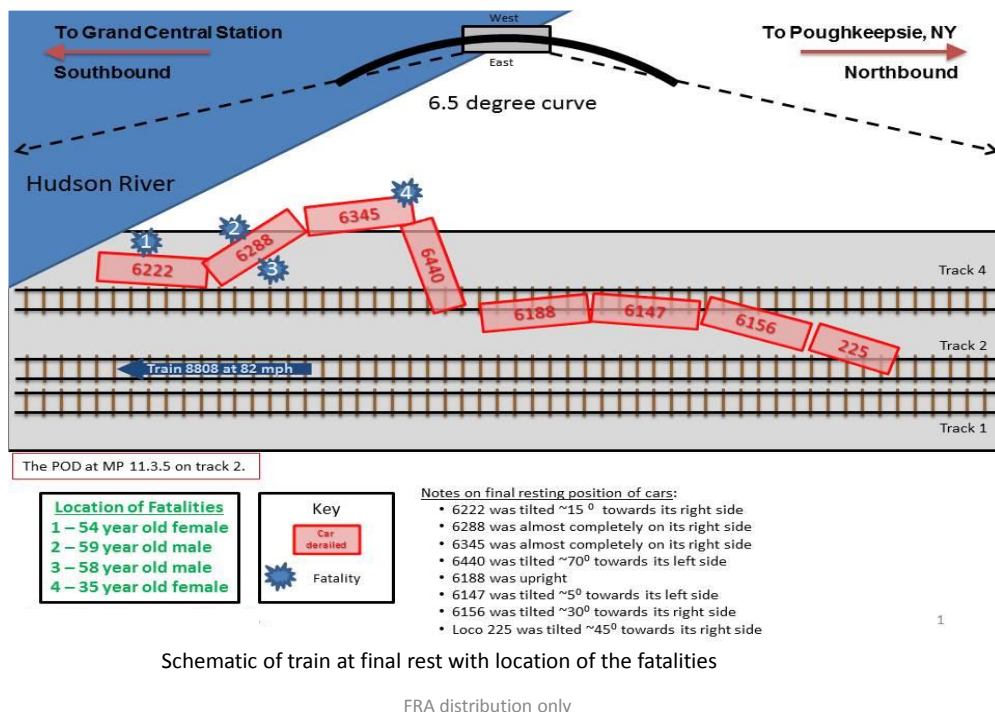
Figure 2: Derailment car and fatality locations

235 The forensics investigation determined all the fatally injured passengers were ejected from the
236 train via windows during the derailment. All train occupants that were contained within the cars
237 survived the derailment. Results of the forensics investigation indicate the rubber gaskets
238 holding the window panes in place were pulled out when the cars slid on their sides and the
239 windows were pushed inside the cars creating openings.
