***Federal Railroad Administration
Office of Railroad Safety
Accident and Analysis Branch***

***Accident Investigation Report
HQ-2016-1165***

***CSX Transportation (CSX)
Chester, PA
October 28, 2016***

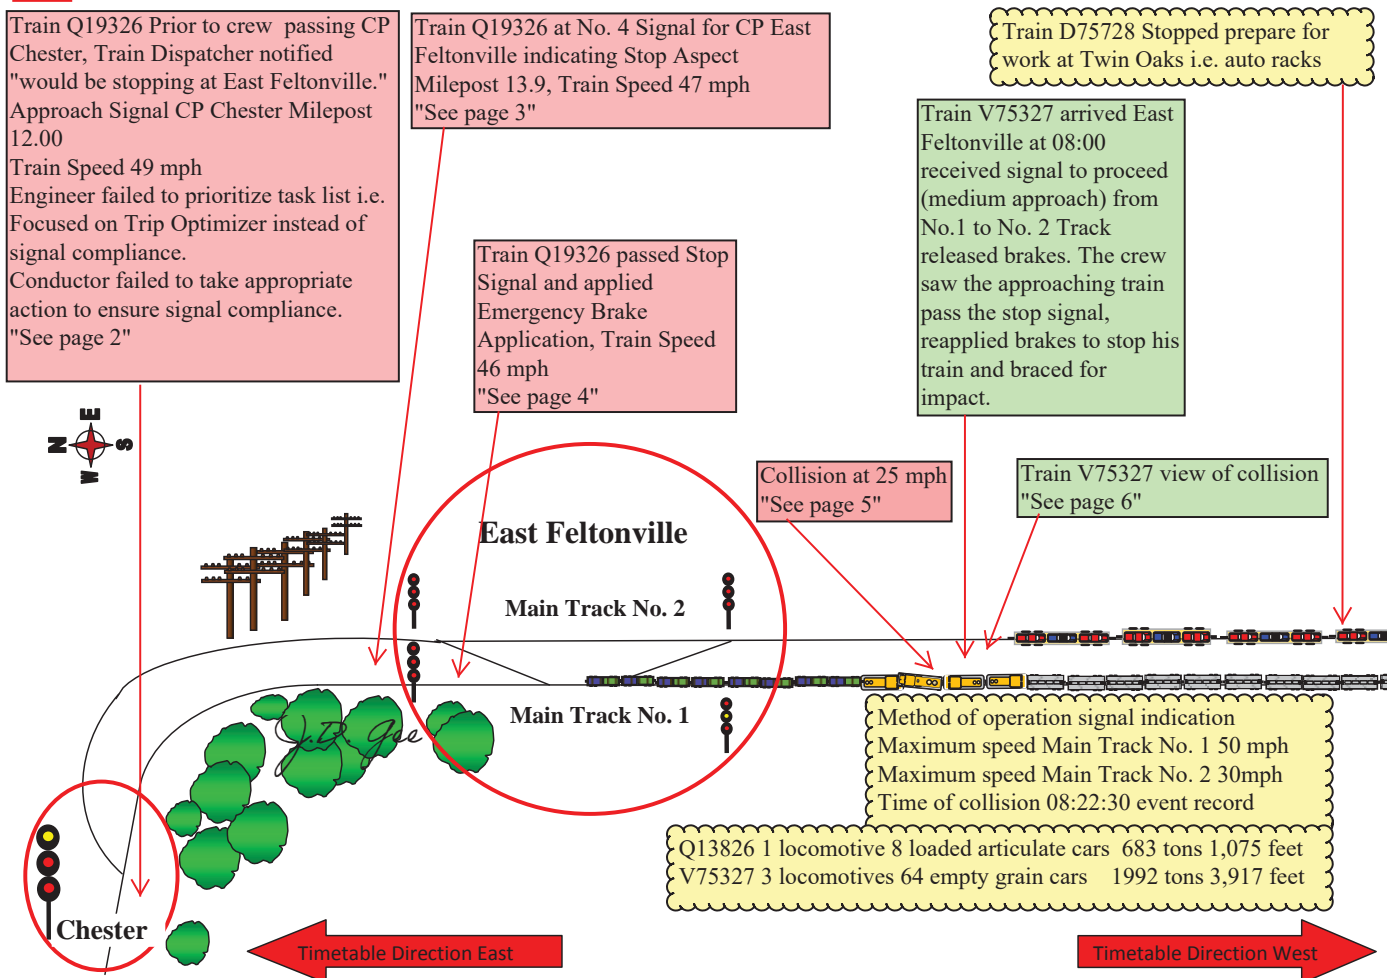
Approach signal at Chester
BAK 12, at 49 mph

Stop signal at East
Feltonville BAK 13.9 at 47

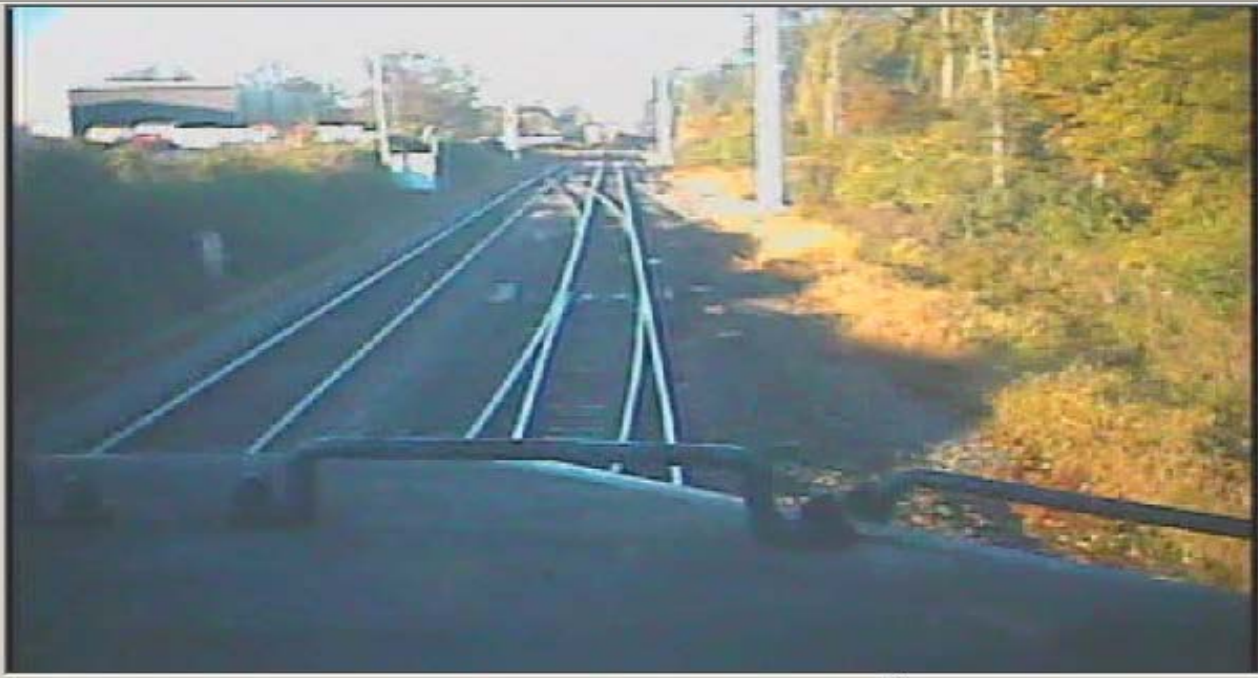
Q19326 in emergency, PCS
open at 46 mph.

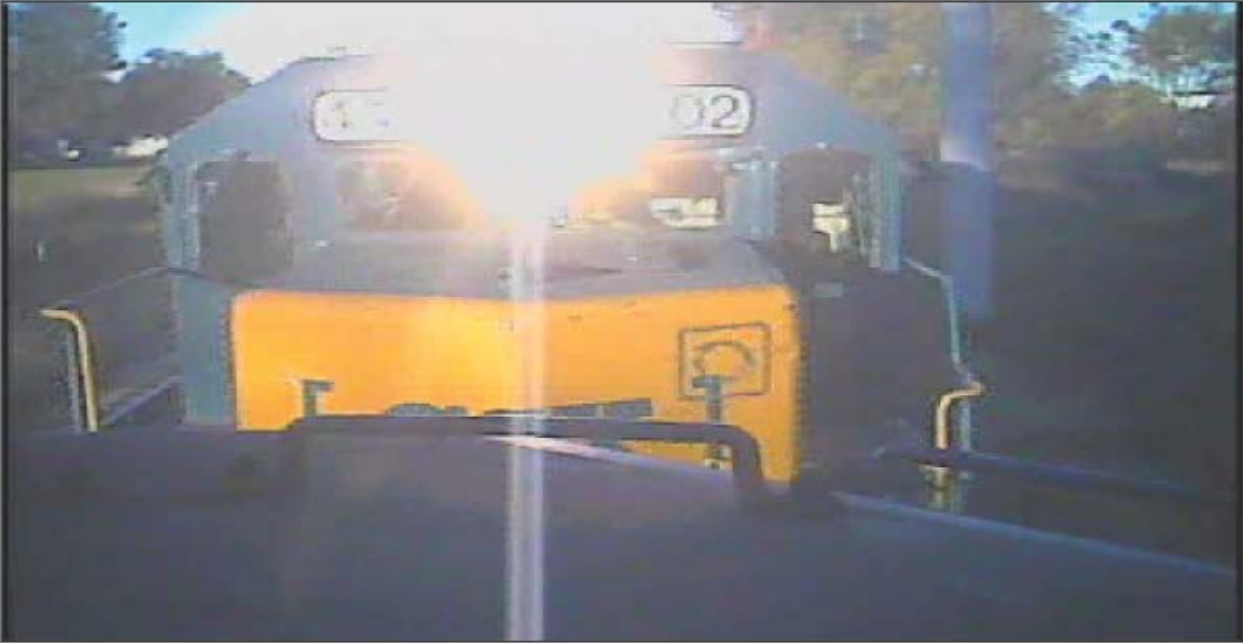
Q19326 impacting the
V75327 at 25 mph
