***Federal Railroad Administration
Office of Railroad Safety
Accident and Analysis Branch***

***Accident Investigation Report
HQ-2016-1169***

***CSX Transportation (CSX)
Citra, FL
November 16, 2016***

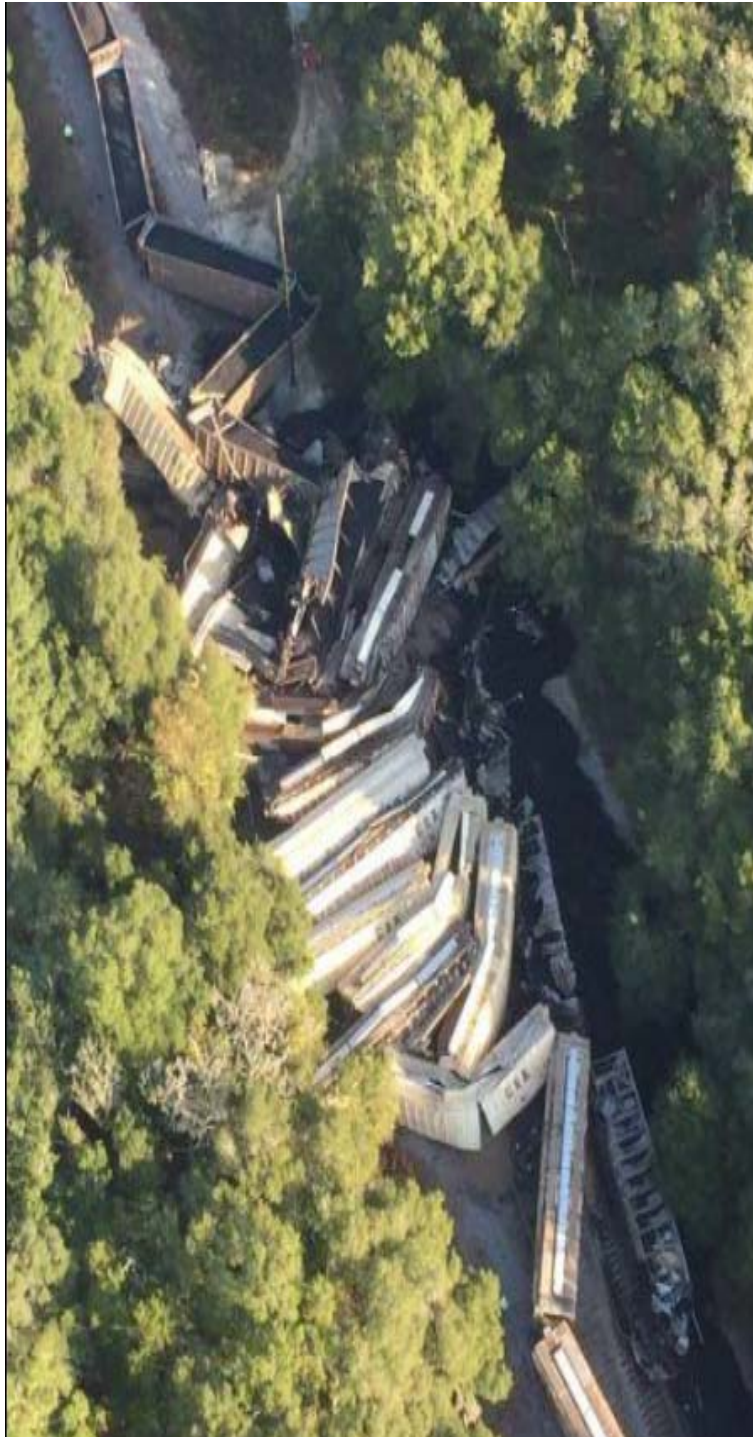
Accident overview

The Dispatcher planned for the striking train to hold the main line at the north-end of Sparr as the struck train entered the siding on the north-end and cleared the main line. The striking train failed to respond to an approach signal at SE Sparr and failed to stop at the stop signal at NE Sparr. The striking train passed the stop signal and collided with the struck train's nineteenth car, as it traversed the NE Sparr turnout.
