***Federal Railroad Administration  
Office of Railroad Safety  
Accident and Analysis Branch***

***Accident Investigation Report  
HQ-2016-1160***

***New Jersey Transit Rail Operations (NJTR)  
Hoboken, NJ  
September 29, 2016***

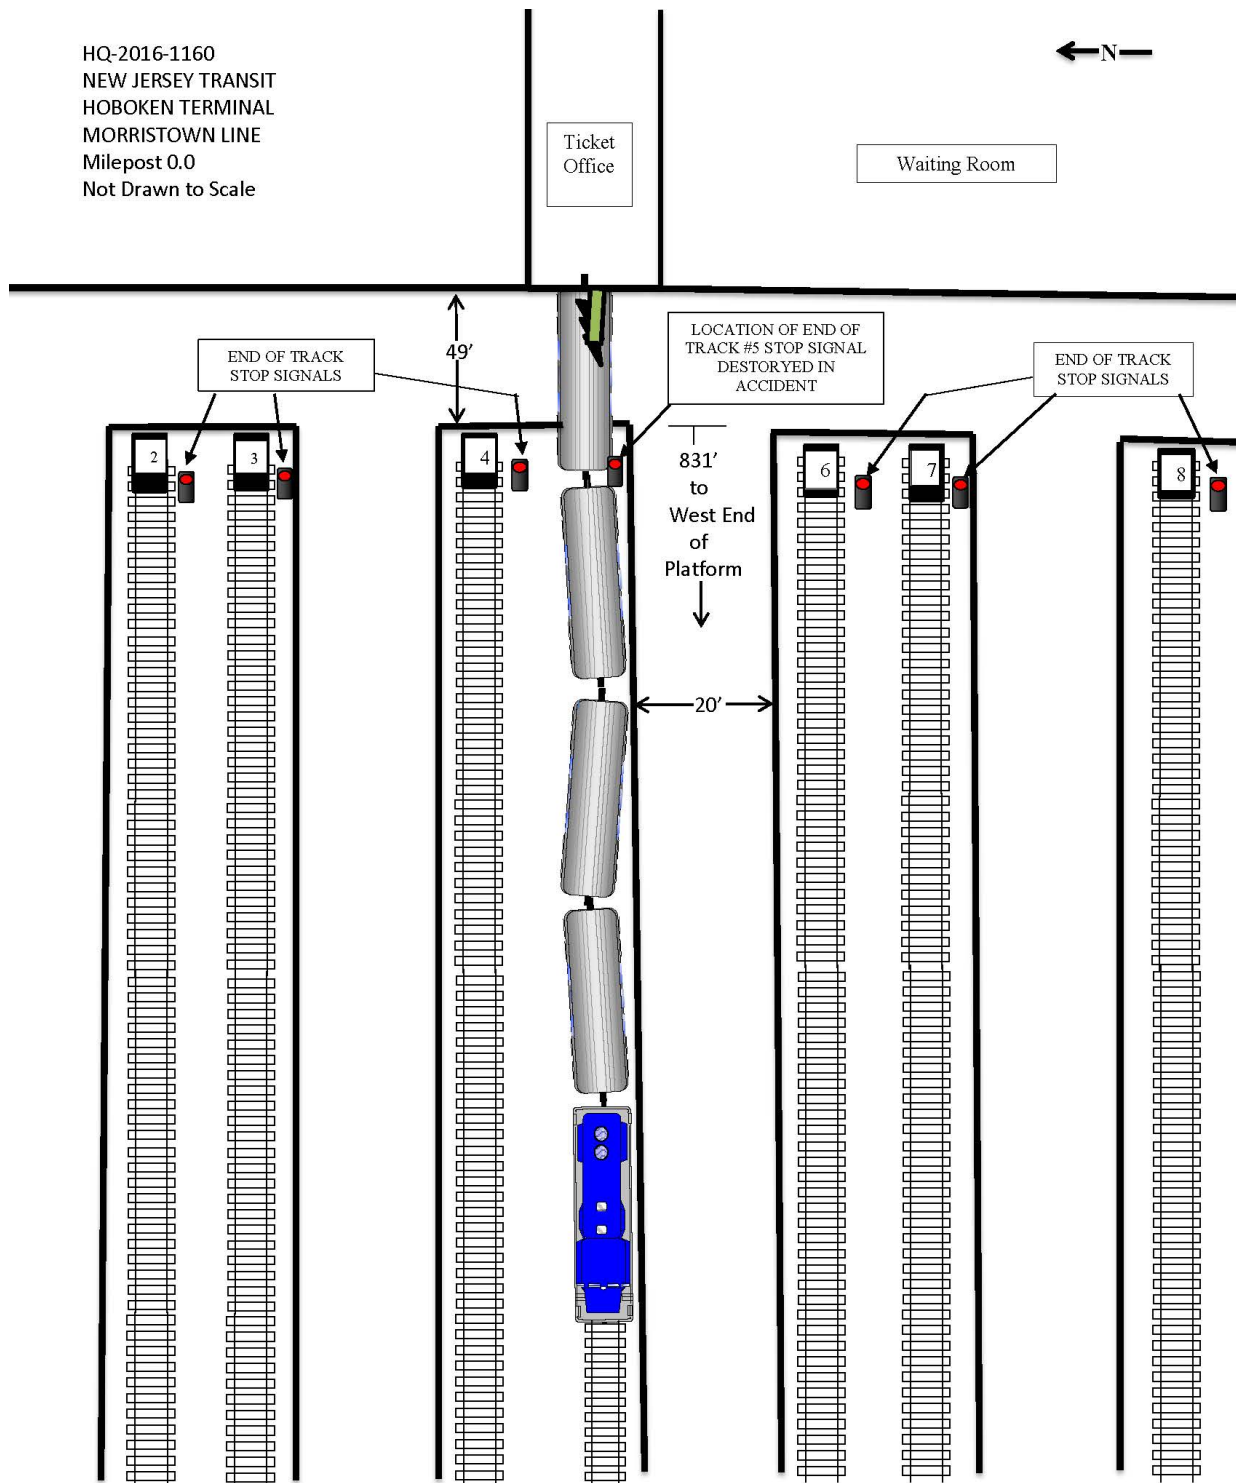
HQ-2016-1160  
NEW JERSEY TRANSIT  
HOBOKEN TERMINAL  
MORRISTOWN LINE  
Milepost 0.0  
Not Drawn to Scale

The train impacted the bumping block causing the Cab Car to derail and lift upward and over the bumping block onto the walkway and striking an overhead steel support beam, a vertical structural support column, and then into the wall of the Hoboken Station building before coming to rest. The impact caused structural debris to fall onto the walkway resulting in a fatality to a civilian on the walkway.
