**RESEARCH RESULTS**  
FRA OFFICE OF RAILROAD POLICY & DEVELOPMENT

RR 18-06 | March 2018

## FULL-SCALE SHELL IMPACT TEST OF A DOT-105 TANK CAR

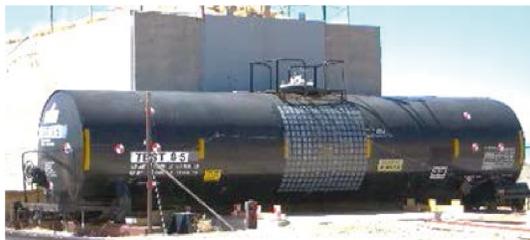
Figure 1. Pre-test photo of DOT-105

On April 27, 2016, FRA conducted a full-scale shell impact test of a DOT105A500W (DOT-105) tank car at the Transportation Technology Center (TTC) in Pueblo, CO. The shell of the car was struck at its mid-length by a 297,000 pound ram car equipped with a 12-inch by 12-inch impactor. Figure 1 shows the tank car in its pre-test position against the impact wall at TTC.

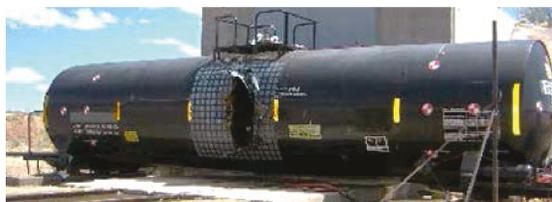
Figure 2. Post-test photo of DOT-105

After an indentation of approximately 38 inches, the tank was punctured at a peak force of approximately 1.4 million pounds. The impact

vehicle and the tank itself rebounded from the impact wall after the test, leaving approximately a 30 inch gap between the wall and the back of the tank.

A review of the test measurements indicates that the impactor had slowed to less than 1 mph when puncture occurred, demonstrating that the impact speed of 15.16 mph only slightly exceeded the speed necessary to puncture this car. Figure 2 shows the tank car in its post-test condition.

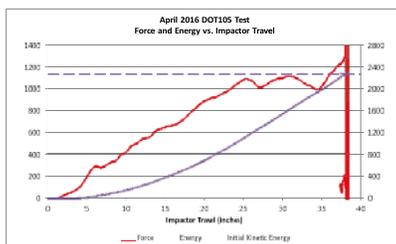
Figure 4. Force- and Energy-displacement Test Results

The force-displacement and energy-displacement results from the test, as well as the initial kinetic energy of the ram, are shown in Figure 4. These results are from the average of the five longitudinal accelerometers on the impact cart. A CFC60 filter has been used on these results. From this graph, it is clear that the impactor's energy had nearly been completely dissipated at the time of puncture.

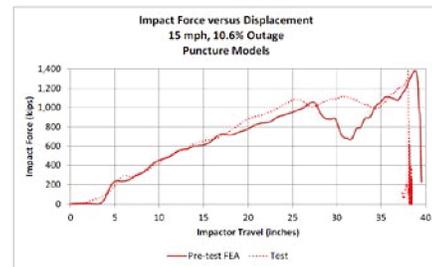
Figure 5. Force-displacement Results, Test and FEA

The force-displacement results from the test and the pre-test FE model at 15 mph are compared to one another in Figure 5. The model used a material with a ductility that slightly exceeded the requirements of TC128. There is generally good agreement between the test and the model, with the model predicting a peak force of approximately 1.4 million pounds and a displacement at puncture of approximately 39 inches.

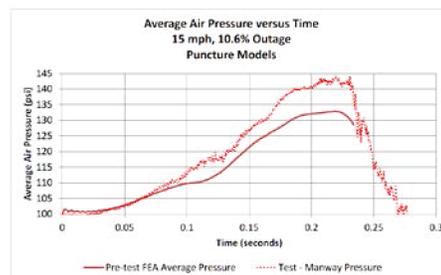
Figure 6. FEA and Test Average Air Pressure Results

In Figure 6, the average air pressure in the pre-test FE model is compared to the air pressure measured in the manway during the test. Overall, there is good agreement between the air pressure in the FE model and the test.
