U.S. Department of
Transportation

**Federal Railroad
Administration**

Rail Base Corrosion and Cracking Prevention: Phase 2

1. AGENCY USE ONLY (Leave blank)		2. REPORT DATE April 2018		3. REPORT TYPE AND DATES COVERED Technical Report – July 2014 - April 2017
4. TITLE AND SUBTITLE Rail Base Corrosion and Cracking Prevention: Phase 2			5. FUNDING NUMBERS DTFR53 14-C-00007

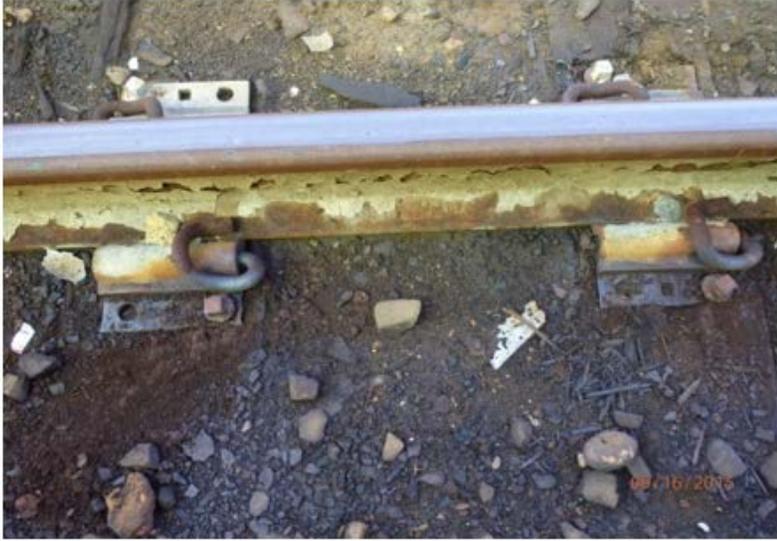
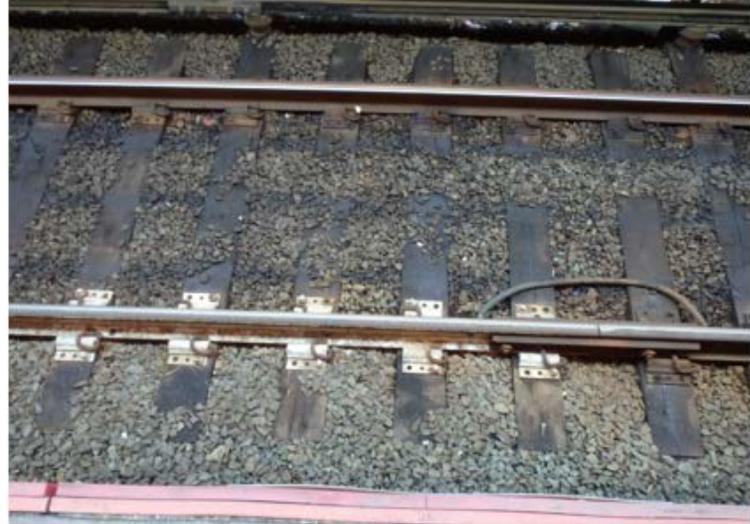
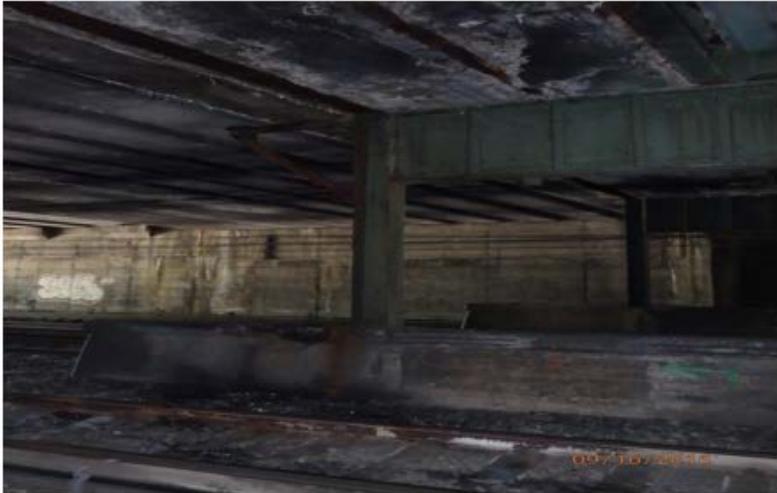
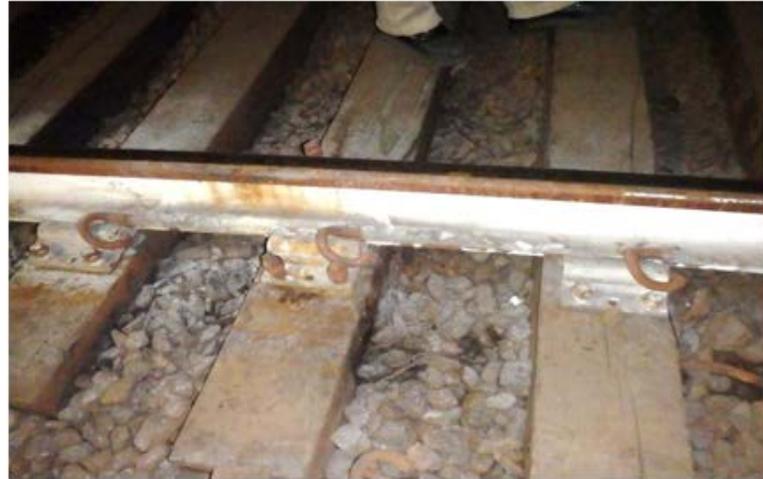
Figure 6. LIRR (Clockwise: UL – Port Washington, UR – Jamaica Station, LR – Atlantic Terminal, LL – LeFrack Overbuild)

By late summer and early fall of 2015, almost 10 months after installation, reports came back regarding premature failure of the coating. This was observed by all the railroads regardless of location. This indicated a systematic problem, given that the installations represented diverse locations, exposures, track usage, and electrically live or dead rail (Table 1). A pictorial review of the in-track installations by the railroads is given in Figure 6 through Figure 8. These photographs represent 6–10 months in service, depending on location, for example:

- At ground return the corrosion rate is about 30 percent higher than that at other locations.
- At LeFrack Overbuild which carries both diesel and electric locomotives estimated coating losses was 50 percent higher than other locations.
- Lambert Yard is likely the most aggressive environment. Seepage from coal cars is quite acidic.

All the participating railroads reported that damage to the coating may have occurred during installation. They also reported that chipping and spalling are common on the rails themselves. Where coating is being lost, there is evidence of incipient corrosion. However, the tie plates appear to be holding up very well and generally did not display mechanical damage to the coatings. In consultation with EC, it was determined that adhesion to rail steel was the culprit. EC ran many tests and isolated at least one issue as stemming from the inclusion of bubbles (likely hydrogen) at the interfacial surface of the coating and the steel. The combination of the steel chemistries and the size of the specimen being coated may have influenced coating adhesion on the rails.

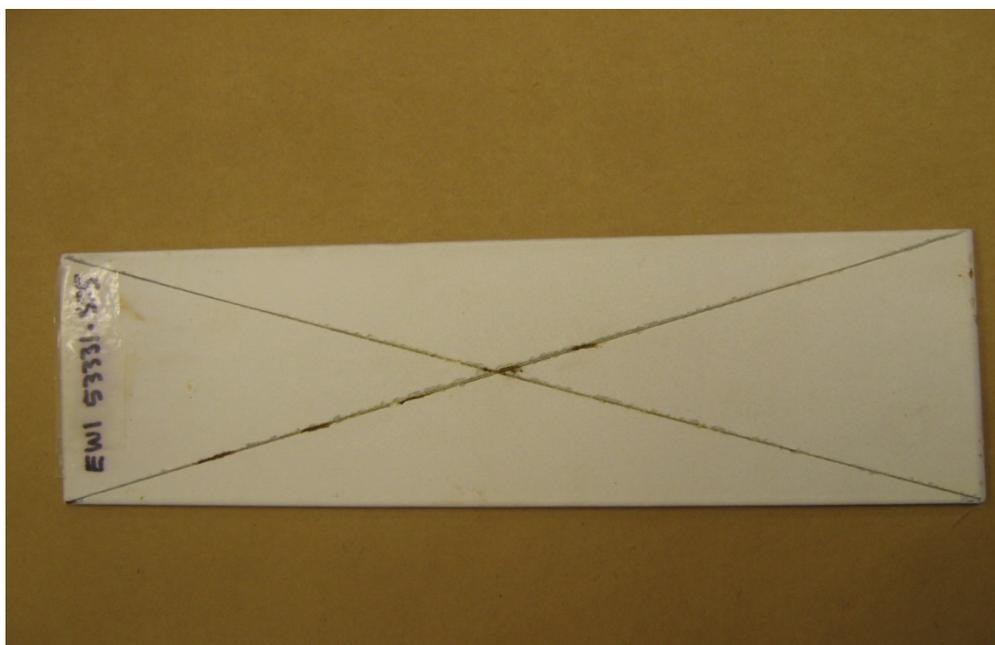
Figure 9. Salt Fog Specimen of EonCoat® After 5,000 Hours Salt Fog Exposure (ASTM B117)

Considerable salt fog testing was performed in Phase 1. The test panels used in Phase 1 were small compared with a full stick of rail, being only 4×12 inches. Salt fog testing of those panels produced exceptional results even after 5,000 hours (see Figure 9 taken from the Phase 1 work). There was no exposure to excessive moisture or UV, as would be found in an outdoor setting. Overall, there was no evidence of significant loss of adhesion.

Smaller plates, and even tie plates, can be coated faster than a large rail, simply because of sample size. There would be less overall time between coats. One of the observations from the field testing was the tie plates seemed to retain coating much better than the rails, suggesting better adhesion (Figure 6 through Figure 8). Therefore, it is possible the combination of size, surface chemistry, surface morphology, and coating time may have worked against good coating adhesion on the rails, while providing better mechanical performance on the tie plates. Taken in concert with the formation of bubbles and a foamy region near the steel surface, these linked concepts suggested that the causes for poor adhesion had been identified.

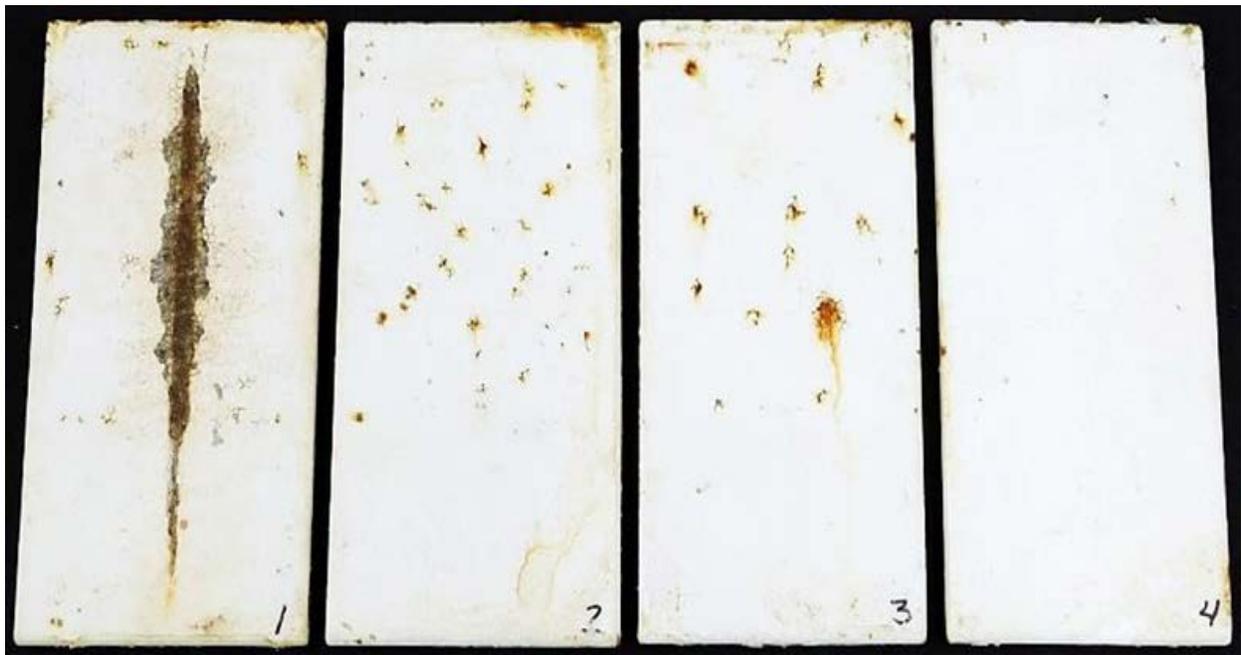
Figure 15. EonCoat® V – Macro of Panels After Testing

Figure 14 and Figure 15 show the before and after pictorial record from the DNV exposures. There are penetrations to metal on the plates that were initially undamaged. On the scribed plate, there is obvious pulling back of the coating from the scribe region, however, there is still rust protection outside the region. That is a trait of the EonCoat® V system. It converts the surface, not just coats it, so there is additional resistance to corrosion with time in regions where coating has been lost physically.

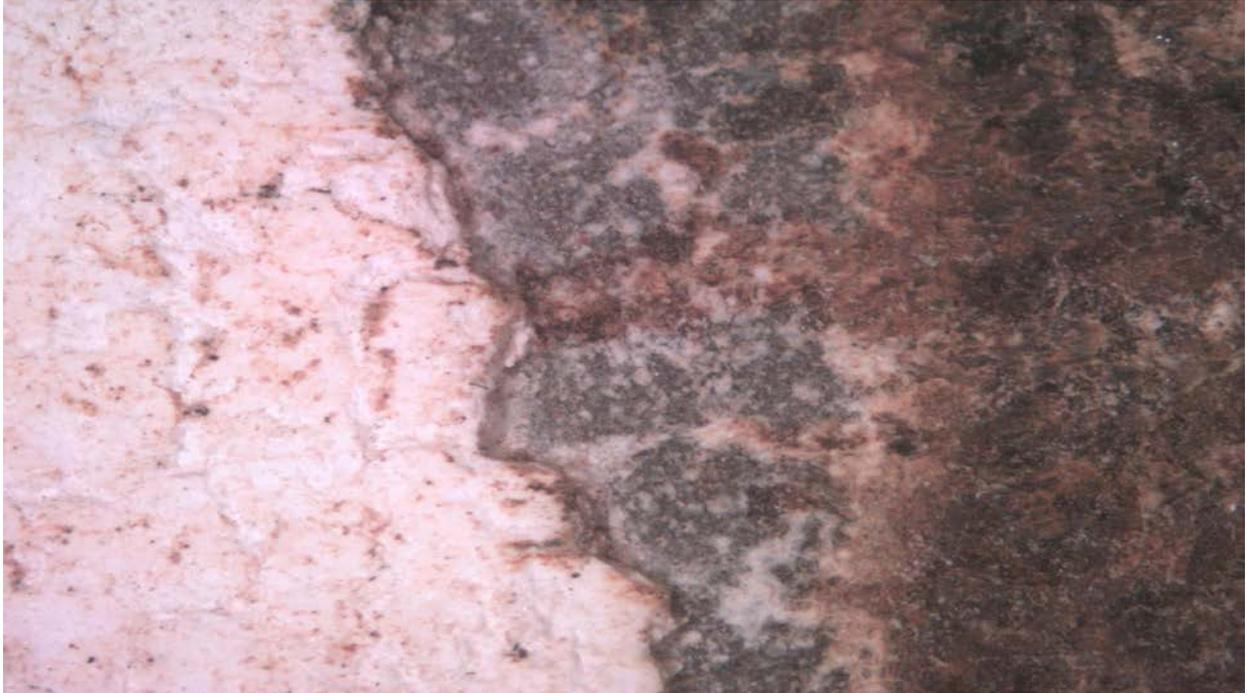
In examining Figure 16 through Figure 19, it can be seen that micro-cracking is developing along with incipient adhesion loss. While this performance is better than the original EonCoat® coating, it suggests the longer-term protection might be compromised.

Figure 16. EonCoat® V – Scribe Region Into Field (2× Magnification)

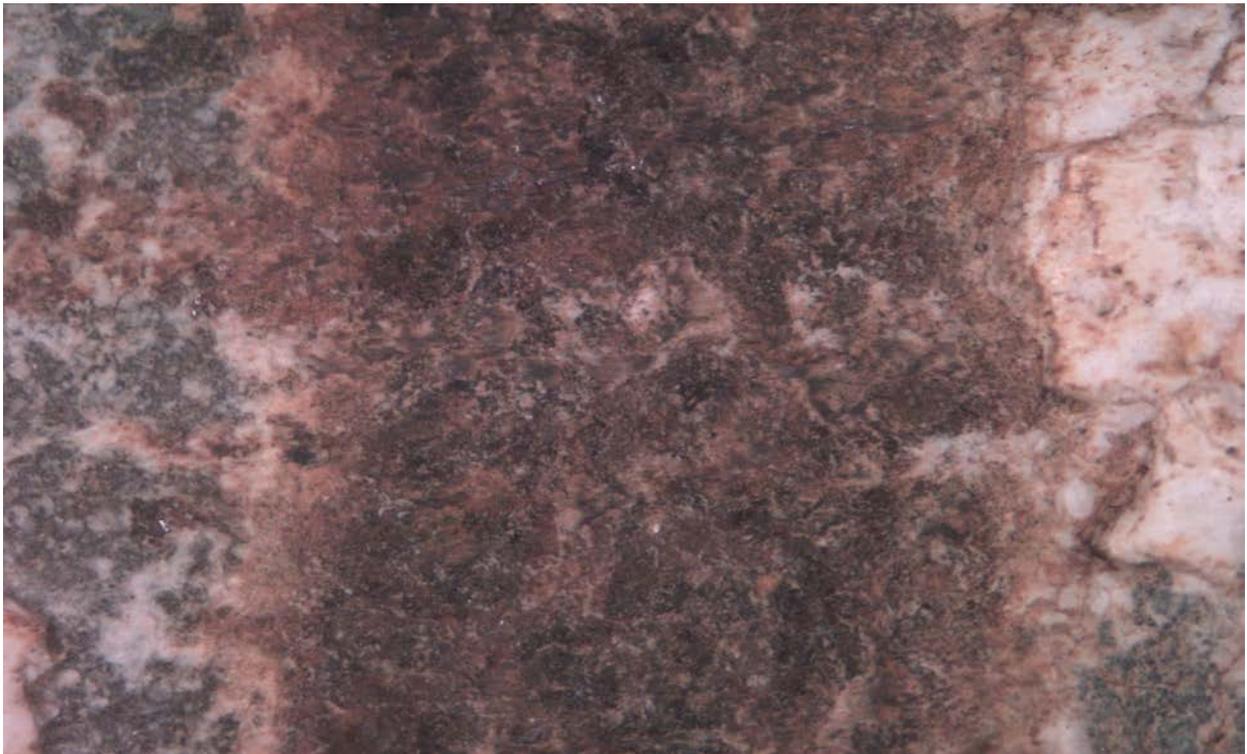
Figure 17. EonCoat® V – Scribe (4× Magnification)

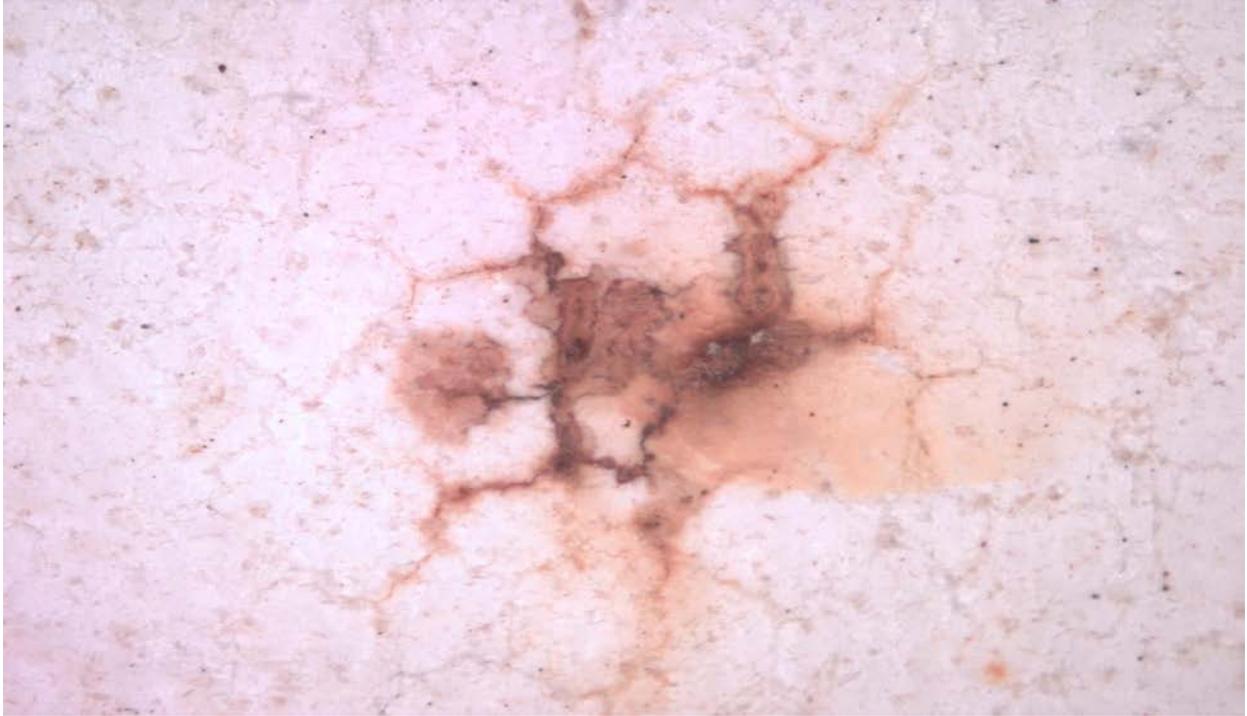
Figure 18. EonCoat® V – Blister (2× Magnification)

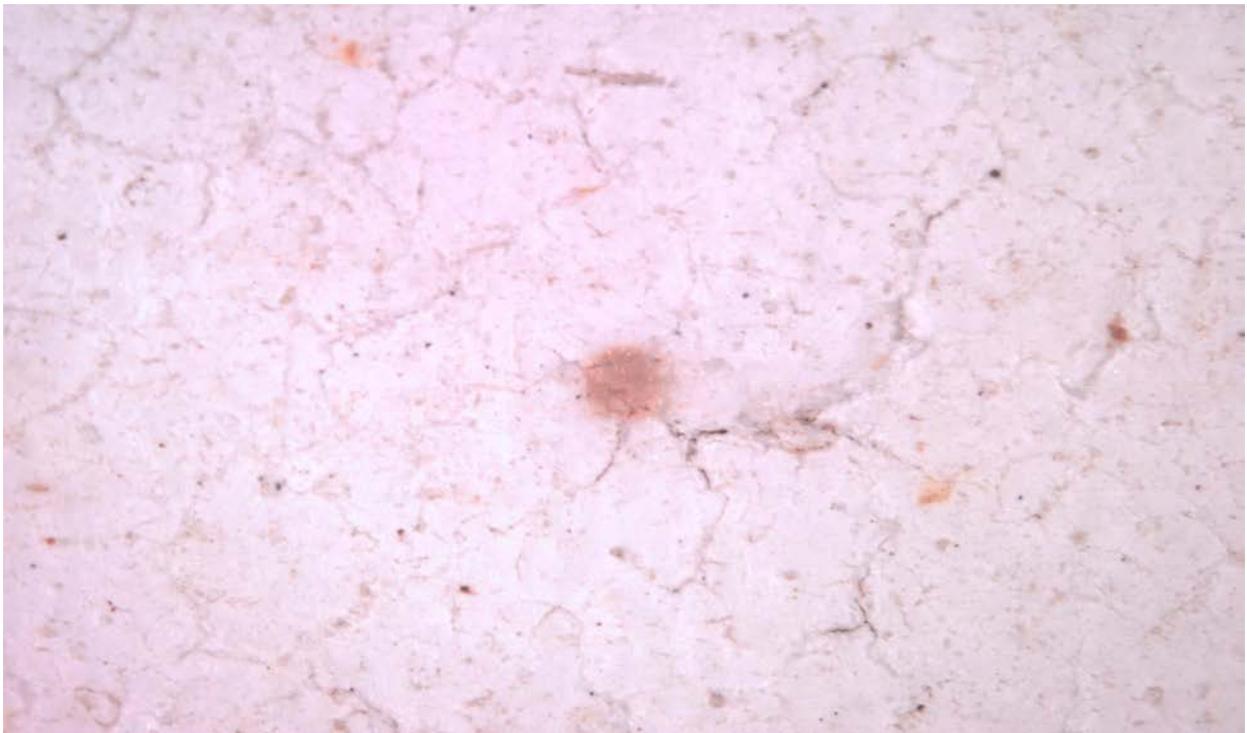
Figure 19. EonCoat® V – Developing Blister into Field (2× Magnification)

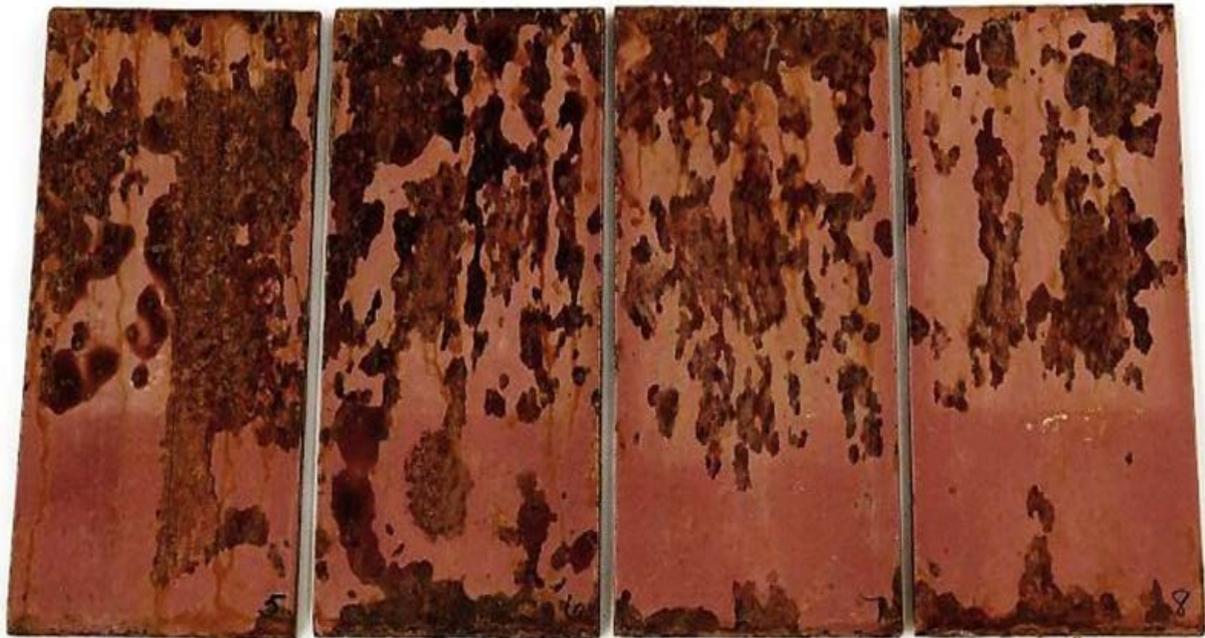
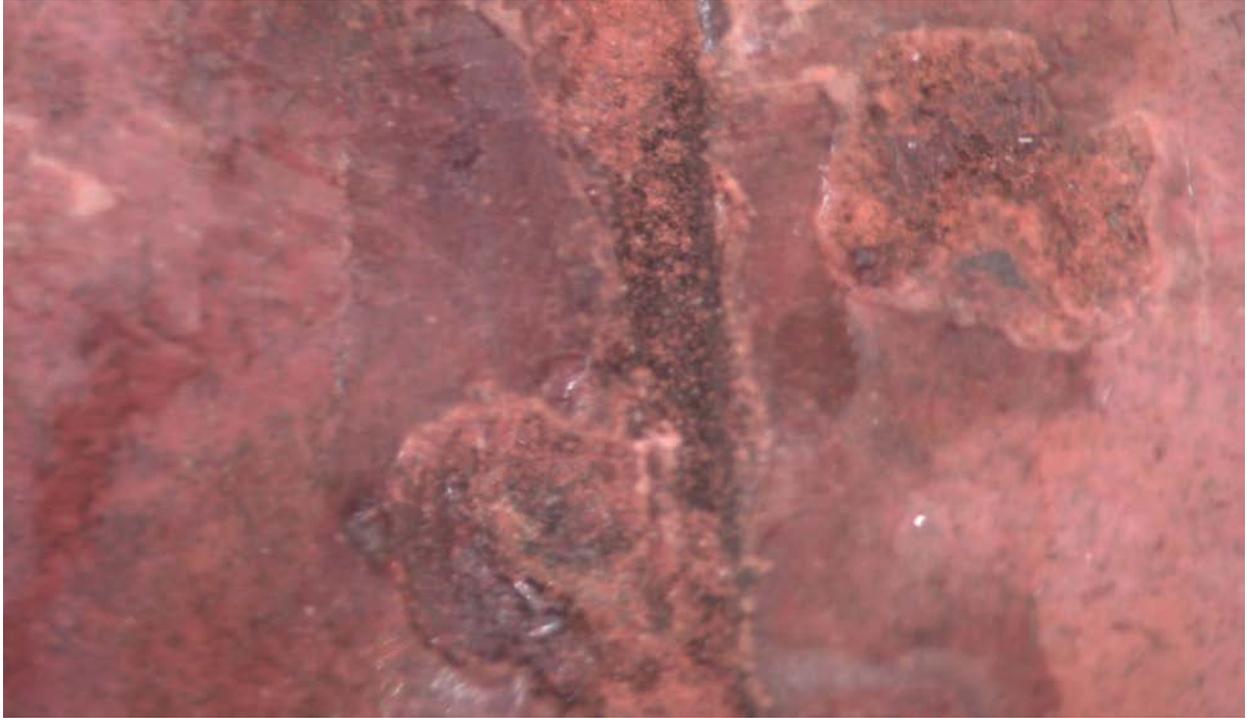
This is an experimental coating and not commercially available. Figure 20 through Figure 23 show that the coating has remained substantially intact. However, moisture and possibly salt have transgressed its protection to reach the surface and begin corrosion. In Figure 23, the development of a blister is evident.

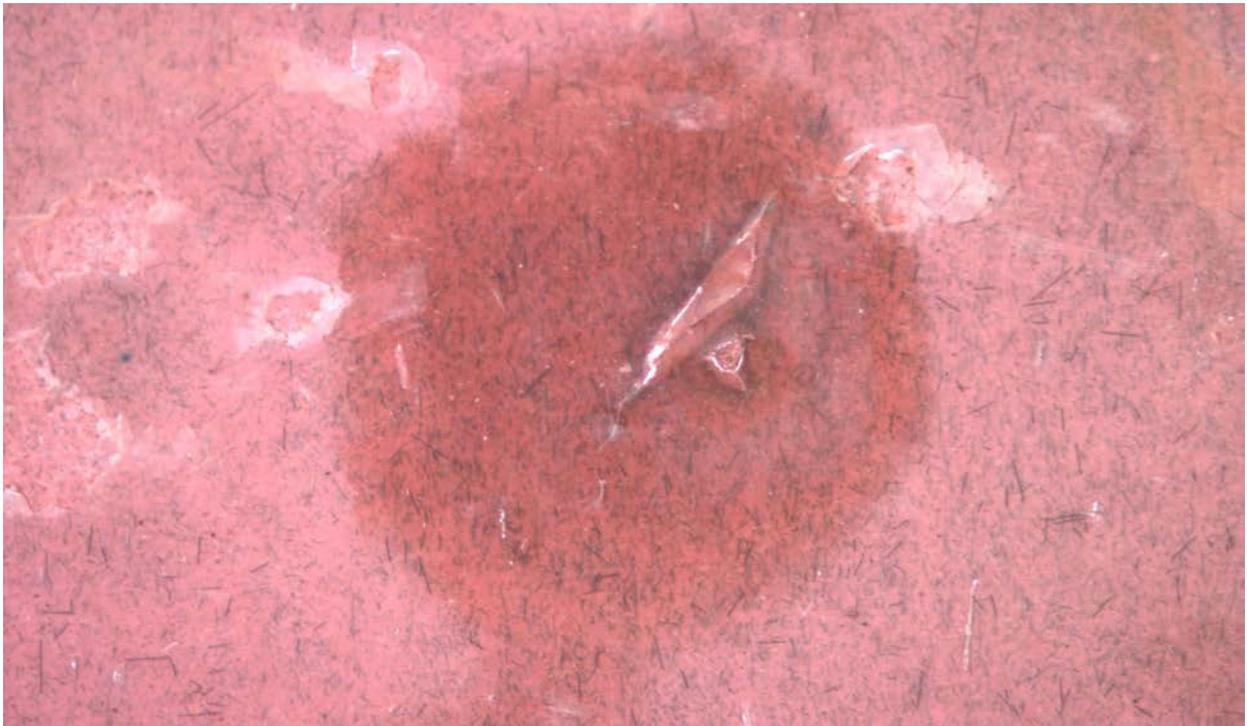
Figure 23. Rutgers Coating – Blister (2× Magnification)

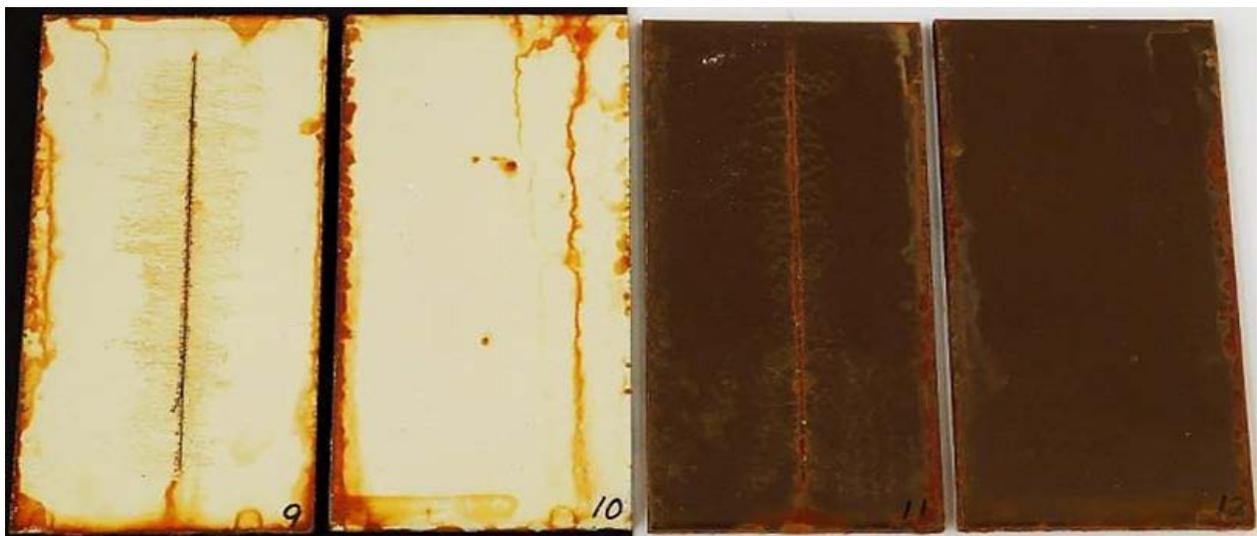
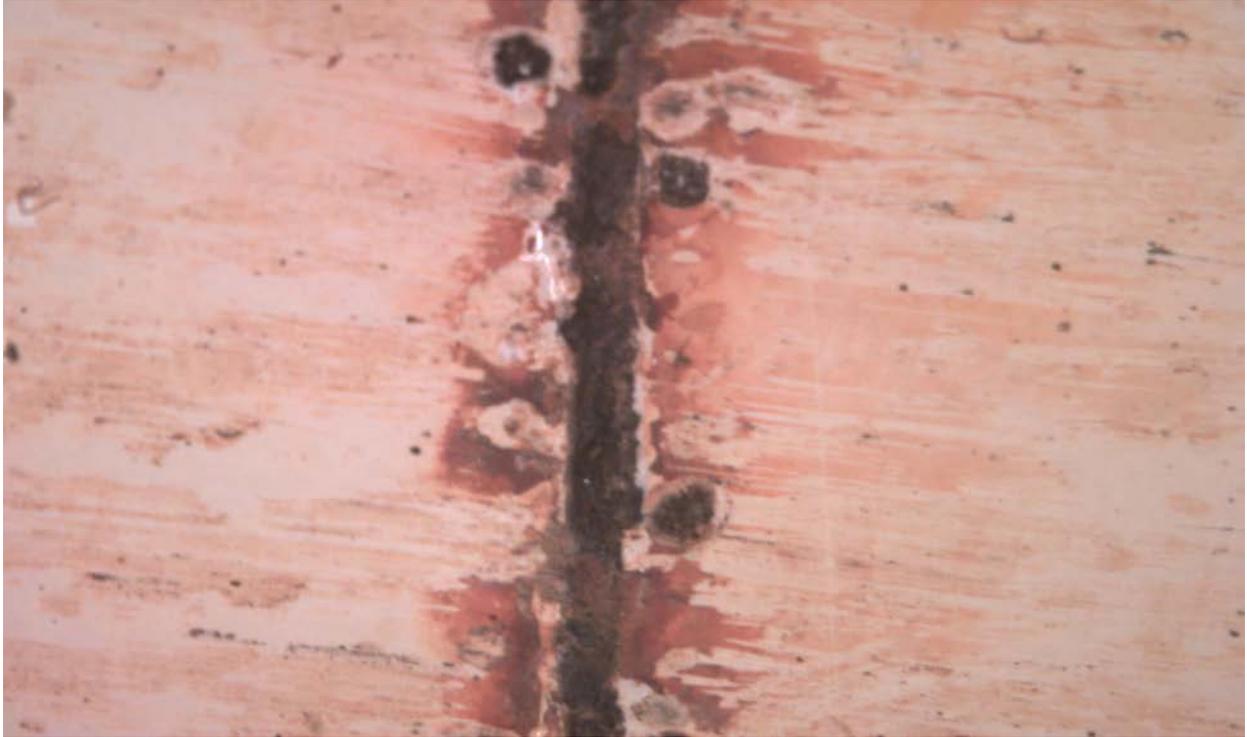
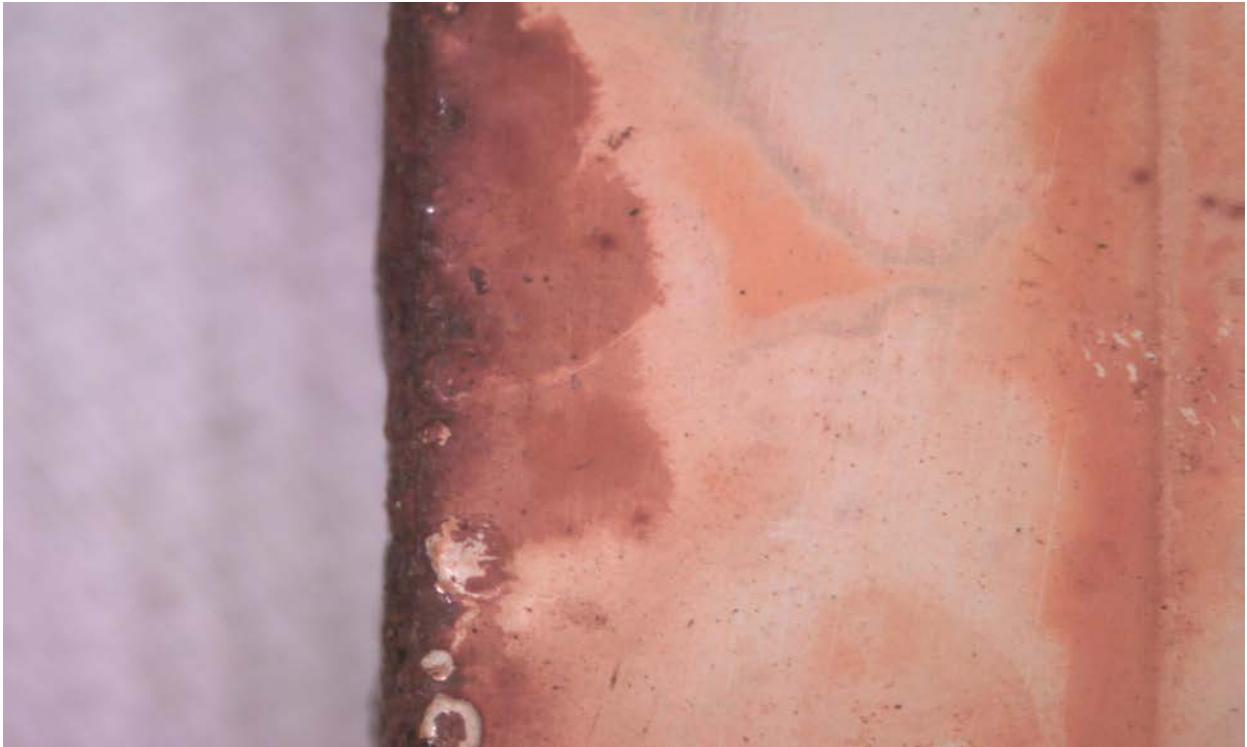
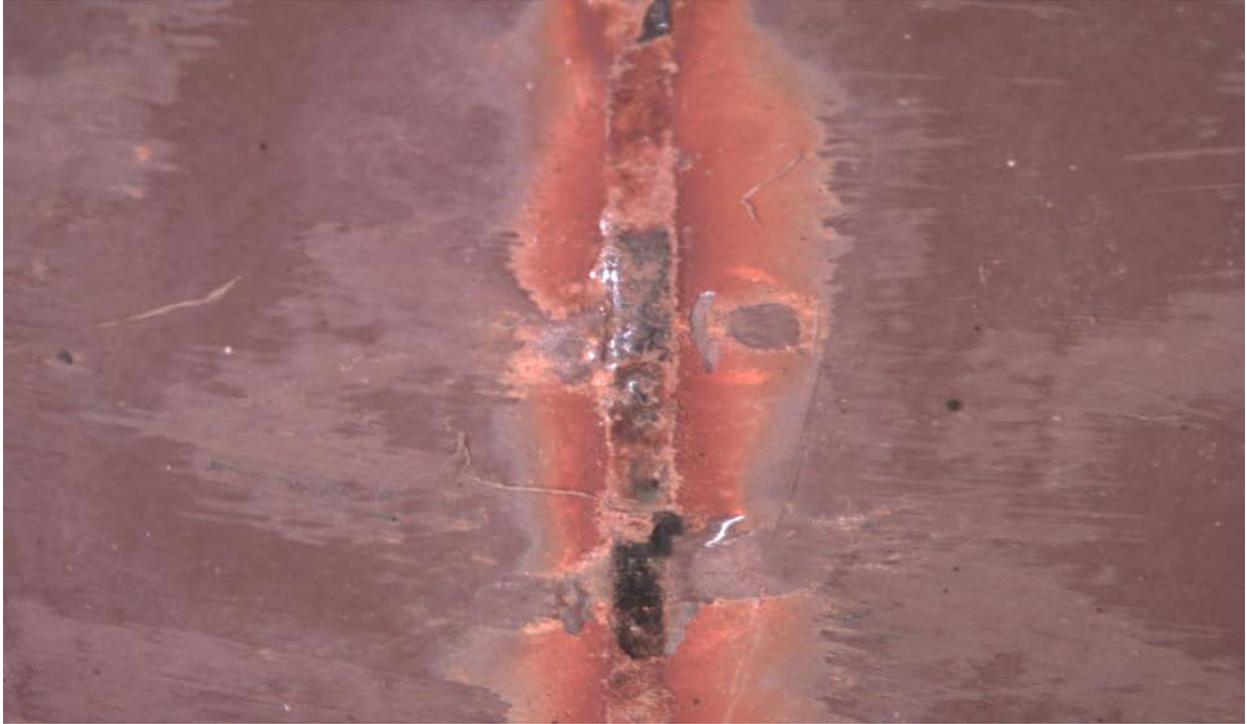
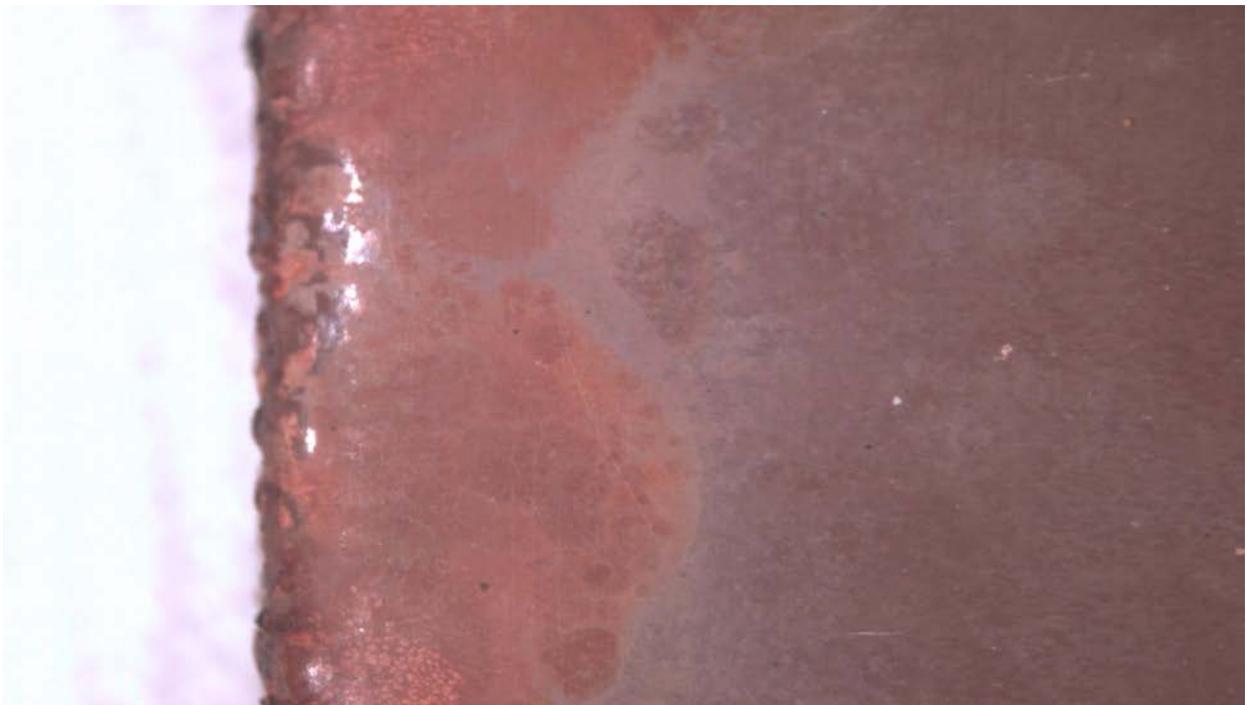
Both the PCI-3000 and PCI-5000 coatings performed well, with the PCI-5000 appearing to perform better of the two (and the best of the set of four) coatings. The plate coated with PCI-5000 had good resistance to blistering and peeling in the scribe region. All the coatings showed incursion from the edges, which is common in this type of testing. However, the PCI coatings showed good resistance to creeping corrosion from the edges, much as they had done in the scribe region. Based on the results of this testing (Figure 24 through Figure 29), the PCI-5000 coating is a good candidate for field testing.

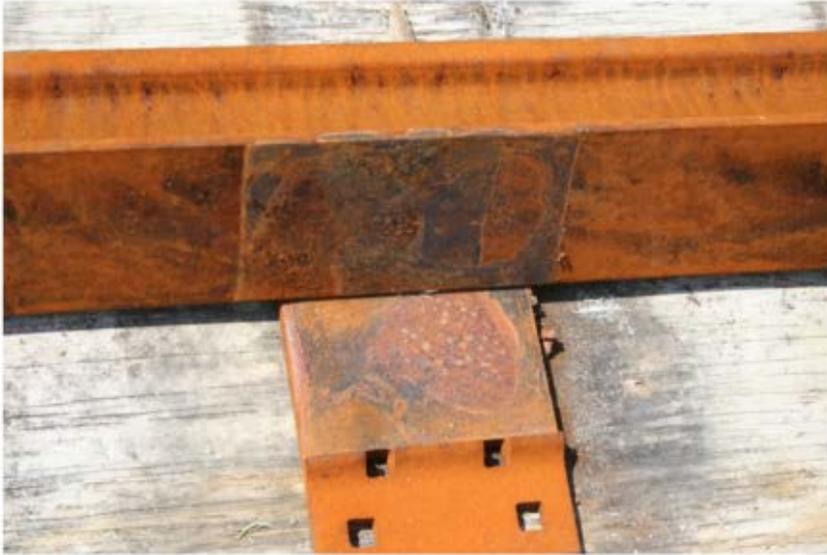
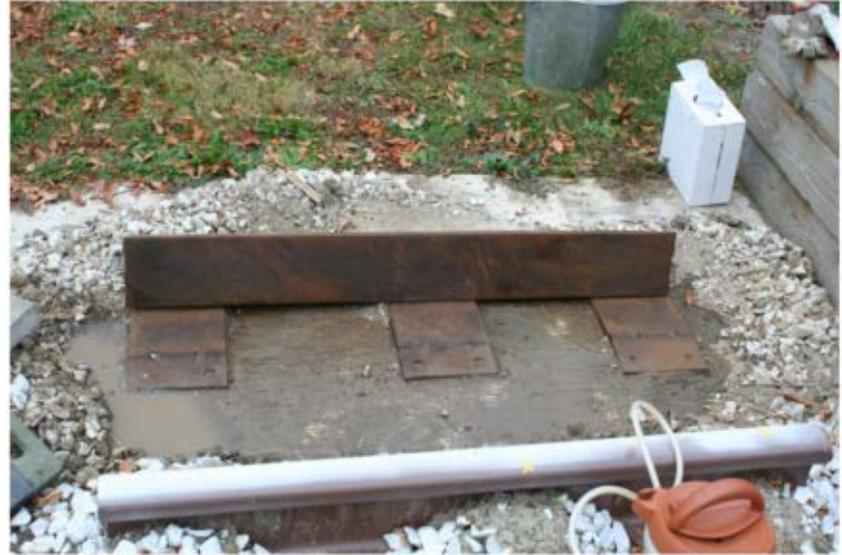
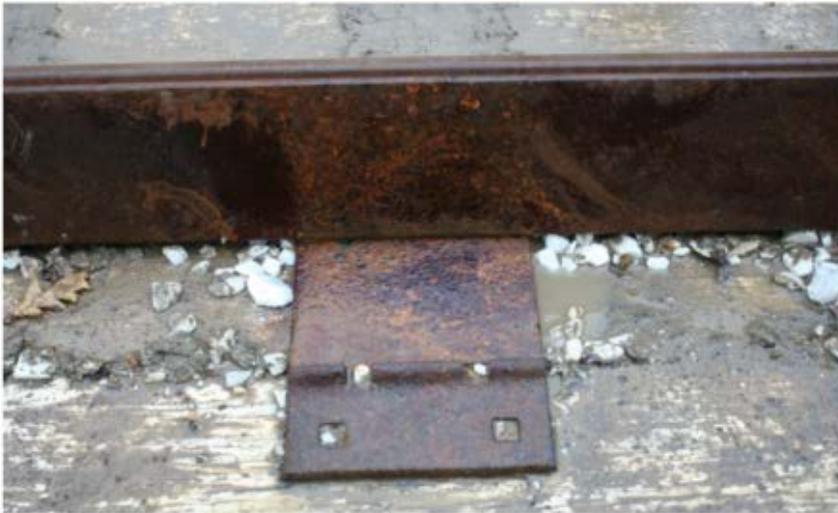
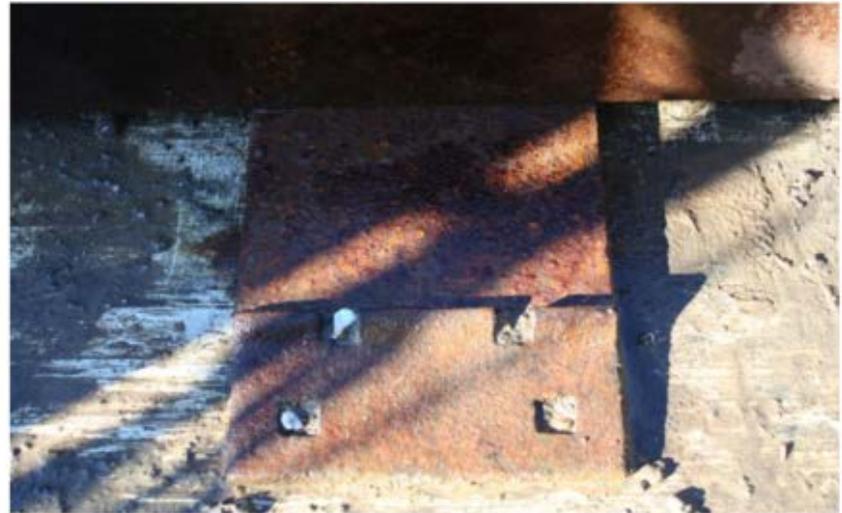
Figure 30. Bare Rail (Clockwise: UL – Start, UR – 2 Months, LR – 4 Months, LL – 6 Months)

It is almost surprising how fast bare rail succumbs to rail base corrosion. In Figure 30, the lower left picture shows 6 months of exposure in the wet and salty environment. There is deep pitting in the contact region. Also, this took place in the absence of electrification which would undoubtedly increase the rate of attack. In light of that, all the coatings showed at least some benefit compared with untreated rail.

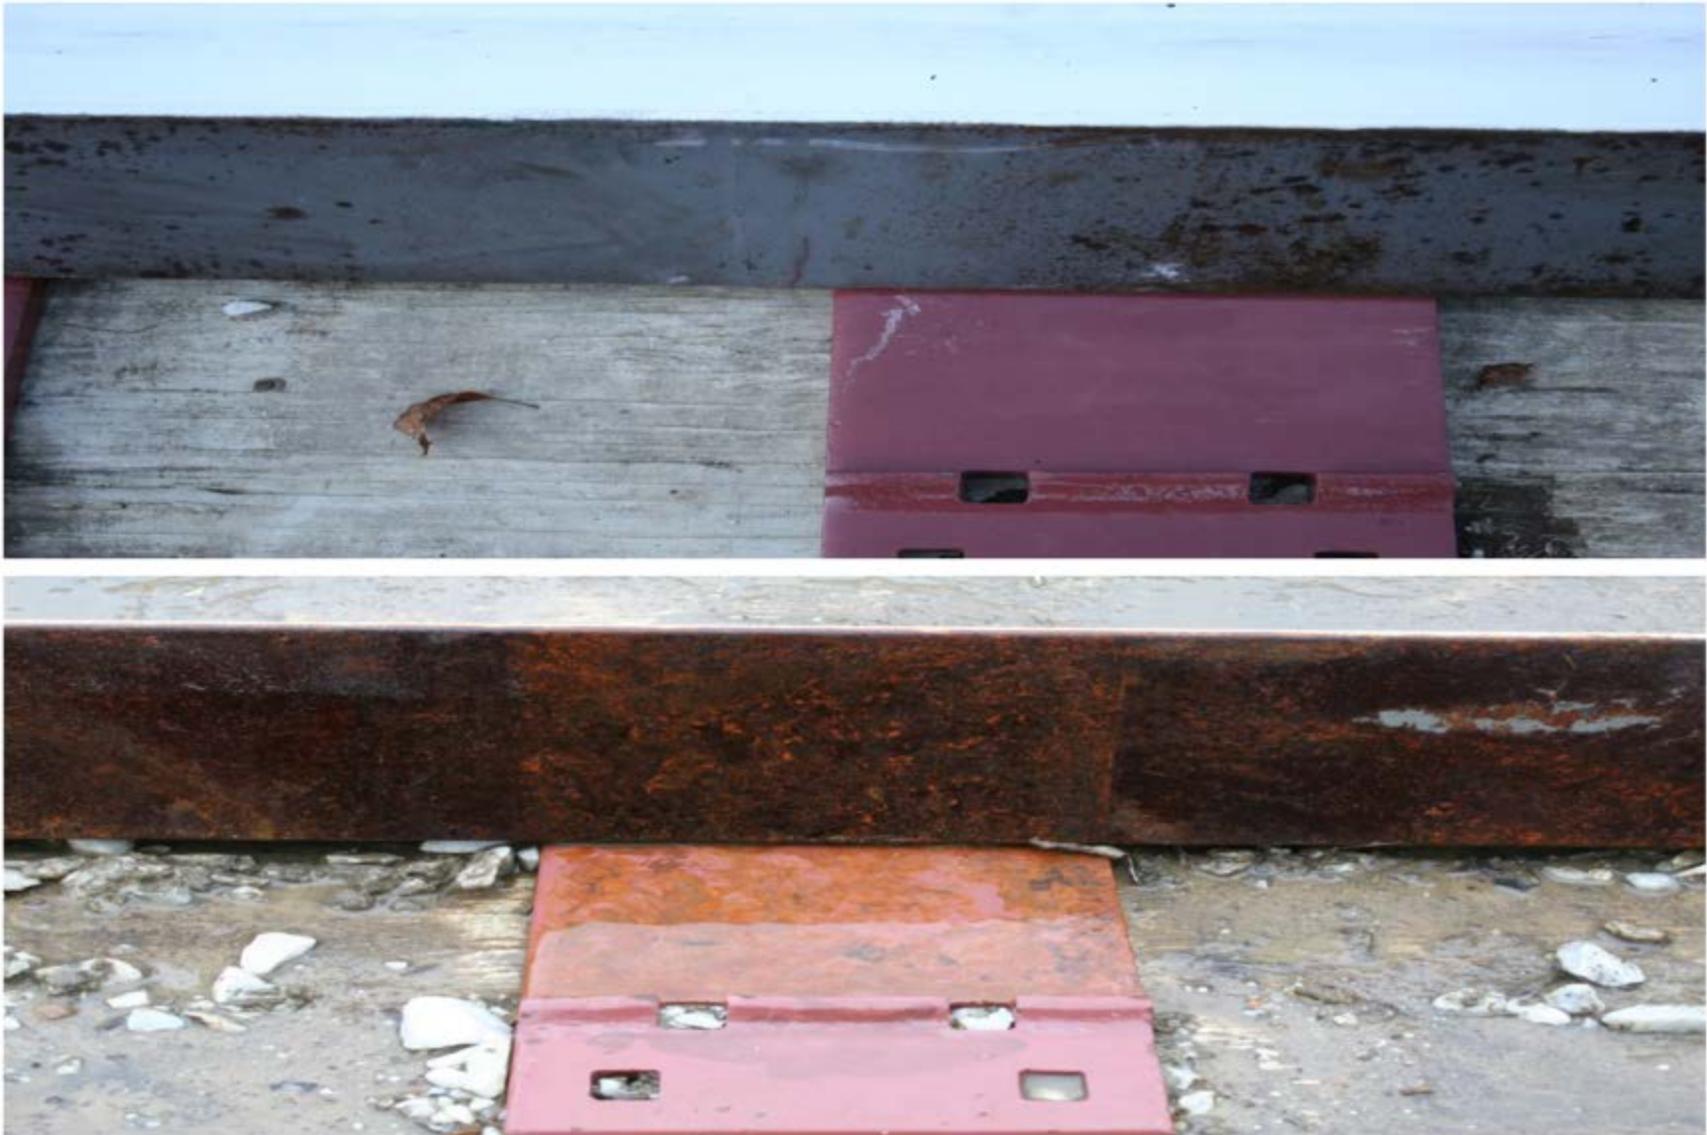
Figure 32. Rutgers Coating (Top – Start, Bottom – 3 Months)

Rutgers did not coat the base of their rail. The Rutgers experimental coating (Figure 32) showed substantial deterioration in the rail-tie plate interface after only 3-months exposure—it was not available for testing outdoors until the fourth month. This too paralleled the relative results from the DNV testing.

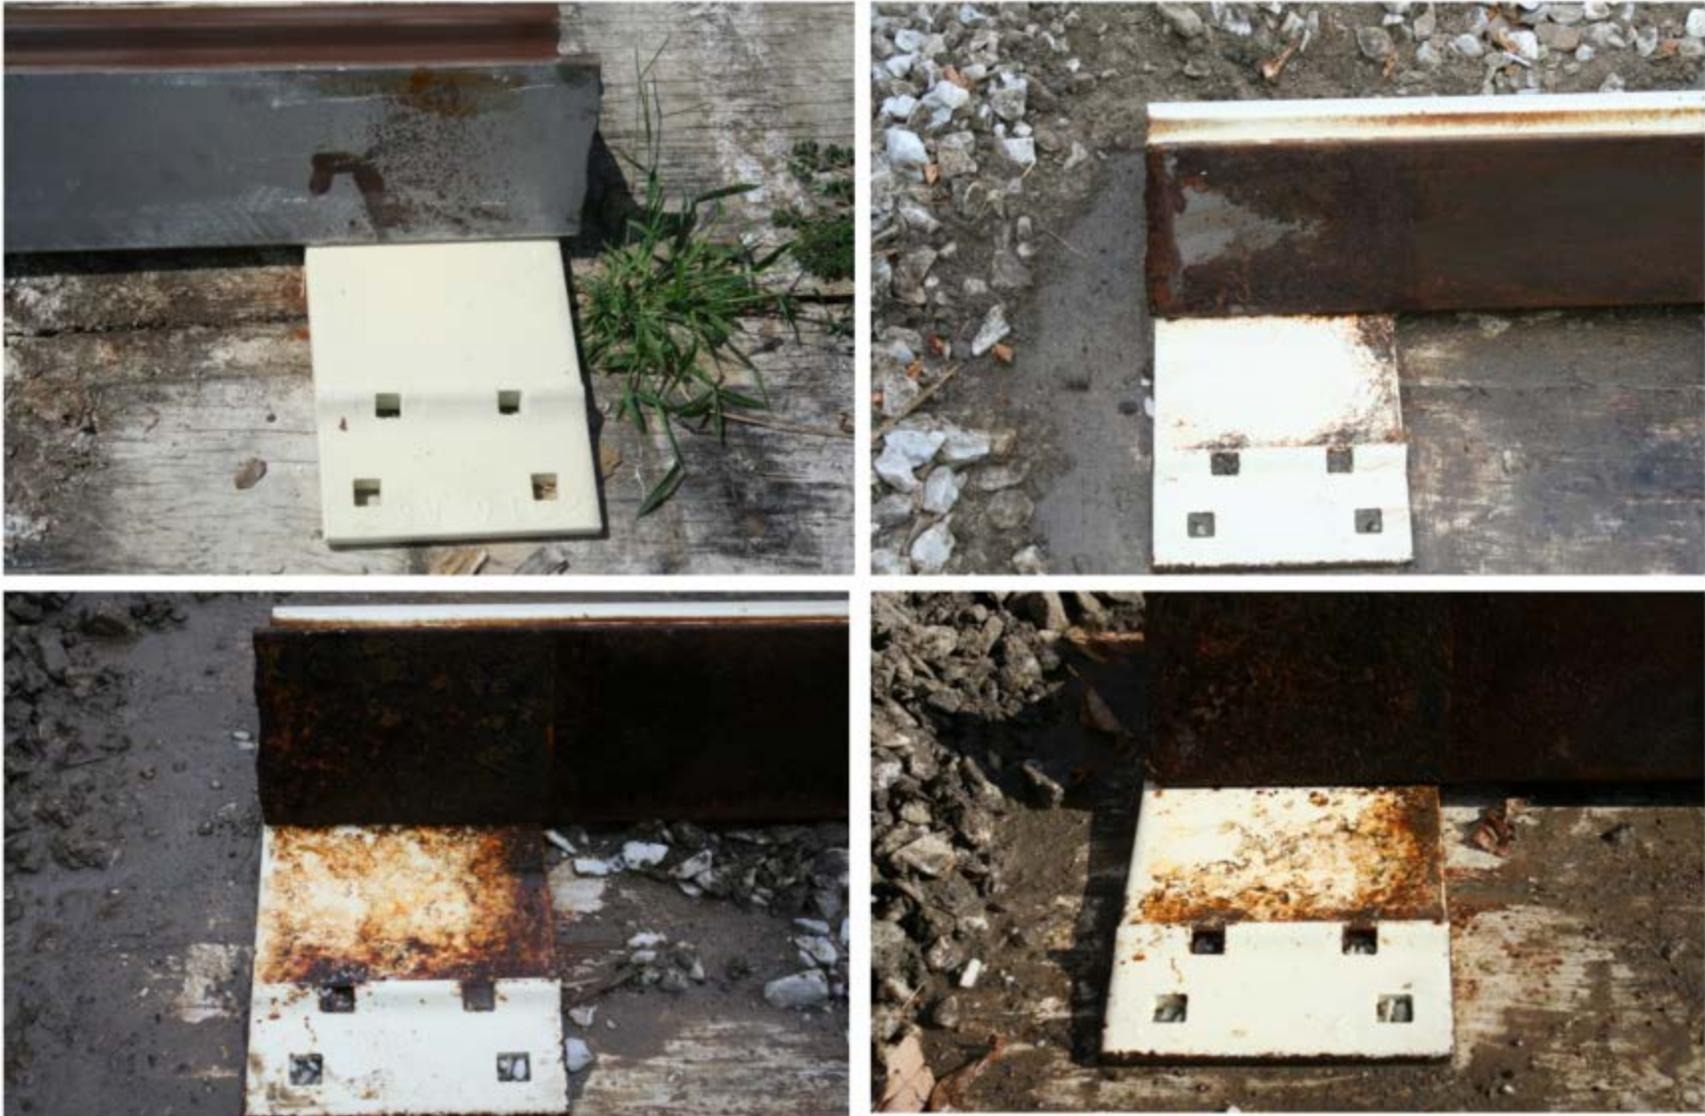
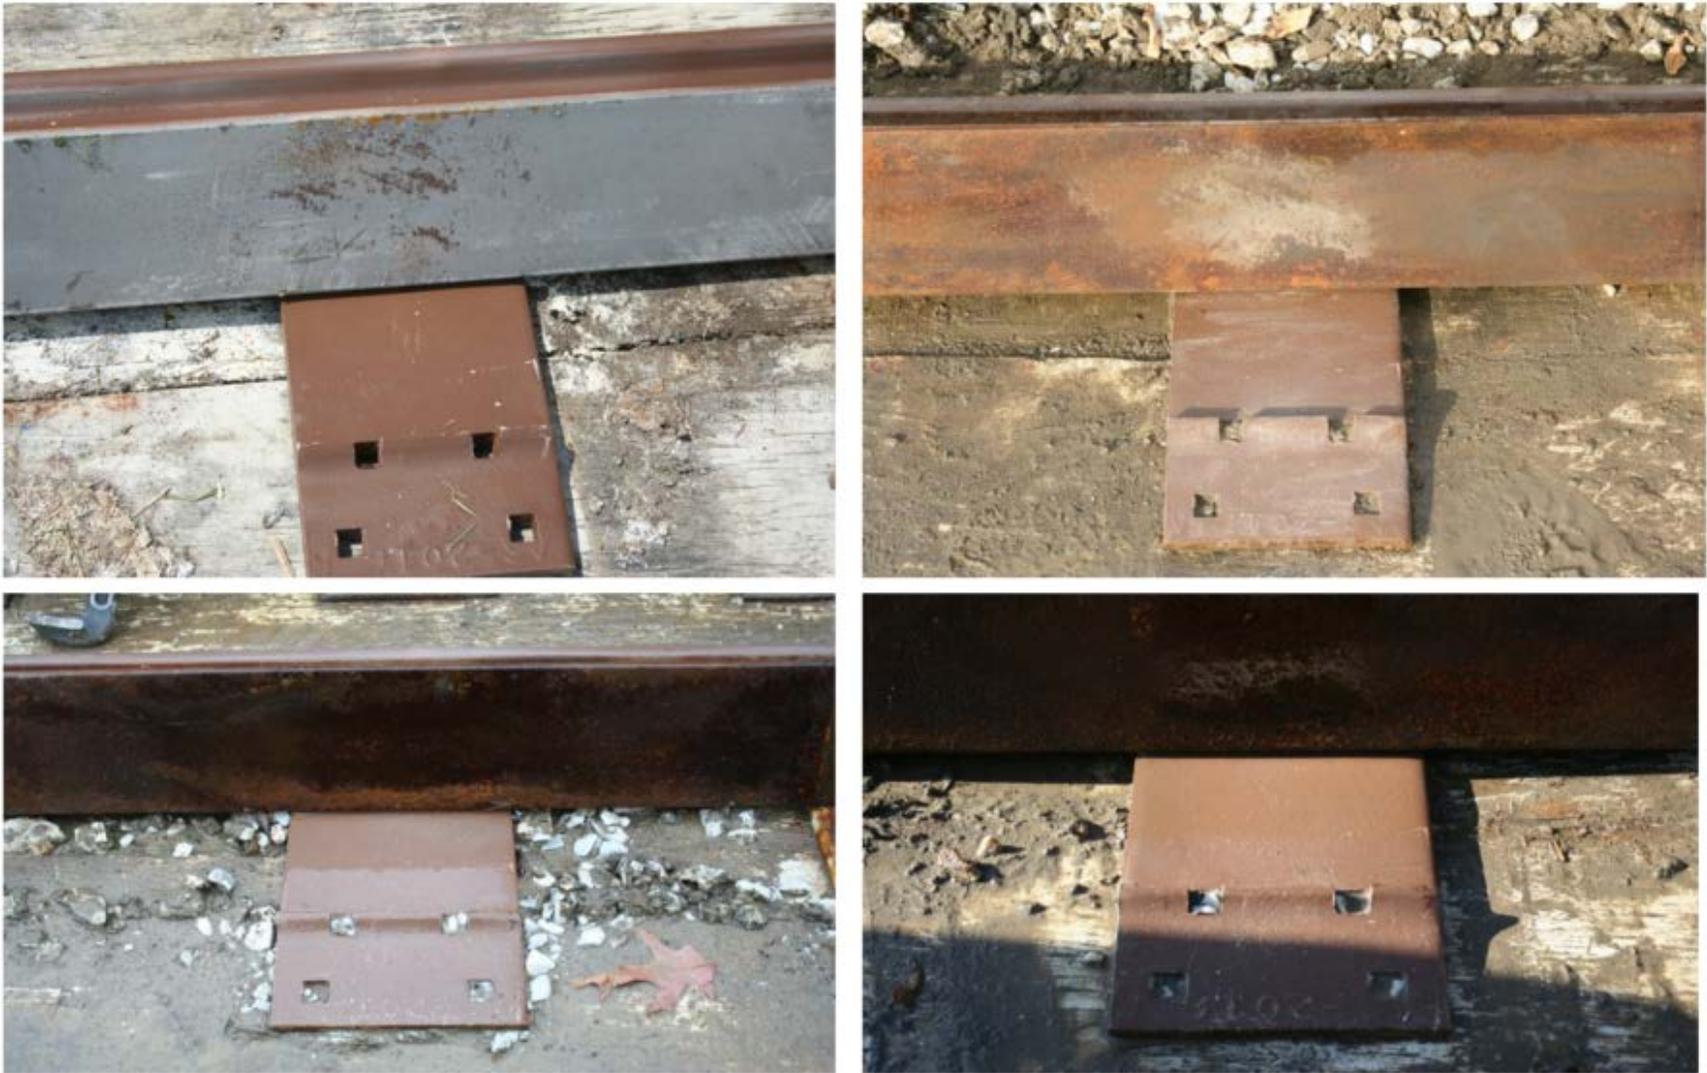
The PCI-3000 system did moderately well, but the interfacial rail-tie plate region did not hold up as well as the PCI-5000 system (Figure 33 and Figure 34). Having the bottom of the rail untreated enabled more advanced corrosion on the PCI-3000 system, but did not attack the PCI-5000 system within the same time frame. This is an encouraging result since it suggests the PCI-5000 coating may be inherently more resistant to corrosion. As shown in Figure 34, the rail base has developed severe corrosion even though the coated tie plate is in very good condition. These results also paralleled those found in the DNV testing.
