U.S. Department of
Transportation

**Federal Railroad
Administration**

Rail Base Corrosion and Cracking Prevention: Phase 2

1. AGENCY USE ONLY (Leave blank)		2. REPORT DATE April 2018		3. REPORT TYPE AND DATES COVERED Technical Report – July 2014 - April 2017
4. TITLE AND SUBTITLE Rail Base Corrosion and Cracking Prevention: Phase 2			5. FUNDING NUMBERS DTFR53 14-C-00007

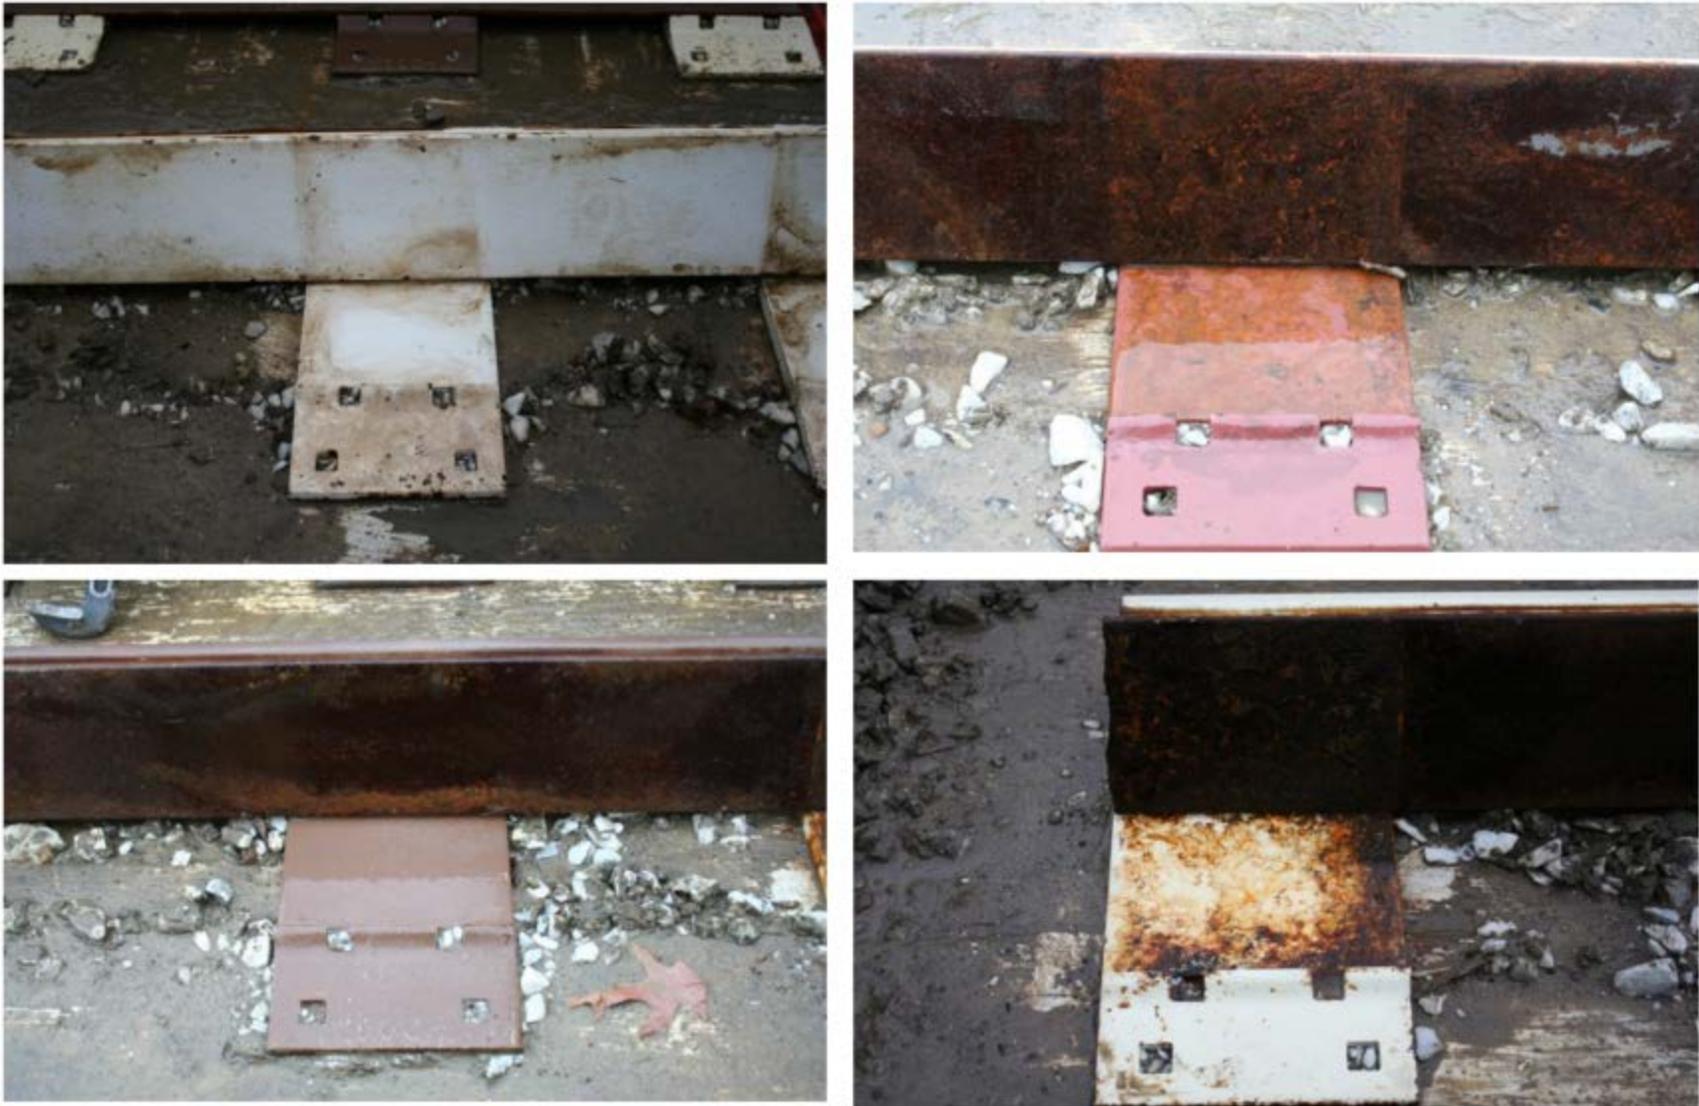
Figure 35. Six Months (Clockwise: UL – EonCoat® V, UR – Rutgers 3 Months, LR – PCI-3000, LL – PCI-5000)

Figure 35 shows the 6-month end result for the four coatings. Since these results parallel the predictions based on the DNV testing, it appears the DNV testing protocol is useful for predicting long-term performance and for screening purposes. It also shows the PCI-5000 system provides the most corrosion resistance of the four systems under the conditions presented.
