***Federal Railroad Administration
Office of Railroad Safety
Accident and Analysis Branch***

***Accident Investigation Report
HQ-2017-1205***

***Metro North Commuter Railroad Company (MNCW)
Rye, NY
May 18, 2017***

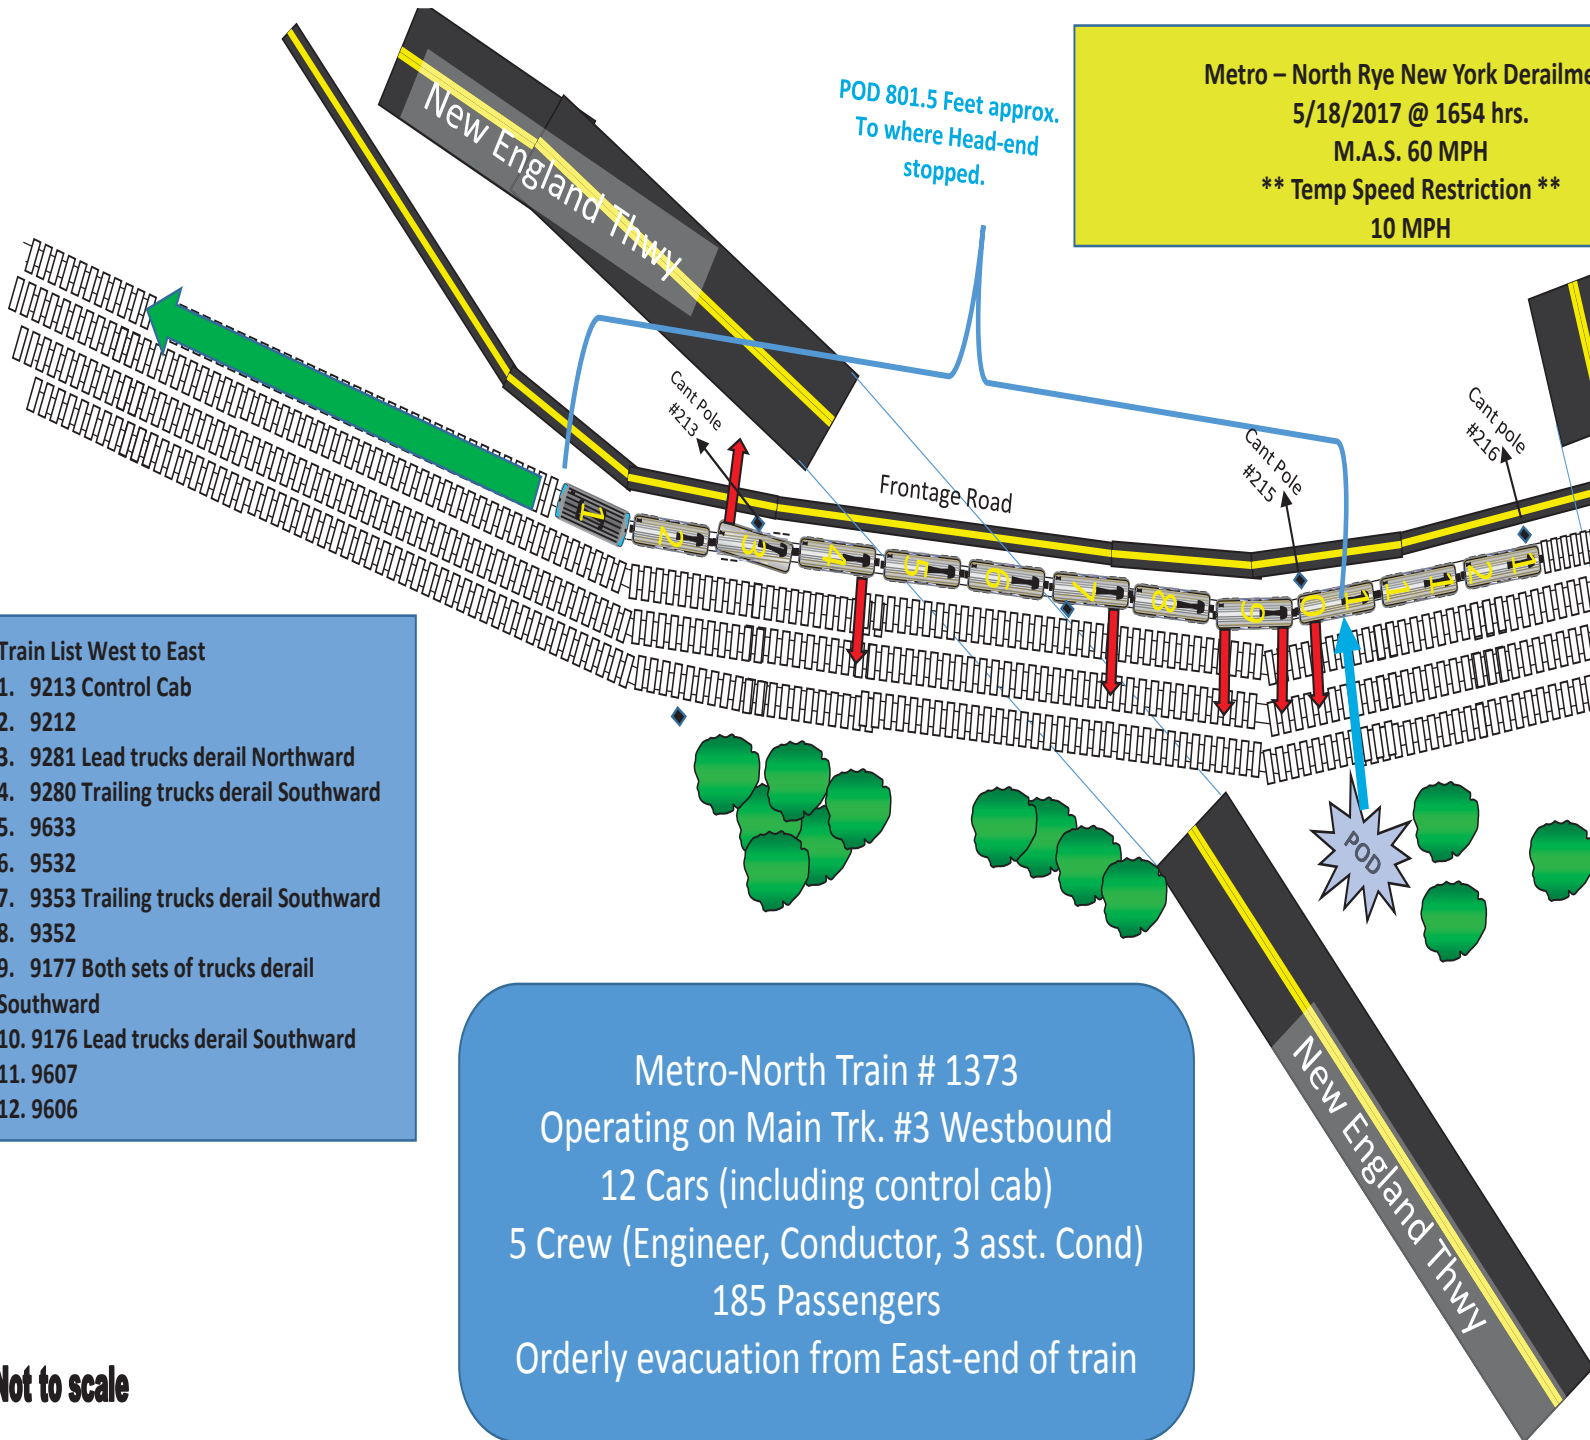
Accident Site Sketch

At 4:54 p.m., Train No. 1373's Engineer failed to comply with a 10-mph temporary speed restriction between Catenary Pole 216 (MP 24.6) and 214 (MP 24.49) on MNCW Main Track 3 in Rye, New York.

The train was traveling at a recorded speed of 56 mph at the point of derailment (MP 24.55). The excessive speed caused five of the twelve passenger cars to derail. Of the 185 passengers on the train, one reported minor injuries. Four crewmembers reported injuries.
