***Federal Railroad Administration
Office of Railroad Safety
Accident and Analysis Branch***

***Accident Investigation Report
HQ-2017-1212***

***Amtrak (ATK)
Steilacoom, WA
July 2, 2017***

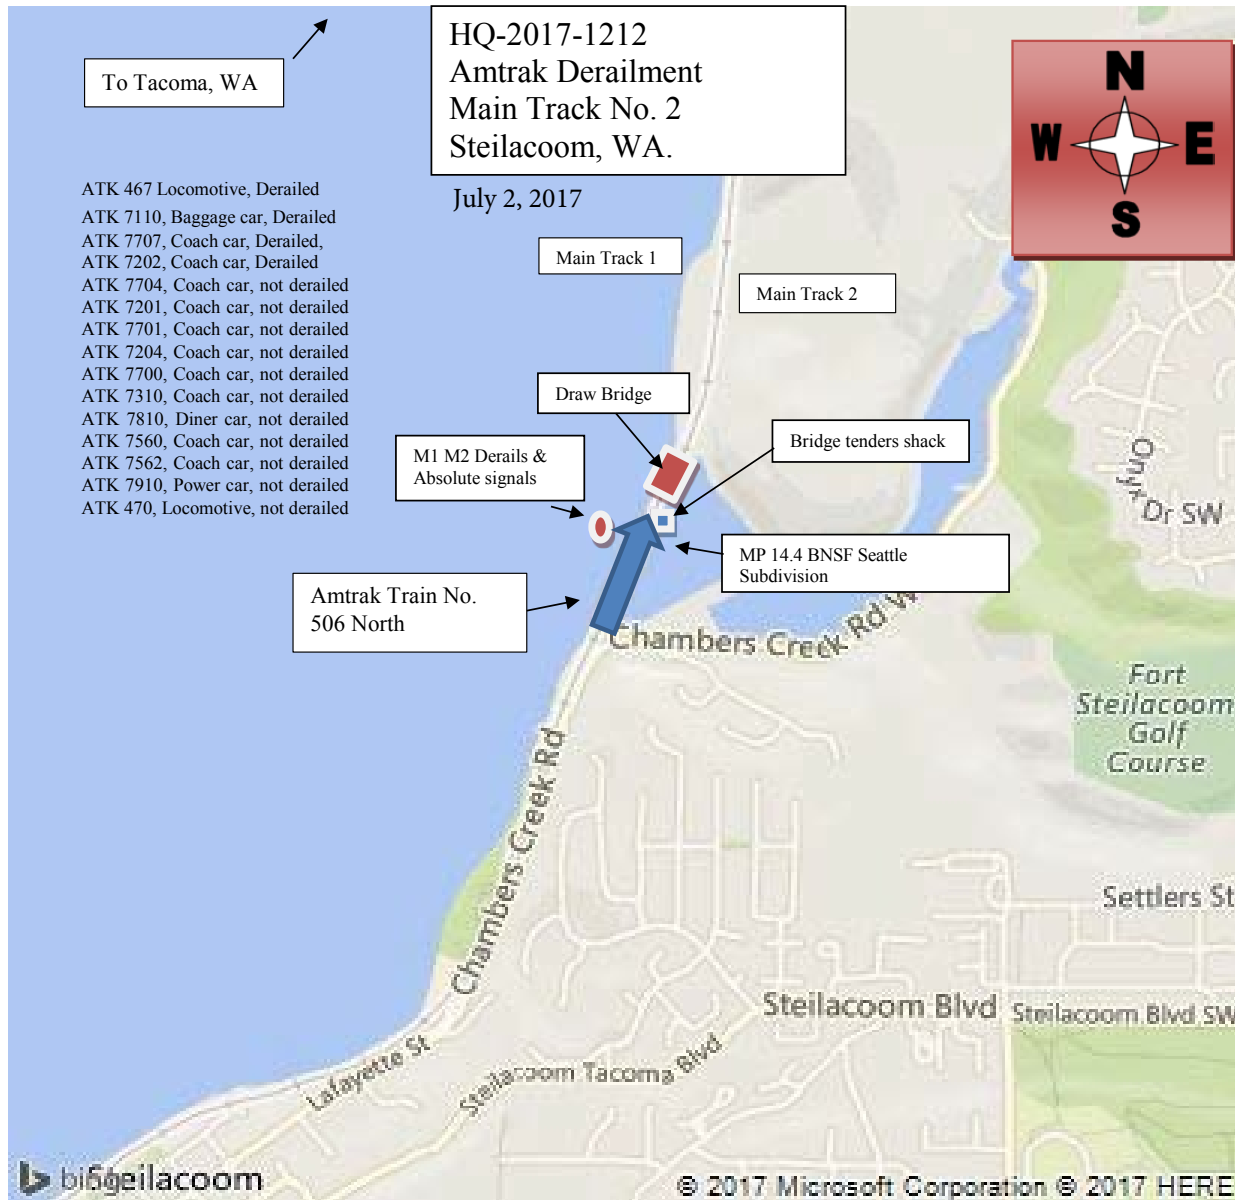
HQ-2017-1212 Sketch

Approaching the accident site from the south traveling north on Main Track No. 2 starting at MP 14.88, there is in succession tangent track, followed by a 3-degree curve and then tangent track for approximately 1000 feet to the absolute signal protecting BNSF Bridge 14 at MP 14.4 followed by the derail at MP 14.36. The tangent track continues north across BNSF Bridge 14 followed by a 3-degree curve which is approximately 1,100 feet in length. The grade is .28-degree ascending on the 1 mile of track prior to accident site, and the mile after the accident site the grade descends .28-degrees.

According to event recorder data and post-accident statements from the Engineer, Train 506 passed the approach medium signal at MP 19.4 at a recorded speed of 61 mph at 2:23 p.m. The train passed the approach signal at MP 16.6 at a recorded speed of 64 mph at 2:25 p.m. When the Engineer came around the curve at the park, he noticed BNSF's bridgetender in his orange vest walking along the right-of-way, and then he noticed the red signal. The Engineer made an emergency application of the air brakes and remembers calling out "emergency, emergency, emergency" over the radio. The train passed the stop signal at MP 14.383 at a recorded speed of 32 mph at 2:28 p.m., then hit the derail protecting

Bridge 14 at 15 mph, and derailed at 2:29 p.m.

Lead Locomotive ATK 467 landed on its side. The baggage car behind the locomotive, and two passenger cars also derailed and were leaning to the east, towards Chambers Bay.
