***Federal Railroad Administration
Office of Railroad Safety
Accident and Analysis Branch***

***Accident Investigation Report
HQ-2017-1237***

***CSX Transportation (CSX)
Union, NJ
December 8, 2017***

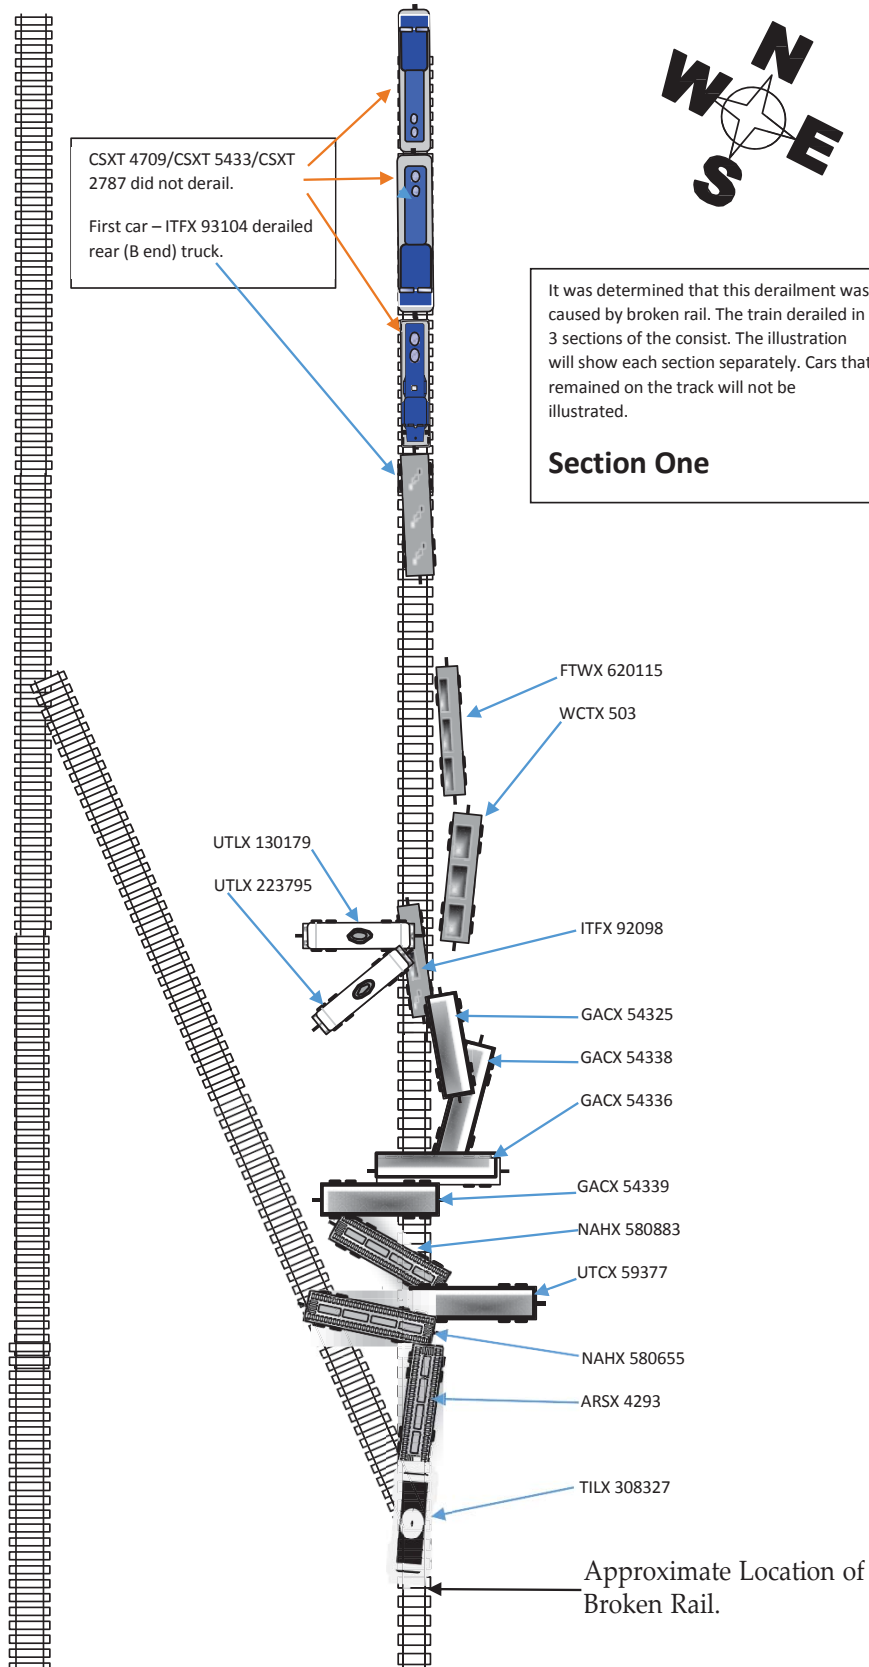
Sketch 1st section derailed

CSXT 4709/CSXT 5433/CSXT 2787 did not derail.
First car – ITFX 93104 derailed rear (B end) truck.

It was determined that this derailment was caused by broken rail. The train derailed in 3 sections of the consist. The illustration will show each section separately. Cars that remained on the track will not be illustrated.

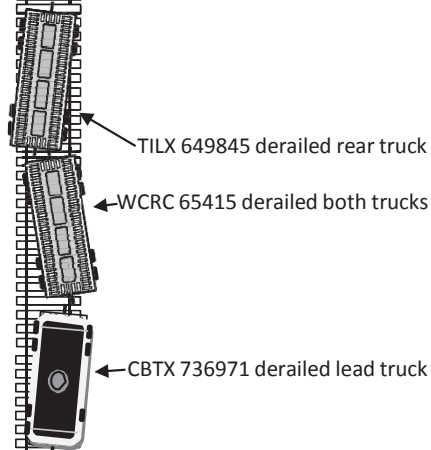
Sketch 2nd section derailed

Due to slack action, and other mechanical forces, a 3 car derailment occurred involving the 28th-30th cars in the consist.

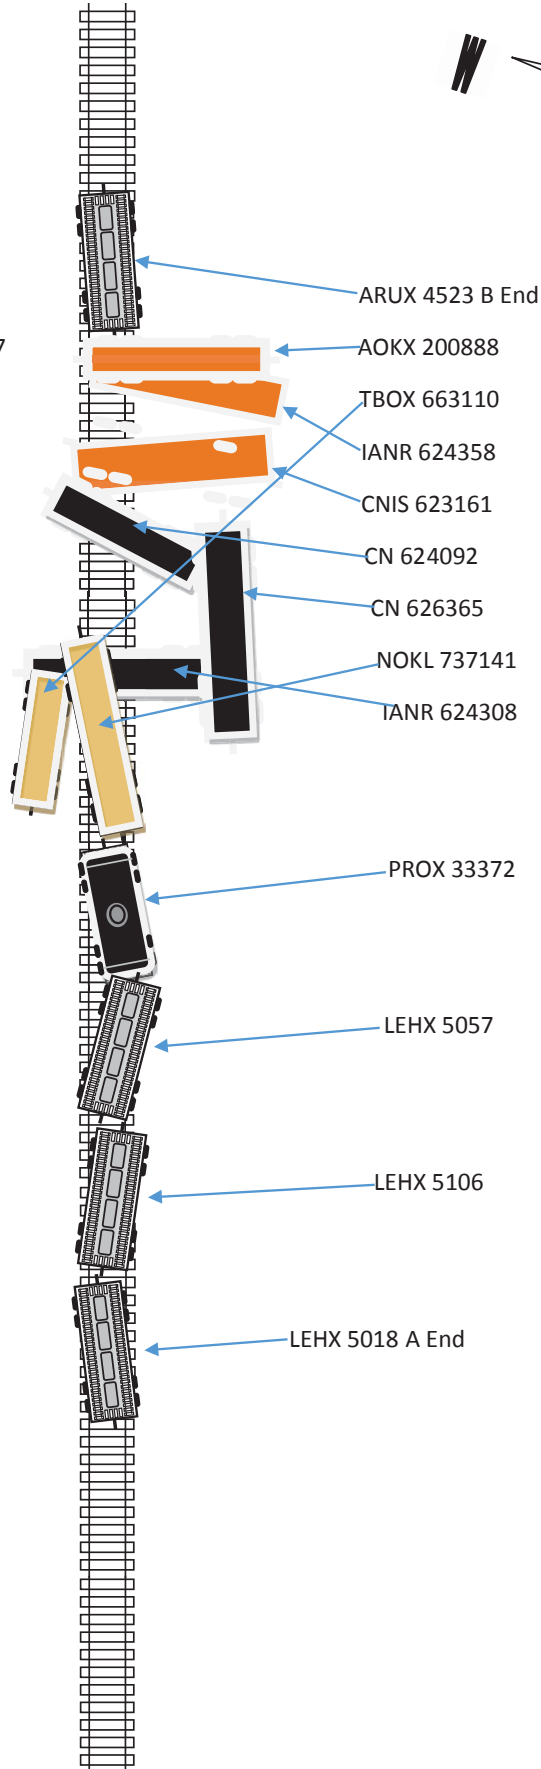
Sketch 3rd section derailed

Due to slack action and other mechanical forces, the 57th – 69th cars derailed. The relative light weight of some of the cars (empty lumber cars) contributed to the cars coming to rest in a general pileup in an accordion pattern.
