***Federal Railroad Administration
Office of Railroad Safety
Accident and Analysis Branch***

***Accident Investigation Report
HQ-2017-1207***

***Norfolk Southern Railway Company (NS)
Pell City, AL
May 19, 2017***

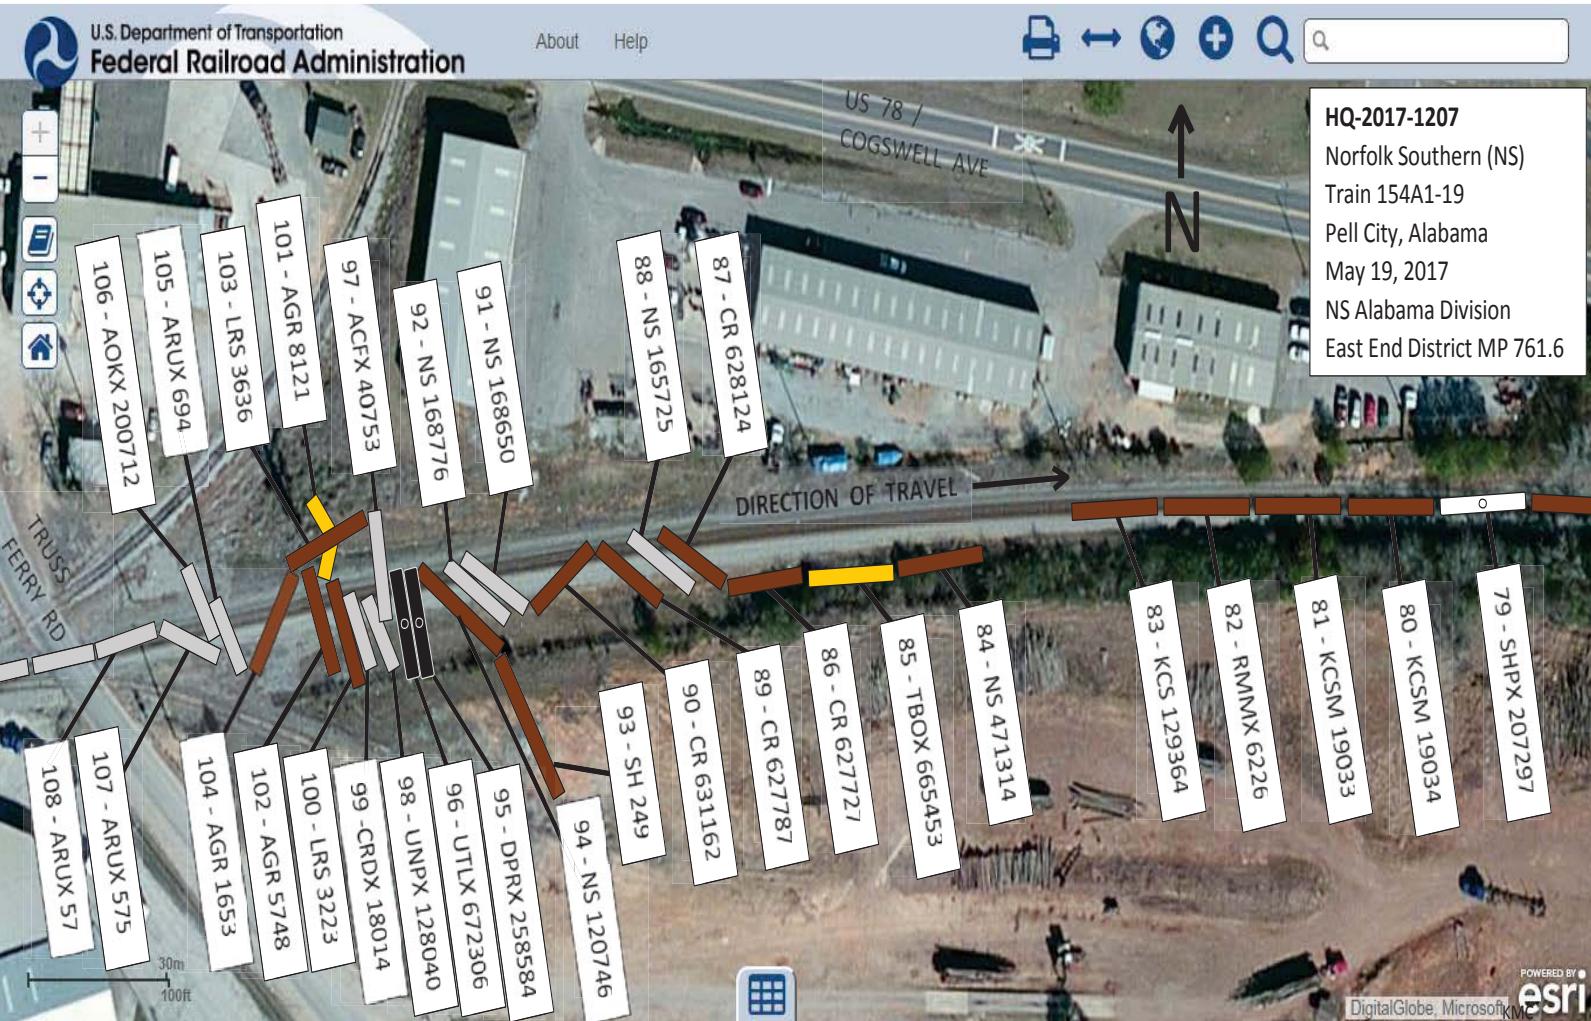
HQ-2017-1207
Norfolk Southern (NS)
Train 154A1-19
Pell City, Alabama
May 19, 2017
NS Alabama Division
East End District MP 761.6
