***Federal Railroad Administration
Office of Railroad Safety
Accident and Analysis Branch***

***Accident Investigation Report
HQ-2017-1234***

***Norfolk Southern Railway Company (NS)
Imboden, VA
November 18, 2017***

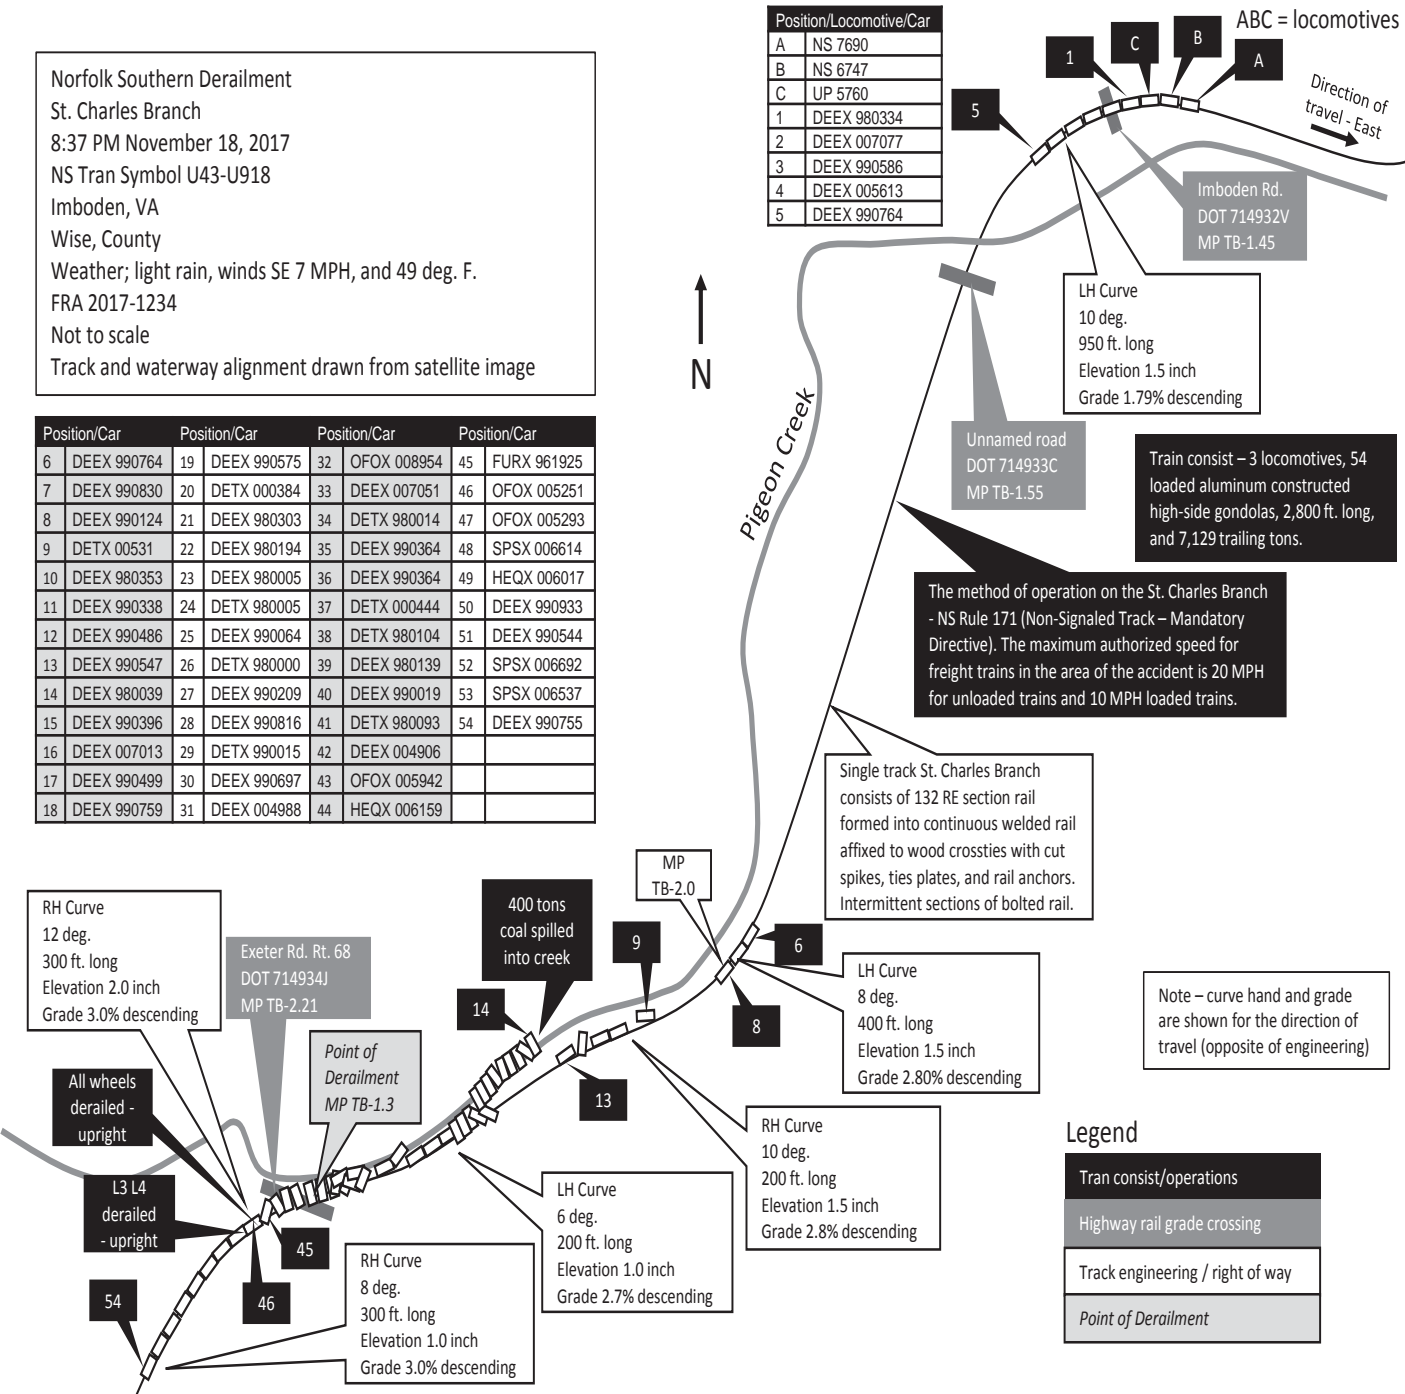
HQ-2017-1234 Site Sketch

Norfolk Southern Derailment
St. Charles Branch
8:37 PM November 18, 2017
NS Tran Symbol U43-U918
Imboden, VA
Wise, County
Weather; light rain, winds SE 7 MPH, and 49 deg. F.
FRA 2017-1234
Not to scale
Track and waterway alignment drawn from satellite image
