**DEPARTMENT OF TRANSPORTATION****Federal Railroad Administration**

[Docket No. FRA-2017-0074, Notice No. 2; Safety Advisory 2018-01]

**Addressing Electrode-Induced Rail Pitting From Pressure Electric Welding**

**Safety Advisory 2018-01**

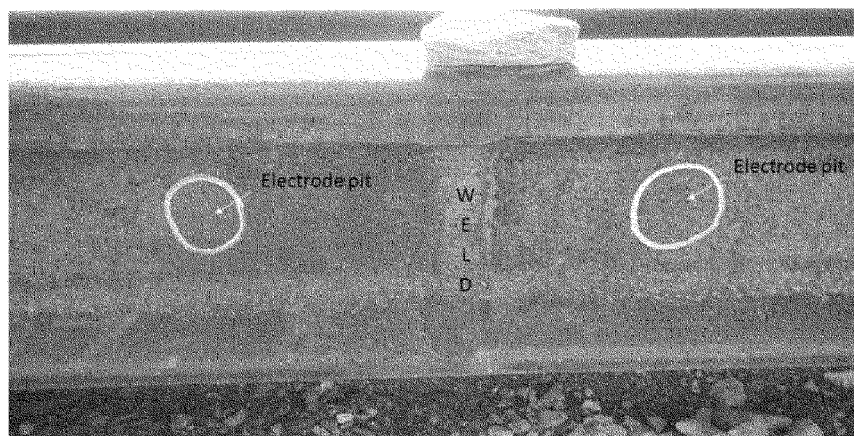
Figure 1 below shows a photograph of a rail with electrode pits in the web. The location of these electrode pits, when they occur, is typically four to eight inches on either side of the weld. Electrode-induced pitting from pressure electric welding may also occur in the head and base of the rail. It is unclear whether traditional ultrasonic rail

Figure 1: Electrode-Induced Pits in a Rail

FRA recognizes that the industry already has practices and procedures in place to avoid electrode pitting during the pressure electric welding process. Therefore, FRA is issuing Safety Advisory 2018-01 to remind railroads,

railroad employees, railroad contractors, and welding companies and their employees of the importance of complying with those procedures to prevent electrode pitting and, ultimately, to prevent rail failures. (FRA has posted a copy of this notice on its public website, [www.fra.dot.gov](http://www.fra.dot.gov), where you may view the figures below in their full resolution.)

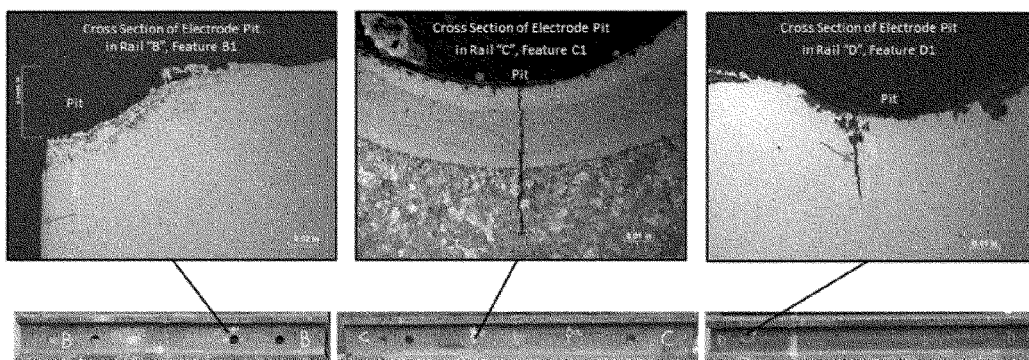
chromium, which were still within AREMA tolerances. Testing of the chemistry and the mechanical properties revealed all three rails were made from standard quality steel containing no other defects except the electrode-induced pitting.

Figure 3: Photographs of Rail Cross Sections
