Notice of Safety Advisory on RoadRailer Trailers

Agency: Federal Railroad Administration (FRA), DOT.

Action: Notice of Safety Advisory.

SUMMARY: FRA is issuing Safety Advisory 99-03 addressing the securement of floor beam cross-members on RoadRailer® trailers in order to prevent the highway tandem wheels on these trailers from falling onto the rails on moving trains.

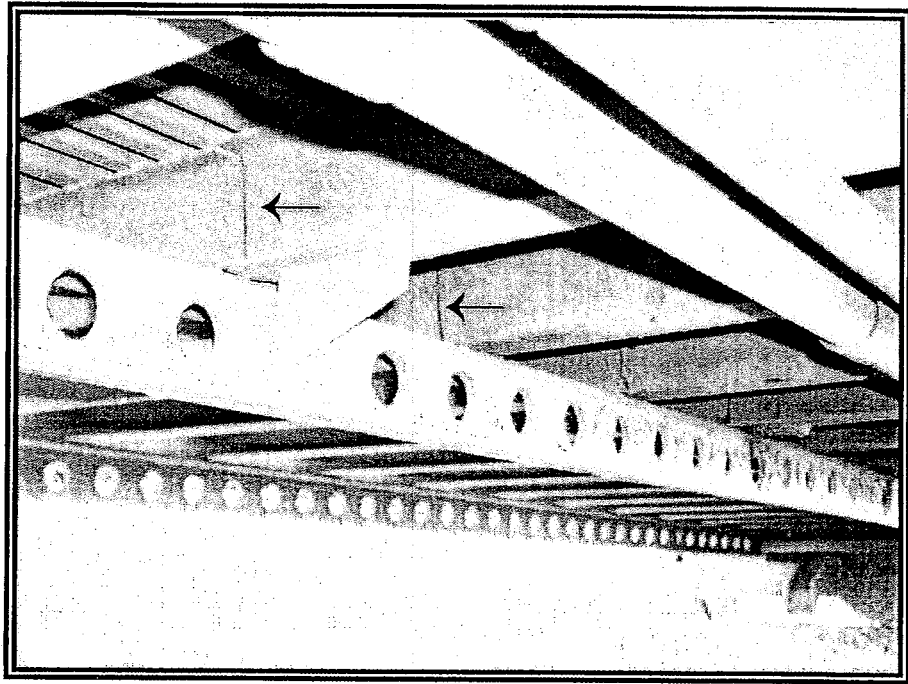
1. A weld crack at the slide rail to I-beam cross-member;
2. A crack in the cross-member I-beam flange (which usually starts at the end of a weld);
3. A crack which has progressed into the web of the I-beam from the flange; or
4. A cross-member broken into two pieces.

Figure 1 - Broken Floor Beam Cross-members

- Each trailer should be inspected upon receipt at a facility from a highway motor carrier prior to being transferred to the rail mode to determine whether it has any of the following conditions:
 1. One broken floor beam cross-member.
 2. Four successive cross-member with cracks.

If either of the conditions are found, the trailer should be held until a repair can be made to correct the deficiency, or if loaded, the lading should be transferred to another trailer that has been inspected and found not to have any of these conditions.

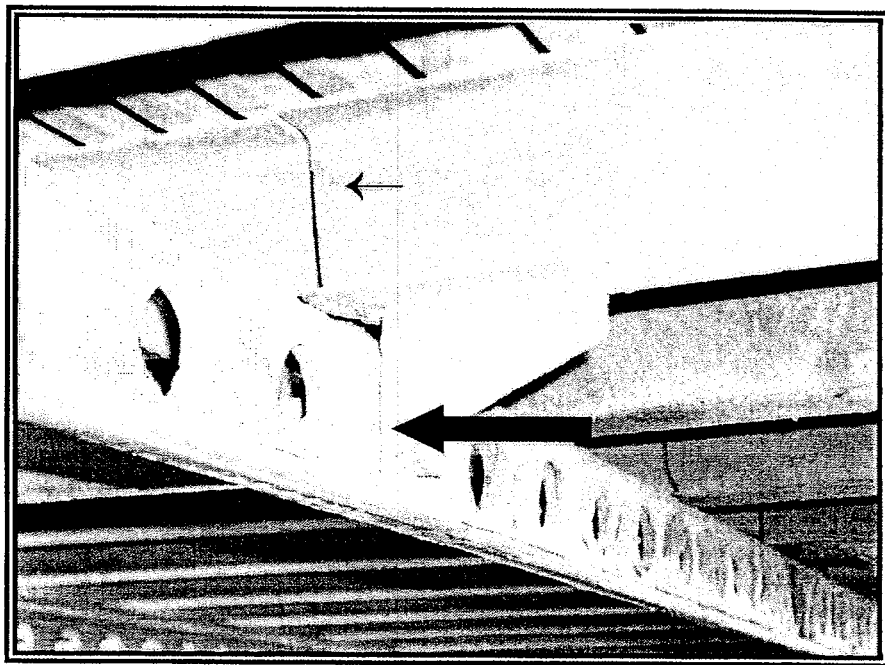
Figure 2 Broken Gusset Plate and Floor Beam Cross-members
